TITLE RC-44 (RC-V2) Motor Burnout #2 (OCONEE-1,2,3)

SITE PROBLEM REPORT

BABCOCK & WILCOX

CUSTOMER Duke Power Company	CONTRACT NO. 600-0003	SPR NO. 560	REV. NO. 0
VENDOR B. & W.	P.O. NO.	TASK NO. 28	GROUP NO. 41
SITE ENGINEER E. L. Logan	REQ'D. RESOL. DATE	REQ'D. COMP. DATE	
TITLE RC-4 (RC-V2) MOTOR BURNOUT

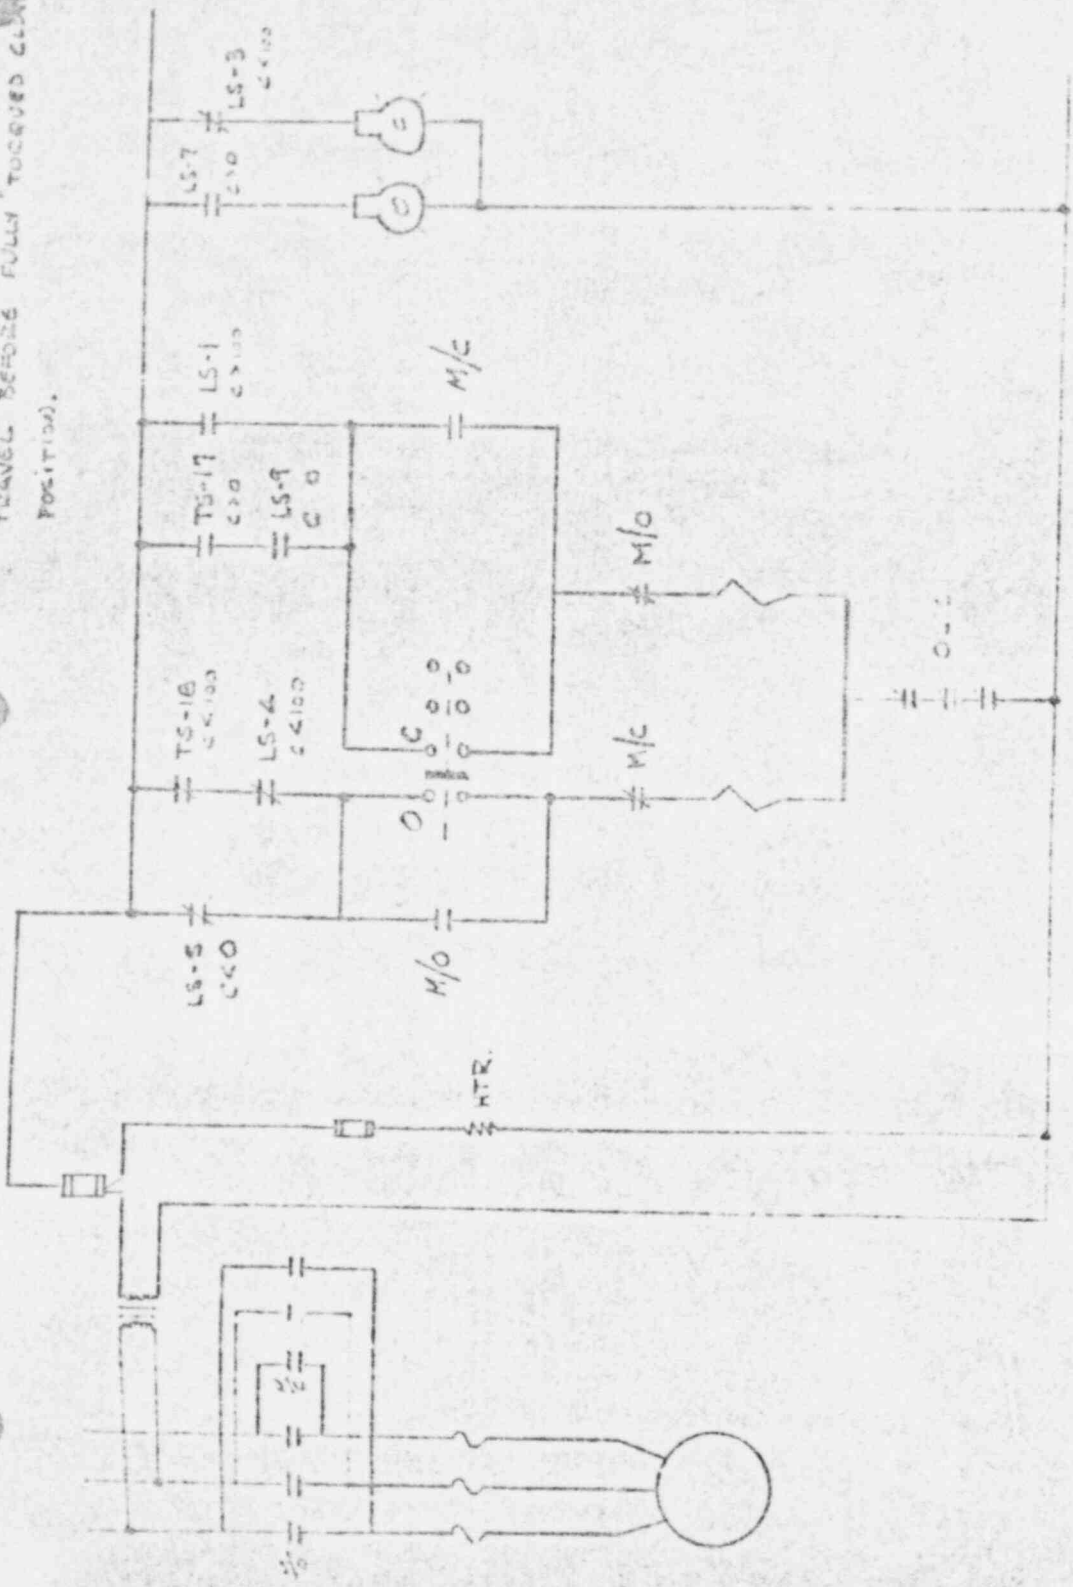
VALVE CONTROL CIRCUIT

NOTE: LS-9 ADDED 11/17/73 TO STOP VALVE TRAVEL BEFORE FULLY TO CLOSED POSITION.

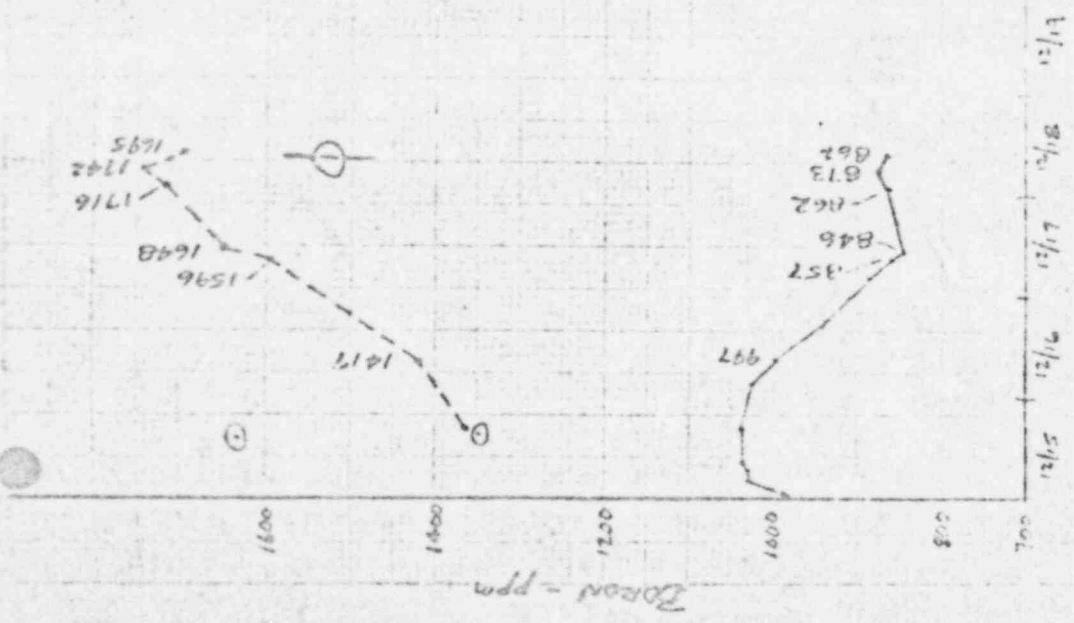
FIGURE 2

Since 12/15/73 we have been able to obtain comparative RCS and pressurizer boron concentrations. This is in response to SPR-557 and B. A. Karrasch's memo of 11/19/73. Figures 2 and 3 are plots of these values for both Units I and II. The Unit I continuous vent (.1 to .4 gpm) was secured on 12/17/73. Before the system is cooled down, we will investigate for leaking valves, etc. Unit II is indicative of normal operation since a conscious effort has been made to maintain RCS boron concentration constant with only the spray valve bypass flow into the pressurizer.
