OCONEE - 1,2,3

FIELD OPERATIONS SITE PROGRAM REPORT

TITLE (MAX. 30 SPACES) RCV Steam Leak

PRESSURIZER SPRAY LINE VALVE LEAKAGE PROBLEMS
(RC-VI & RC-V5)

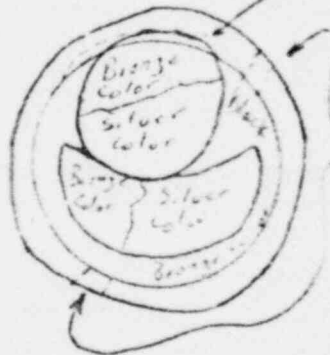
Disk - Disk back seat (on disk nut) is heavily scored while main seat remains in good condition. The inner surface of the disk nut is heavily scored with material deposited on it, possibly from stem.

a. The bottom of the disk nut shows evidence of wear on the inside diameter surface. *See photo #2*

b. A bronze colored ring was found loose under the disk nut. Thickness was .017 to .030 inches

c. Under stem there is an area which could be the stellite bearing pushed and broken, or it could be the bottom of the stem, $\approx 1/32$ of an inch thick. This piece is pushed into a groove in the body of the disk

See photo #2

Holes through disk

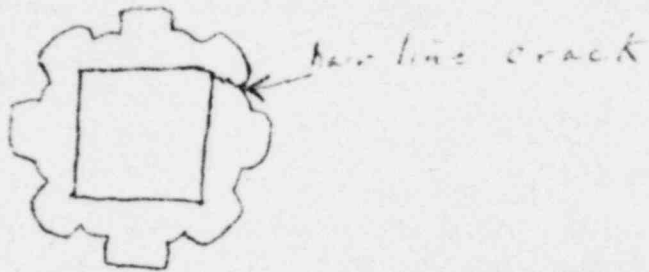
Yoke Bushing - Inner threads stripped out in a coil when the unthreaded portion of the stem was torqued through the bushing.

Junk Ring - Outer surface shows evidence of galling and wear.

Bonnet - Back seat area shown excessive wear as does back seat area of disk nut.

spline - Connects valve stem to operator - shows evidence of excessive wear and has a hair line crack.

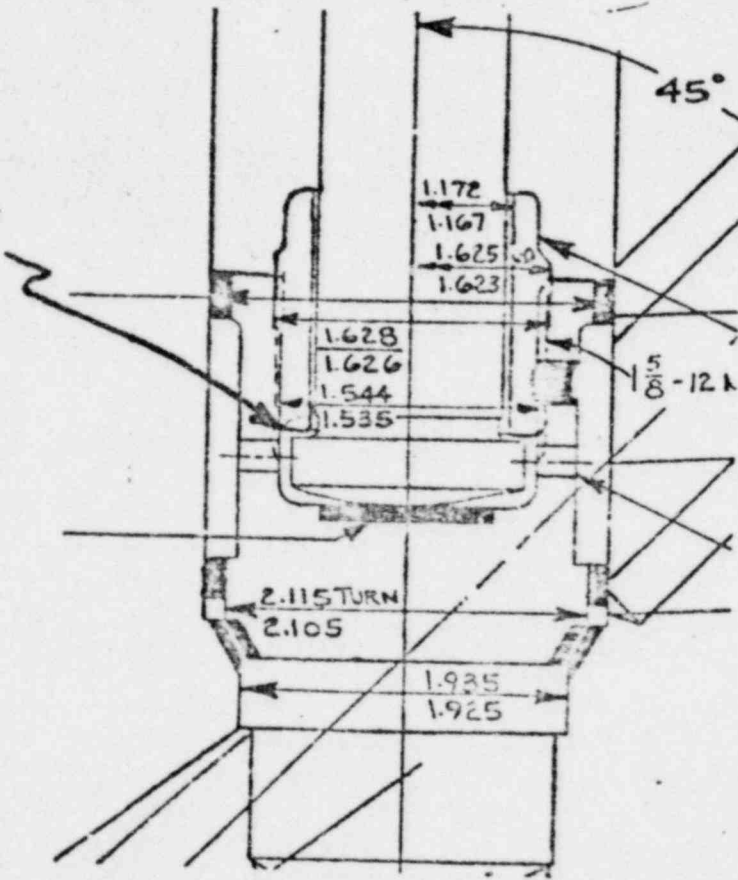
ATTACHMENT #1

Rockwell does not believe it credible that the stem shoulder was only 1/16" thick as was reported in SPR-444. The attached sketch shows the actual size of the component parts and the entire stem is machined from a single piece of bar stock. Based on visual observations by the writer, it appears that the end of the stem was worn away by the grinding action due to repeated

cycling of the valve after initial damage occurred. The two holes in the disk are to prevent pressure buildup in the cavity inside the disk.

THIS SURFACE
IS STELLITED
