U. S. ATOMIC ENERGY COMMISSION
REGION II
DIVISION OF COMPLIANCE

Report of Inspection

CO Report No. 50-269/71-3

Licensee: Duke Power Company
Oconee 1
License No. CPPR-33
Category B

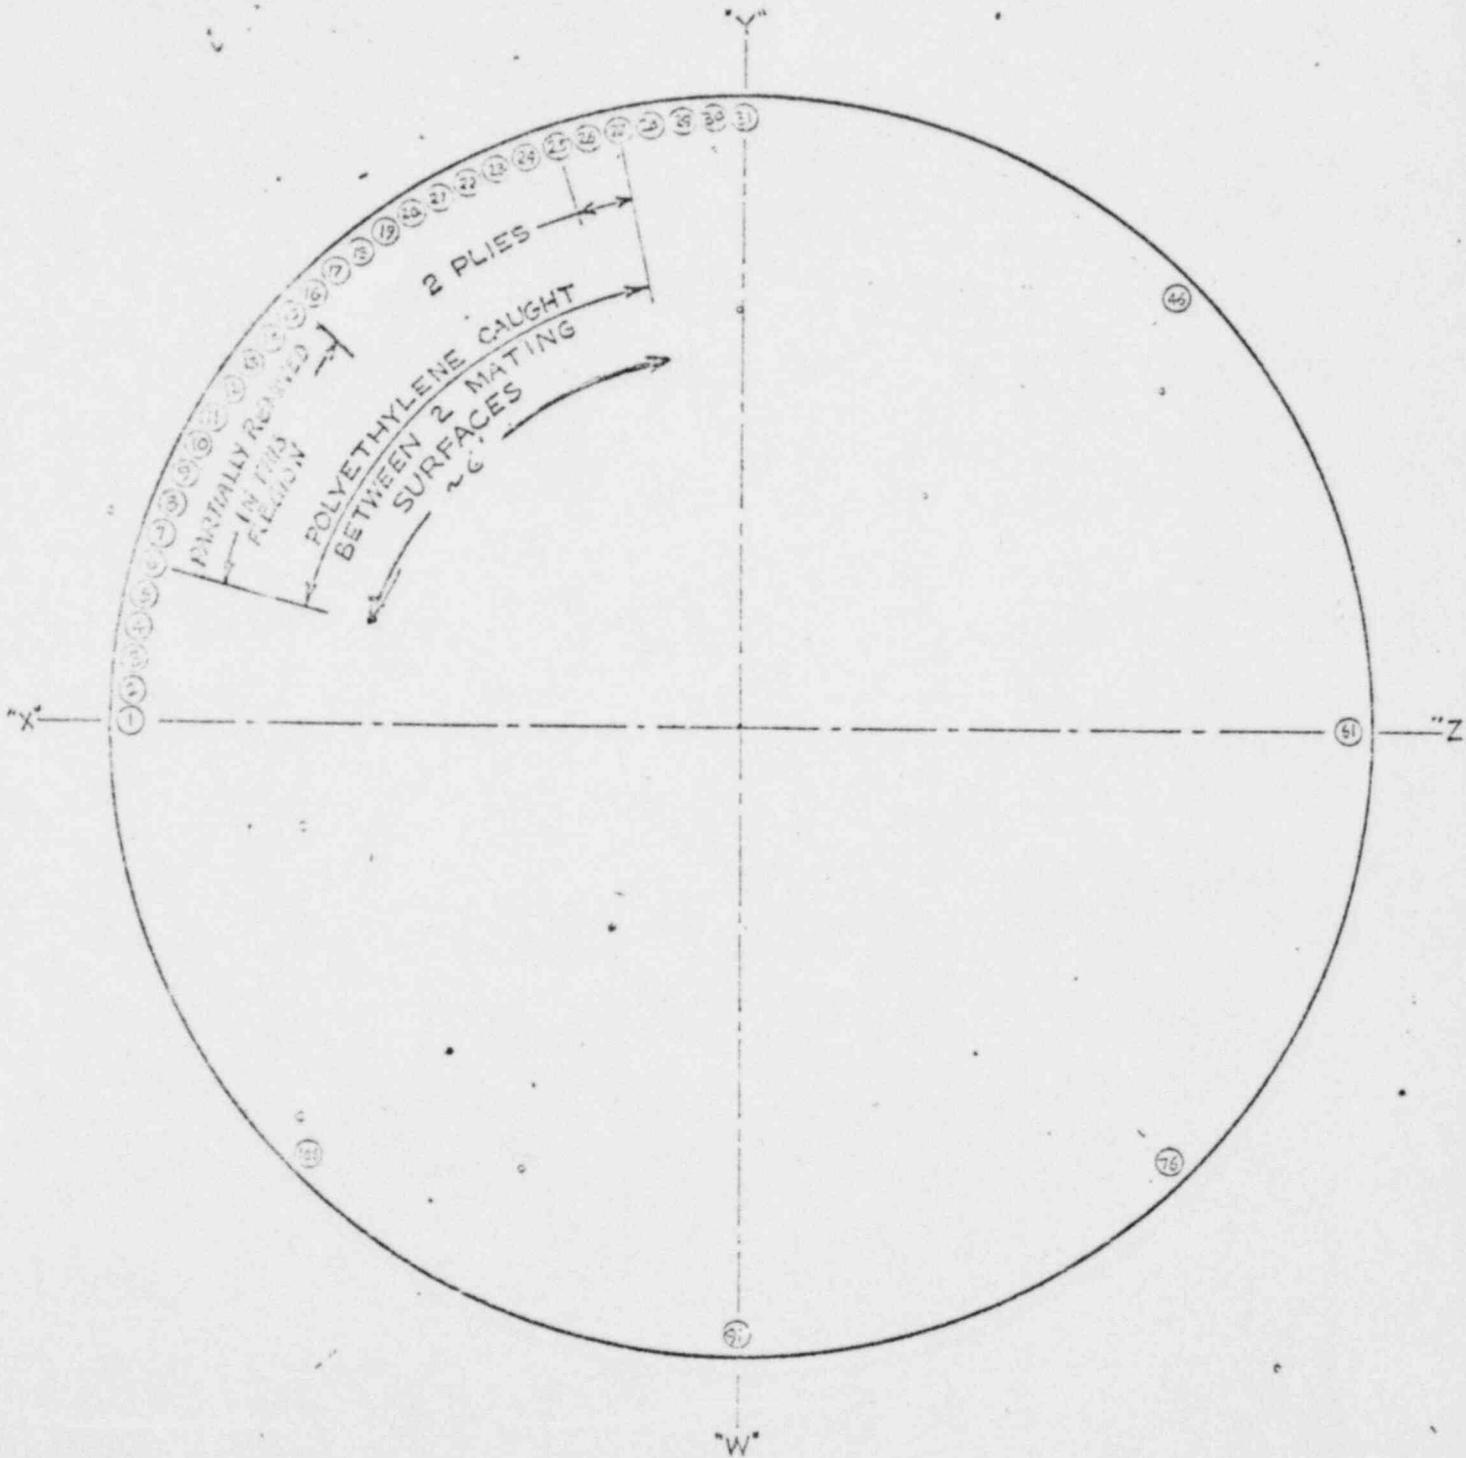
After all bolts had been installed and their retaining clips had been tack welded to them, it was found that one section of polyethylene about six feet long had been trapped between the mating surfaces. (See Exhibit B.)

The licensee attempted to pull the trapped material out and succeeded in removing a strip approximately three feet long. The width of this strip was approximately 1/8 inch. Attempts to remove the remaining piece were unsuccessful. The licensee estimates that the remaining piece is 1/8 to 3/16 inch wide and 3 feet long. Since the distance from the bolt holes to the edge of the flange is 5/8 inch, the licensee is of the opinion that this would represent the maximum possible width of the strip. Two plies of the material are trapped for a distance of about six inches at one end. The licensee has made tests of the polyethylene sheet and found that when compressed to the degree calculated to be approximately represented by the torqued bolts, that the thickness is reduced from 4 mils to 1 mil. The

licensee has postulated that the polyethylene will melt during operation and does not consider that the relaxation of the bolts will be a problem. If the material does melt and is released into the system, the licensee feels that it will be trapped in the purification system filters or will plate out on the steam generator tube sheets. The studies were not complete as yet and Hunnicutt was not able to state what would be the effects of the material in other portions of the coolant system. Both the licensee and B&W are having chemical analyses made of the polyethylene to determine if any halogens are present.

BOLT CIRCLE BETWEEN MATING FLANGES OF THE CORE SHIELD & CORE BARREL SHOWING LOCATION OF TRAPPED POLYETHYLENE
