BAW-1363
December 1970

Analysis and Resolution of Dye-Penetrant
Indications in Submerged Arc Weld
Cladding of Reactor Coolant
System Straight Piping

Duke Power Company
Oconee Unit 1

BABCOCK & WILCOX
Nuclear Power Generation Department
Components Engineering
Barberton, Ohio

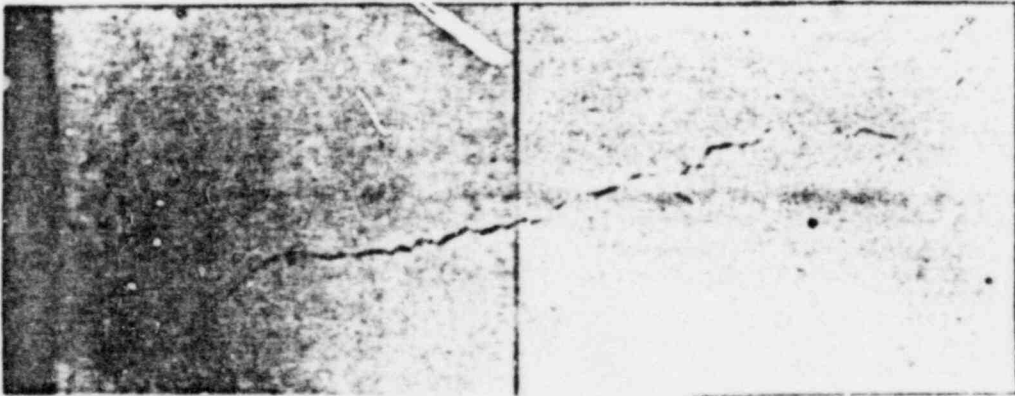
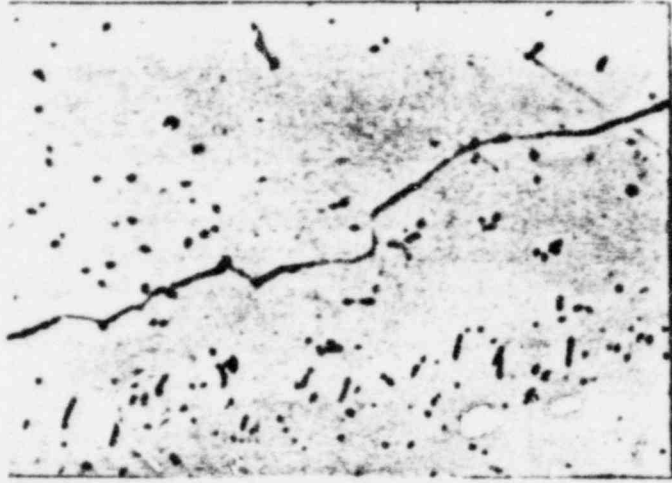
Figure 1 shows photomicrographs of etched and unetched cross sections of typical fissures removed from the same piece of excess length previously discussed. The location of the sample for metallographic examination was immediately adjacent to the area where the ferrite was checked by Severn Indicator and found to be less than 1-1/2%. Metallographic examination, as shown in Figure 1, confirms the low ferrite content of the cladding in this area. It is clear that the indications are typical micro-fissuring caused by insufficient delta ferrite and are therefore defined as such. These photographs should be compared with those shown in Figure 2, the latter illustrating a normal submerged arc weld made by the same procedure, with sufficient delta ferrite. The uncorrected Severn Ferrite Indicator reading of the sample illustrated in Figure 2 shows it to contain 9% to 10% ferrite.

Chemical analyses of five representative areas in the 20 inches of excess length removed from the B-67 pipe are shown in Table II. This analysis confirms the results obtained from both the Severn ferrite check and the metallographic examination which had indicated that the ferrite content was less than 1-1/2% in the area of fissuring. The calculated level of ferrite in this area of the cladding, based upon the Schaeffler diagram, ranges from 0 to 2%.

The low ferrite content of this weld metal results in part from the unusually high carbon content of 0.089 to 0.097% in this portion of the cladding. Carbon will reduce the ferrite content of the weld metal very rapidly; for example, carbon is 30 times as effective as the same percentage of nickel. This effect is demonstrated both by the Severn gauge data as well as by the Schaeffler Calculations. It should be noted that the chrome and nickel contents of this portion of the cladding are on the high side in spite of the high carbon level. This occurs as a result of the previously discussed flux inhomogeneity which changed the weld penetration, thus resulting in greater dilution with the

TRANSVERSE CROSS SECTION OF TYPICAL MICROFISSURES IN SUBMERGED ARC CLADDING ON B67 RETURN COOLANT PIPING - OCONEE No. 1. THE CENTER PHOTOGRAPH SHOWS A CAST DENDRITIC STRUCTURE. SOME DELTA FERRITE IS VISIBLE AT 500X MAGNIFICATION; THIS IS INSUFFICIENT TO PREVENT MICRO FISSURES DURING COOLING.

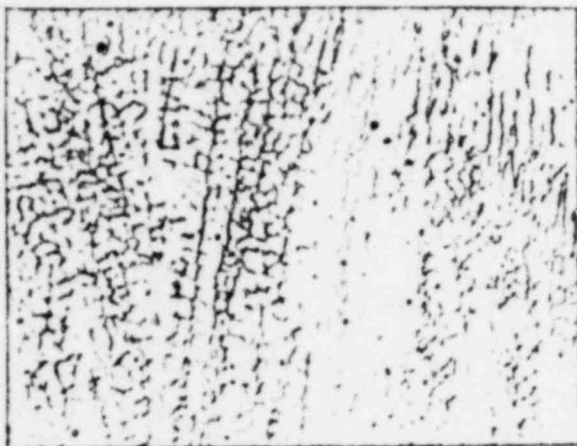
Transverse cross section of typical Stainless Steel Weld Deposit made by B&W multi-wire submerged arc process. This sample shows sufficient delta ferrite to prevent hot short micro-fissures during welding.
