BAW-1364  
December 1970

Analysis and Resolution of Dye-Penetrant  
 Indications in AISI-304 Alloy Cladding of  
 Reactor Coolant System Elbows

Duke Power Company  
 Oconee Unit 1

BABCOCK & WILCOX  
Nuclear Power Generation Department  
Components Engineering  
Barberton, Ohio

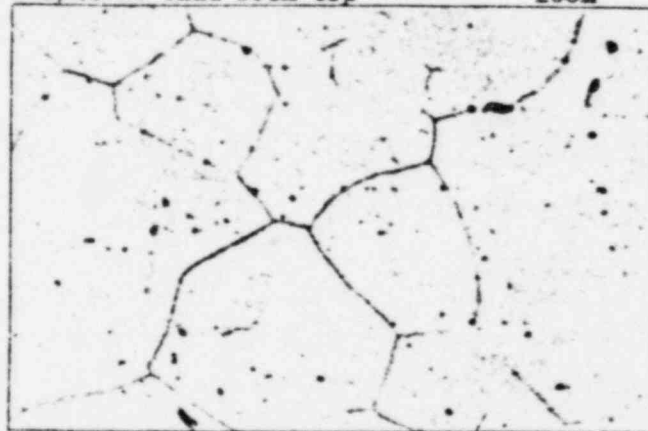
Figure 1 Structure of Explosive Cladding as Received

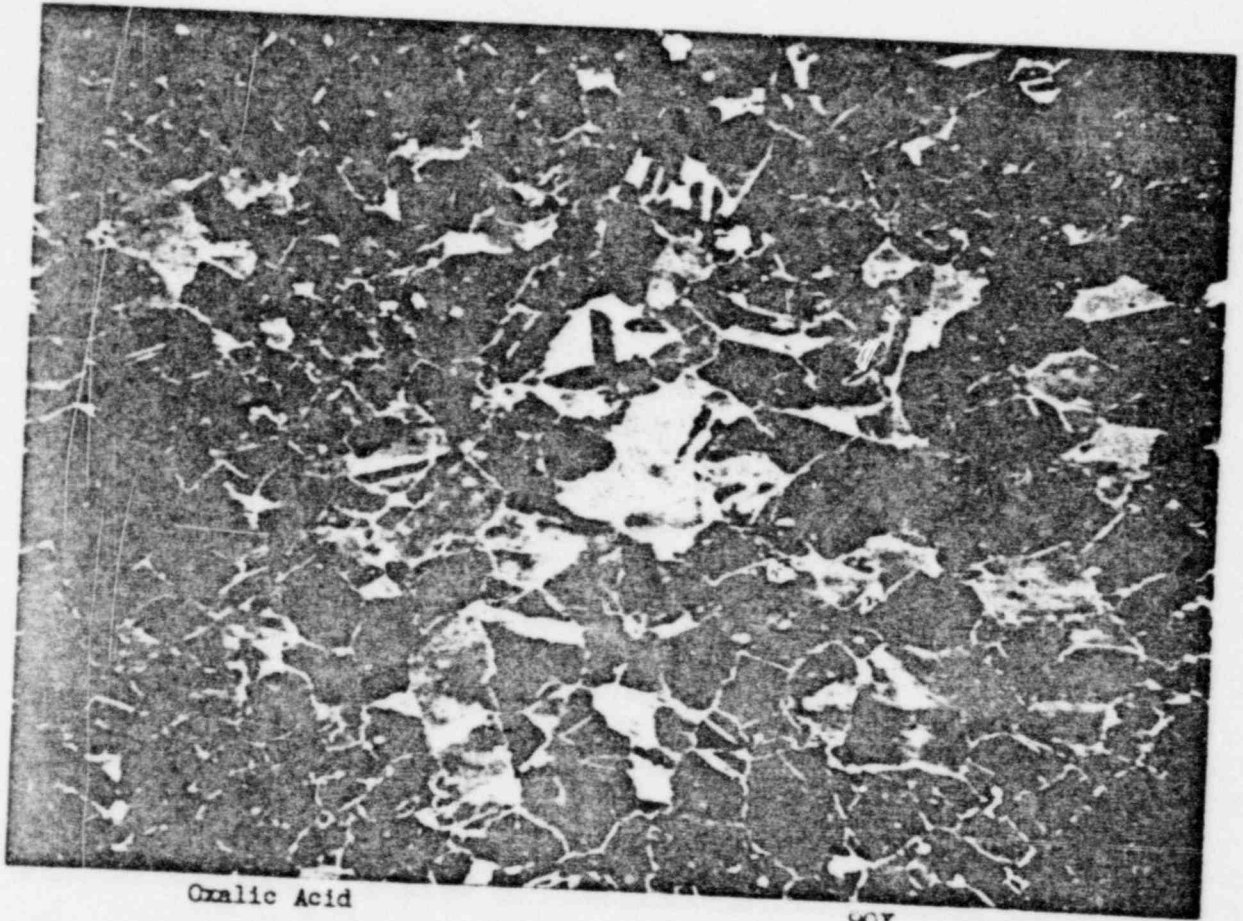
Figure 2 Structure of Explosive Cladding after Thermal Treatments During Elbow Fabrication Before Bend

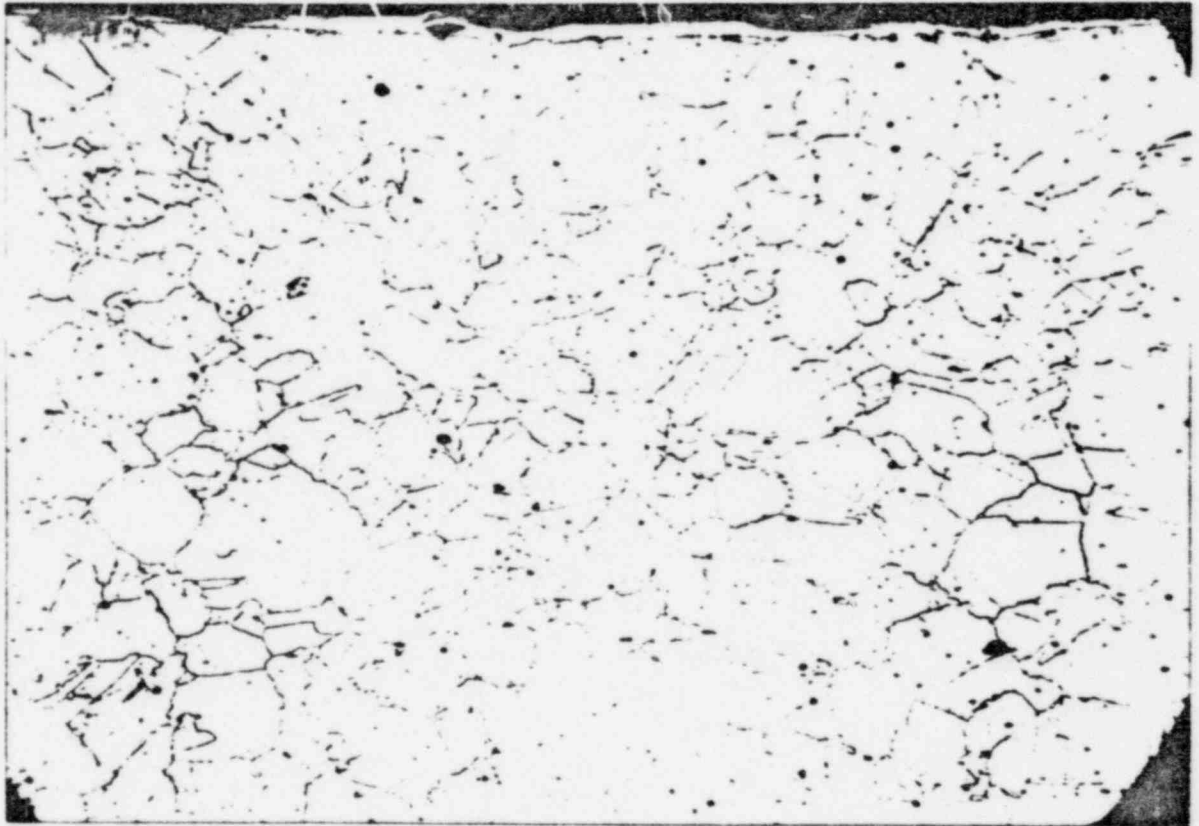
Figure 2A Structure of Explosive Cladding after Thermal Treatments During Elbow Fabrication Before Bend

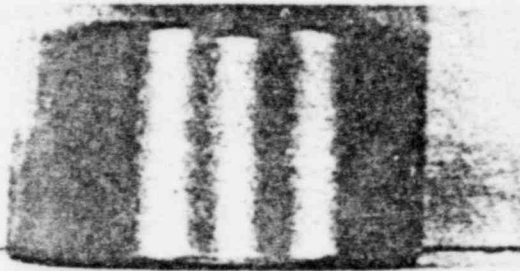
Figure 2B - Bend Specimen of Explosive  
Cladding After Thermal Treatments  
During Elbow Fabrication.

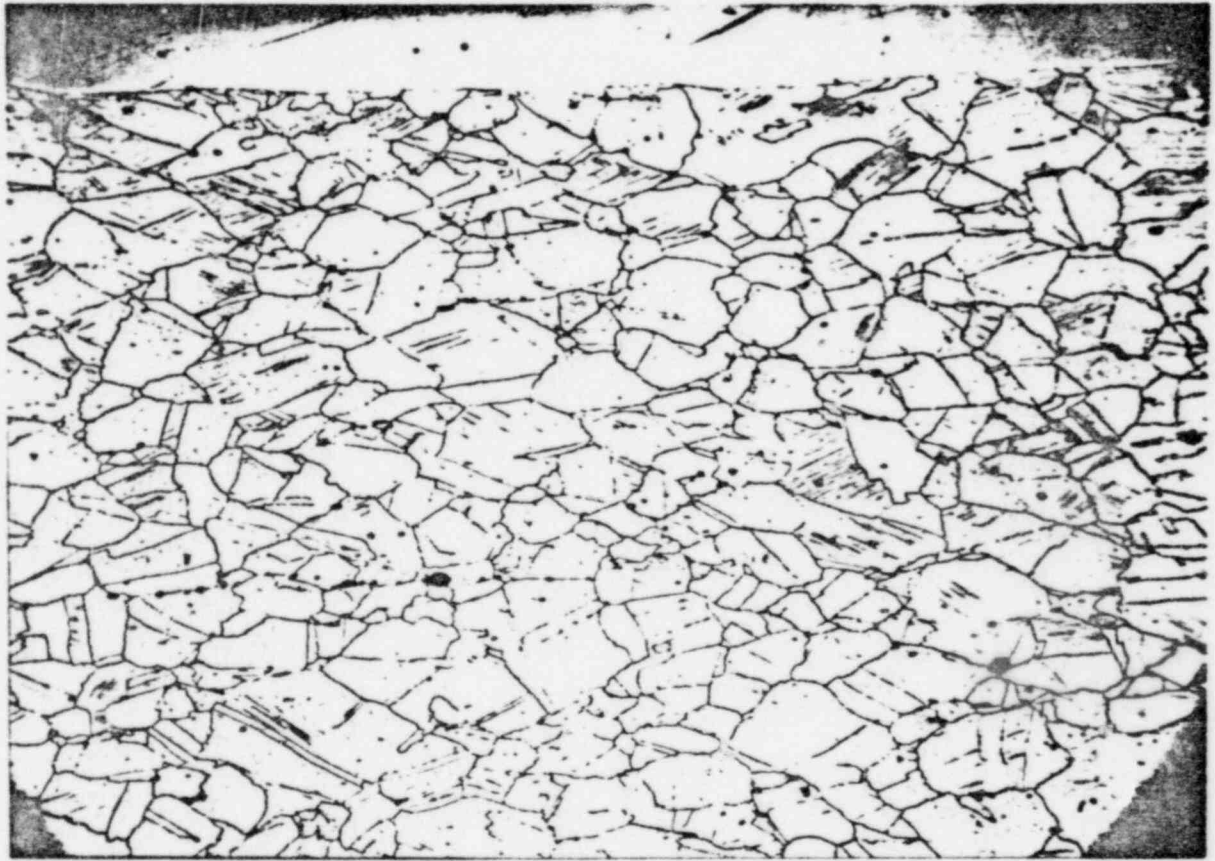
Figure 3 Structure of Explosive Cladding After Bend  
Test to Evaluate Room Temperature Ductility

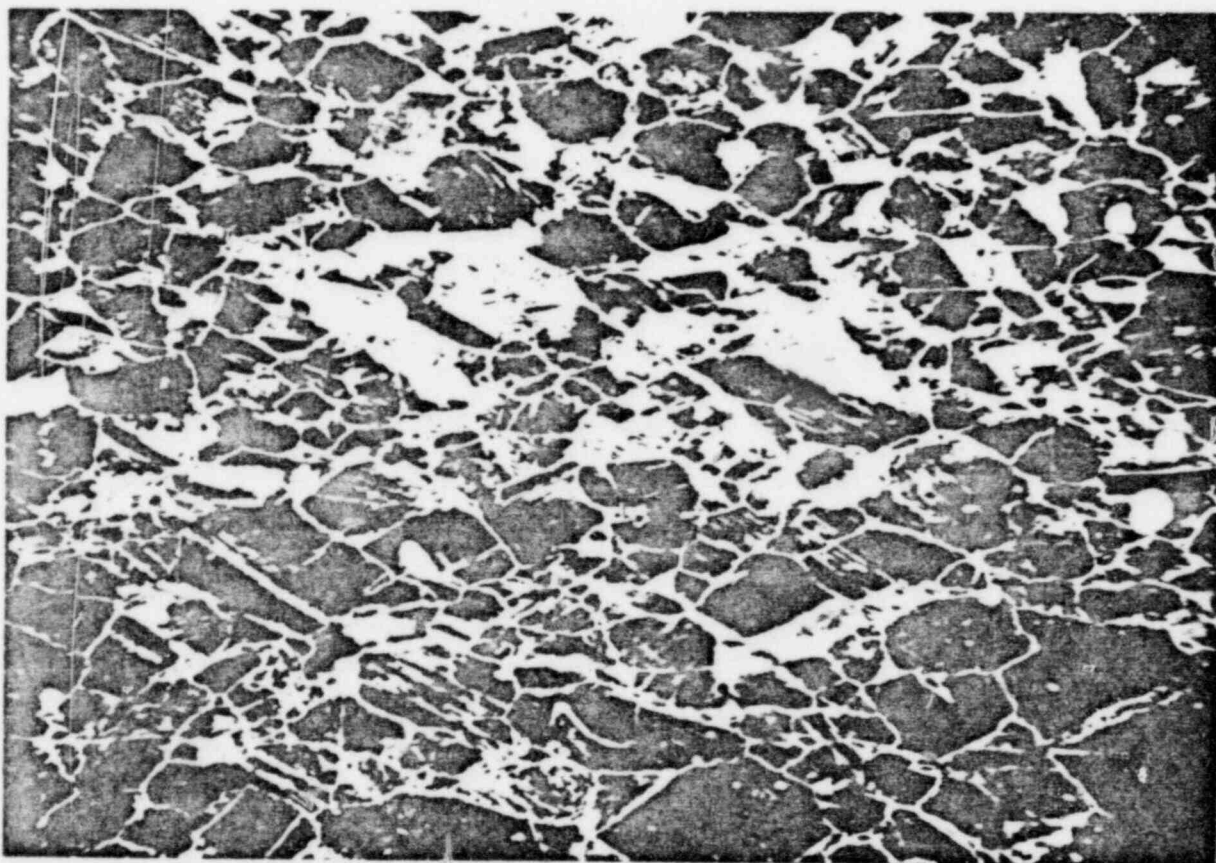
Figure 3A Structure of Explosive Cladding After Bend  
Test to Evaluate Room Temperature Ductility

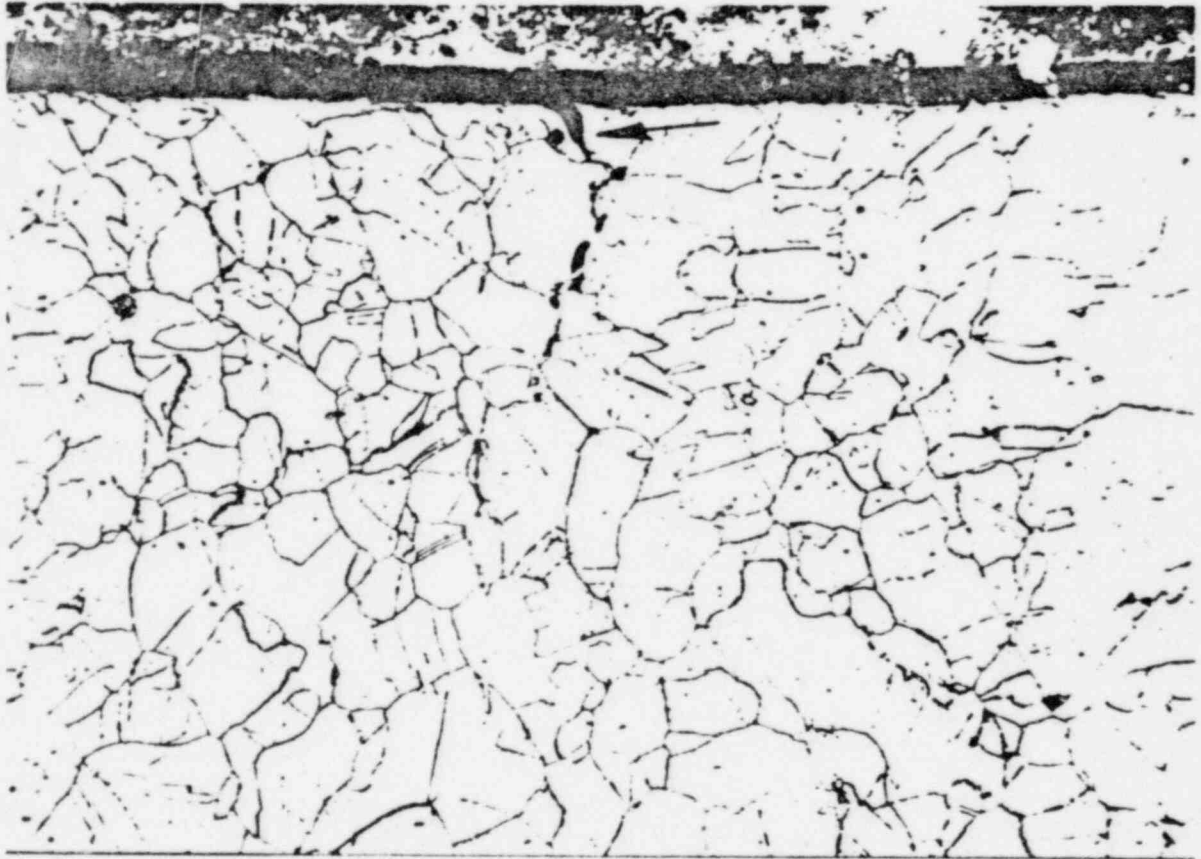
Concurrent with the corrective work at the site, B&W's Alliance Research Laboratory conducted a metallographic investigation of the samples received from affected areas in elbow found in Mt. Vernon as well as some of the cladding material provided by Barberton. Metallographic examination of the surface of the cladding material in the as-received condition indicates this material to be annealed AISI 304 with a perfectly normal microstructure, as shown in Figure 1. Typical chemical analyses of the AISI 304 cladding used for the Oconee Unit 1 elbow cladding are shown in Table 3. In the course of processing the plate into an elbow in the B&W shops, the cladding material is heated to about 2000F. This is followed by slow cooling. The slow cooling from elevated temperature results in almost complete precipitation of the carbides in an intergranular manner. Figure 2 shows the structure of the explosive cladding at 90X under polarized light. Figure 2A illustrates the structure under normal illumination. In order to illustrate that the carbide precipitation does not adversely affect the mechanical properties of the cladding, bend specimens were prepared from the excess material of one of the elbows after complete processing. The bend specimen indicates the material to be sound and ductile, as would be expected from this material. A typical bend specimen is shown in Figure 2B. Figure 3 depicts the microstructure from the bent portion of the bend specimen. The cold work produced by the small amount of elongation involved in bending is reflected in this photomicrograph. Figure 3A illustrates the same structure under polarized light. Typical fissures found in specimens removed from areas that showed dye-penetrant indications are shown in Figures 4 and 5. Figure 4 is a view of a fissure in the unetched condition at 100X, and Figure 4A shows an etched view of the same fissure. Figure 5 shows another fissure in the

Figure 4A Typical Fissure Found in Explosive Cladding  
After Quench and Temper

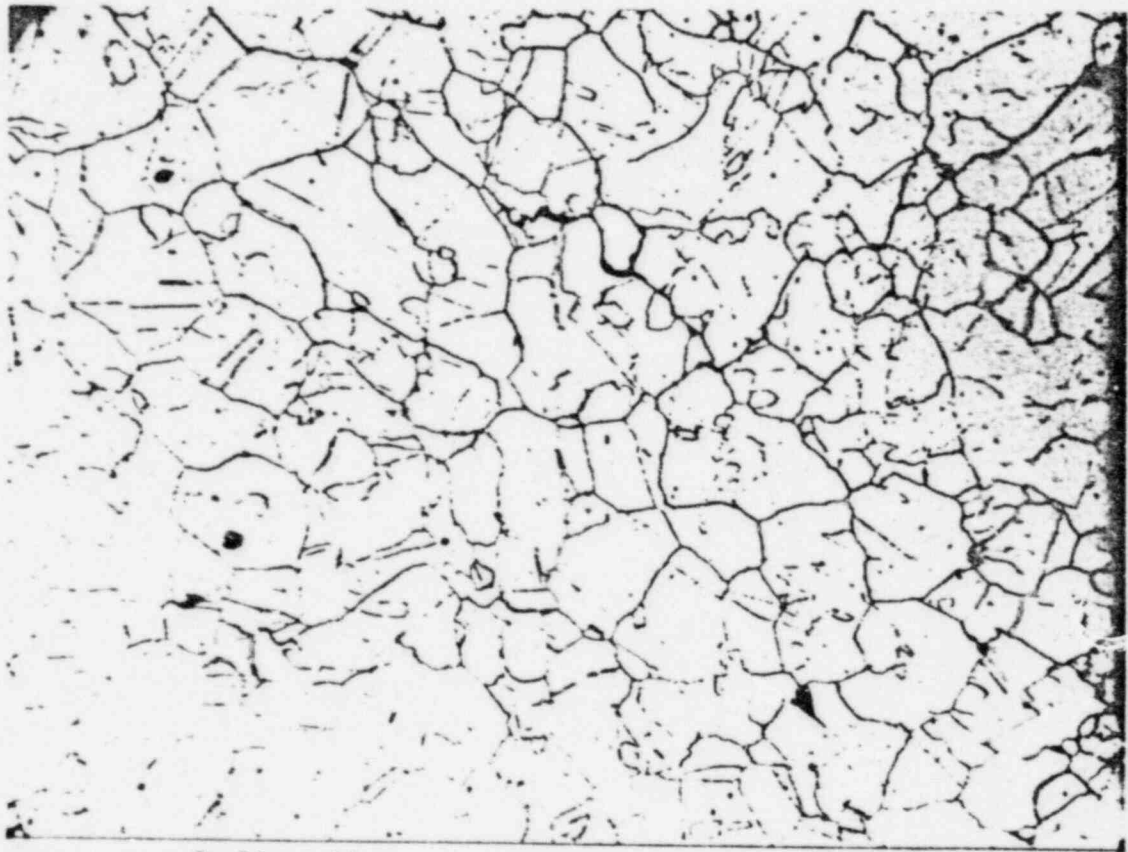
unetched condition, and Figure 5A shows the same view after etching. It is by these findings that the indications are defined as micro-fissures.

Figure 5A Typical Fissure Found in Explosive Cladding  
After Quench and Temper
