Report No.: RO-287/76-18

Facility: Oconee Unit 3, Seneca, South Carolina

Identification of Occurrence: Partial flooding of the Turbine Building

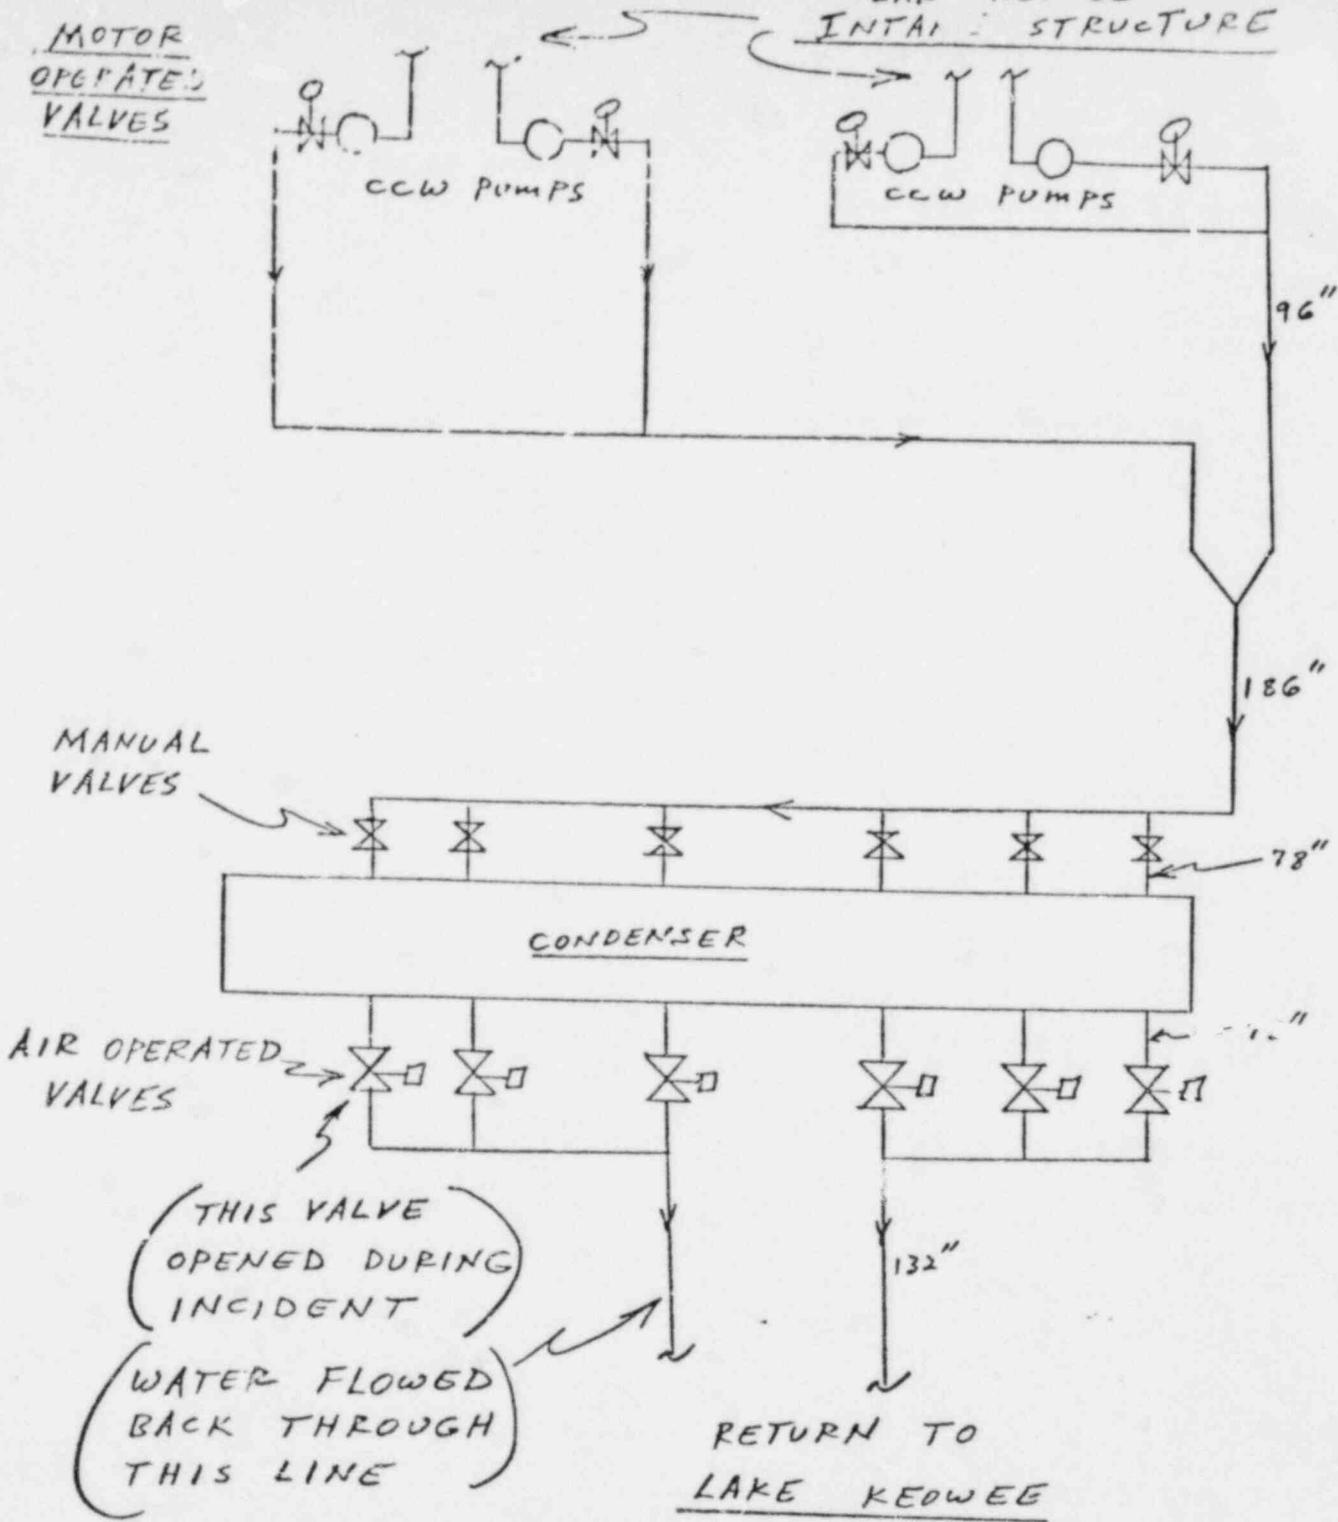
CONDENSER CIRCULATING WATER SYSTEM (OCONEE)

The sequence of events which caused the flooding was initiated by the loss of the 3DID static inverter which supplies 125 volt AC power to the vital instrumentation panelboard 3KVID. Panelboard 3KVID supplies power to the CCW vacuum priming system which controls the four-way solenoid valves which direct air to the opening or closing side of the pneumatic piston-operated CCW discharge valves. Deenergization of these solenoids applied air to the opening side of the pistons for valves 3CCW-20 through 3CCW-25. In the case of 3CCW-20, this opening force was of sufficient magnitude to bend the "hold closed" jack-screw thereby allowing the valve to open. This in turn allowed water to flow back from Lake Keowee, through the CCW discharge piping, into the outlet water-box and out five manways into the Turbine Building basement. Valves 3CCW-21 through 3CCW-25 were maintained closed by the jackscrews.

The apparent causes of this occurrence are twofold. First, a procedural inadequacy was responsible in that the air supply to these pneumatically operated valves was not isolated and thereby preventing motion. Secondly, the design of the CCW pneumatic piston-operated discharge valves is such that they are designed to fail open upon the loss of power to the four-way solenoid control valve.

(THIS VALVE OPENED DURING INCIDENT)
(WATER FLOWED BACK THROUGH THIS LINE)

1. The present pilot solenoids on the condenser discharge valves will be replaced with dual-coil mechanically latched types. This will increase reliability because -

7. The procedures for opening the CCW system inside the Turbine Building are being reviewed and revised as necessary to require:
 - a) Inlet and outlet CCW pipes are vented if all CCW pumps are shut down.
