SITE PROBLEM
REPORT TRANSMITTAL

FILE: 13-14-369
CONTRACT NO: 620-00 14
SPR 369
TITLE ELECTROMATIC
RELIEF VALVE DAMAGE
DATE: 10-2-77
STATUS CODE C

SITE PROBLEM REPORT

CUSTOMER Toledo Edison Company	ORIGINATOR F. R. Faist	DATE 10/3/77	DOC. ID. CONT. NO. 13-620-0014	SPR NO. 269	REV. NO. 0
VENDOR Crosby	P.L. NO. 003090LS	PART NO./TASK NO. GROUP NO. SEQ. NO. 28/041/005			
TITLE (MAX 30 CHARACTERS) Electromatic Relief Valve Failure			PROBLEM CONTACT C. C. England <i>C. C. England</i>

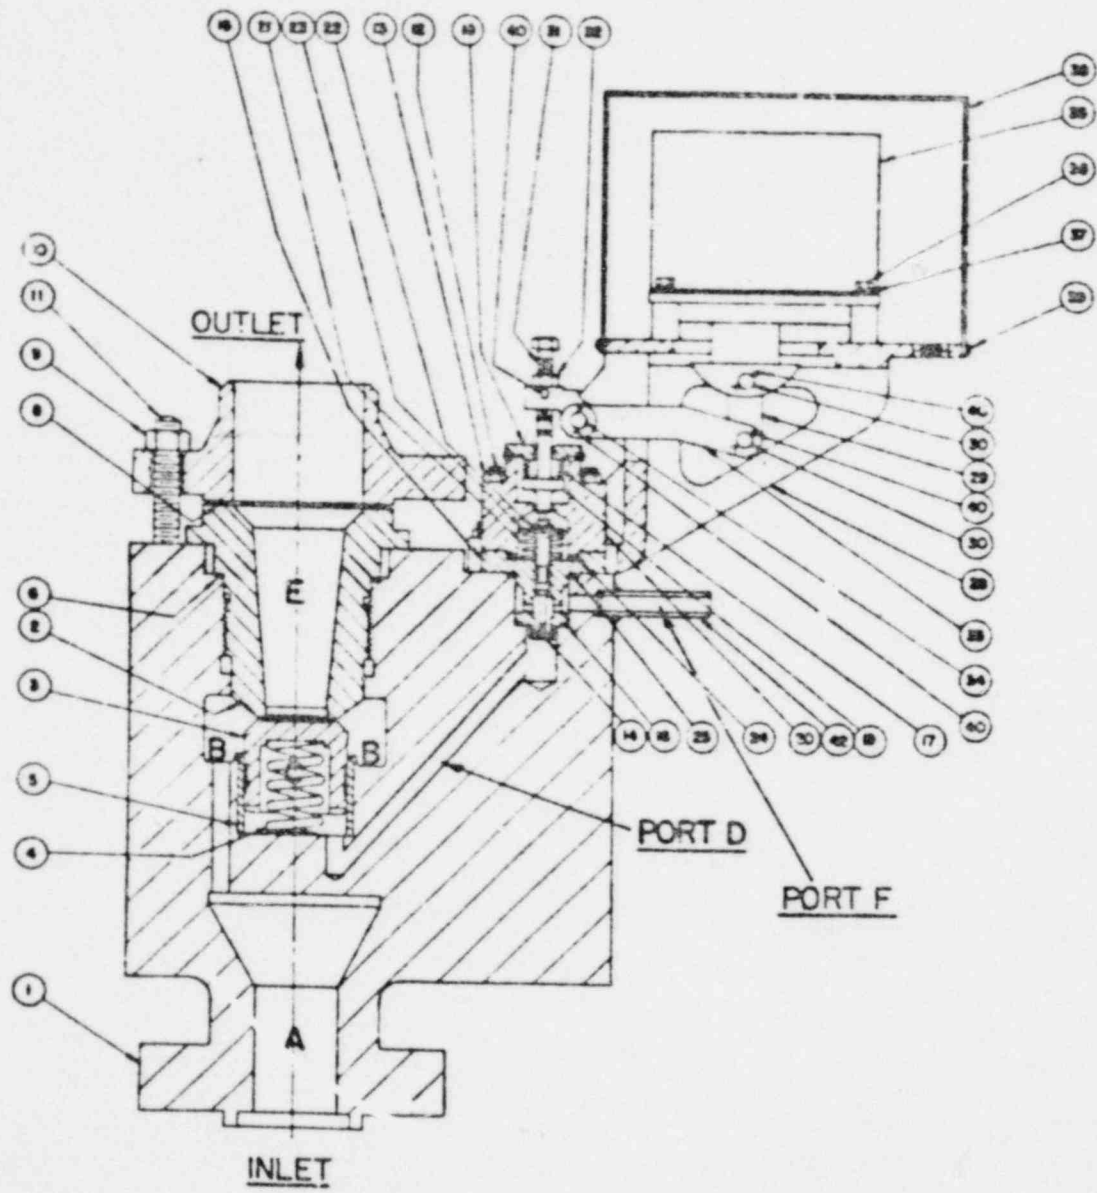
FIG. 1
 ASSEMBLY OF PRESSURMATIC
 VALVE STYLE HPV-SN

This valve has been disassembled and the pilot valve (part # on attached sketch) was open. The stem of the subject valve was pulled and slightly bent (see attached vendor rep's report).

The probable cause of failure was traced to a missing relay (see attached copy of Sectional drawing). The missing relay would have held the valve open until 1100 pressure triggered relief valve action. With the relay missing, the valve would cycle open and closed about 1100 psi.

This valve, as well as the bonnet containing the disc actuator is being replaced from INCO stock under the direction of a Cresty service rep.
