UNITED STATES  
NUCLEAR REGULATORY COMMISSION  
WASHINGTON, D. C. 20555

August 30, 1979

This will confirm my request to you on the telephone today that Babcock and Wilcox provide us with copies of the Site Problem Reports and Preliminary Safety Concerns listed below.

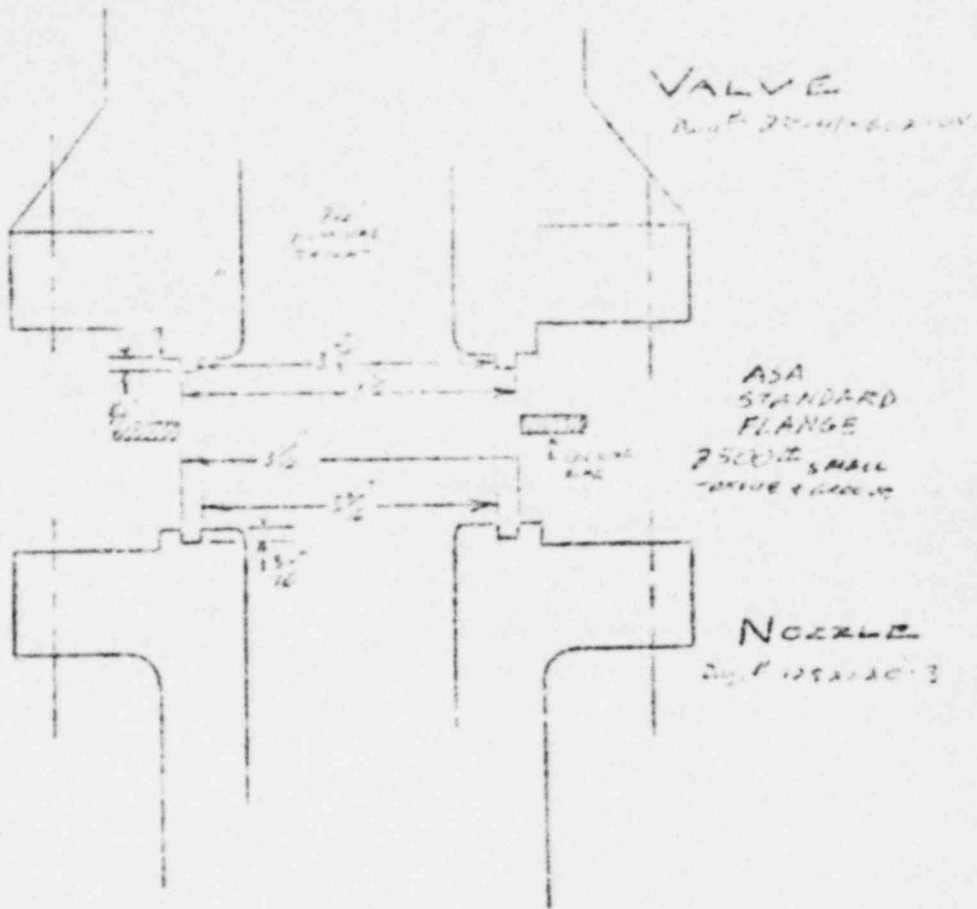
As a result of problems experienced on Unit 1 with leaking pressurizer code relief valves, you are requested to install these valves on Units 2 and 3 per the attached letter and sketch. Please note that the backing ring should be fabricated from stainless steel to the dimensions as shown (0.1625" thick, ID same as groove OD, OD to clear bolts).

MATERIAL - STAINLESS STEEL (RING WILL REST ON SS. FLANGES)

Installation of the pressurizer code relief valves in this manner should circumvent the leakage problems experienced on Unit 1. This work is considered to be a normal change to the particular contract involved.

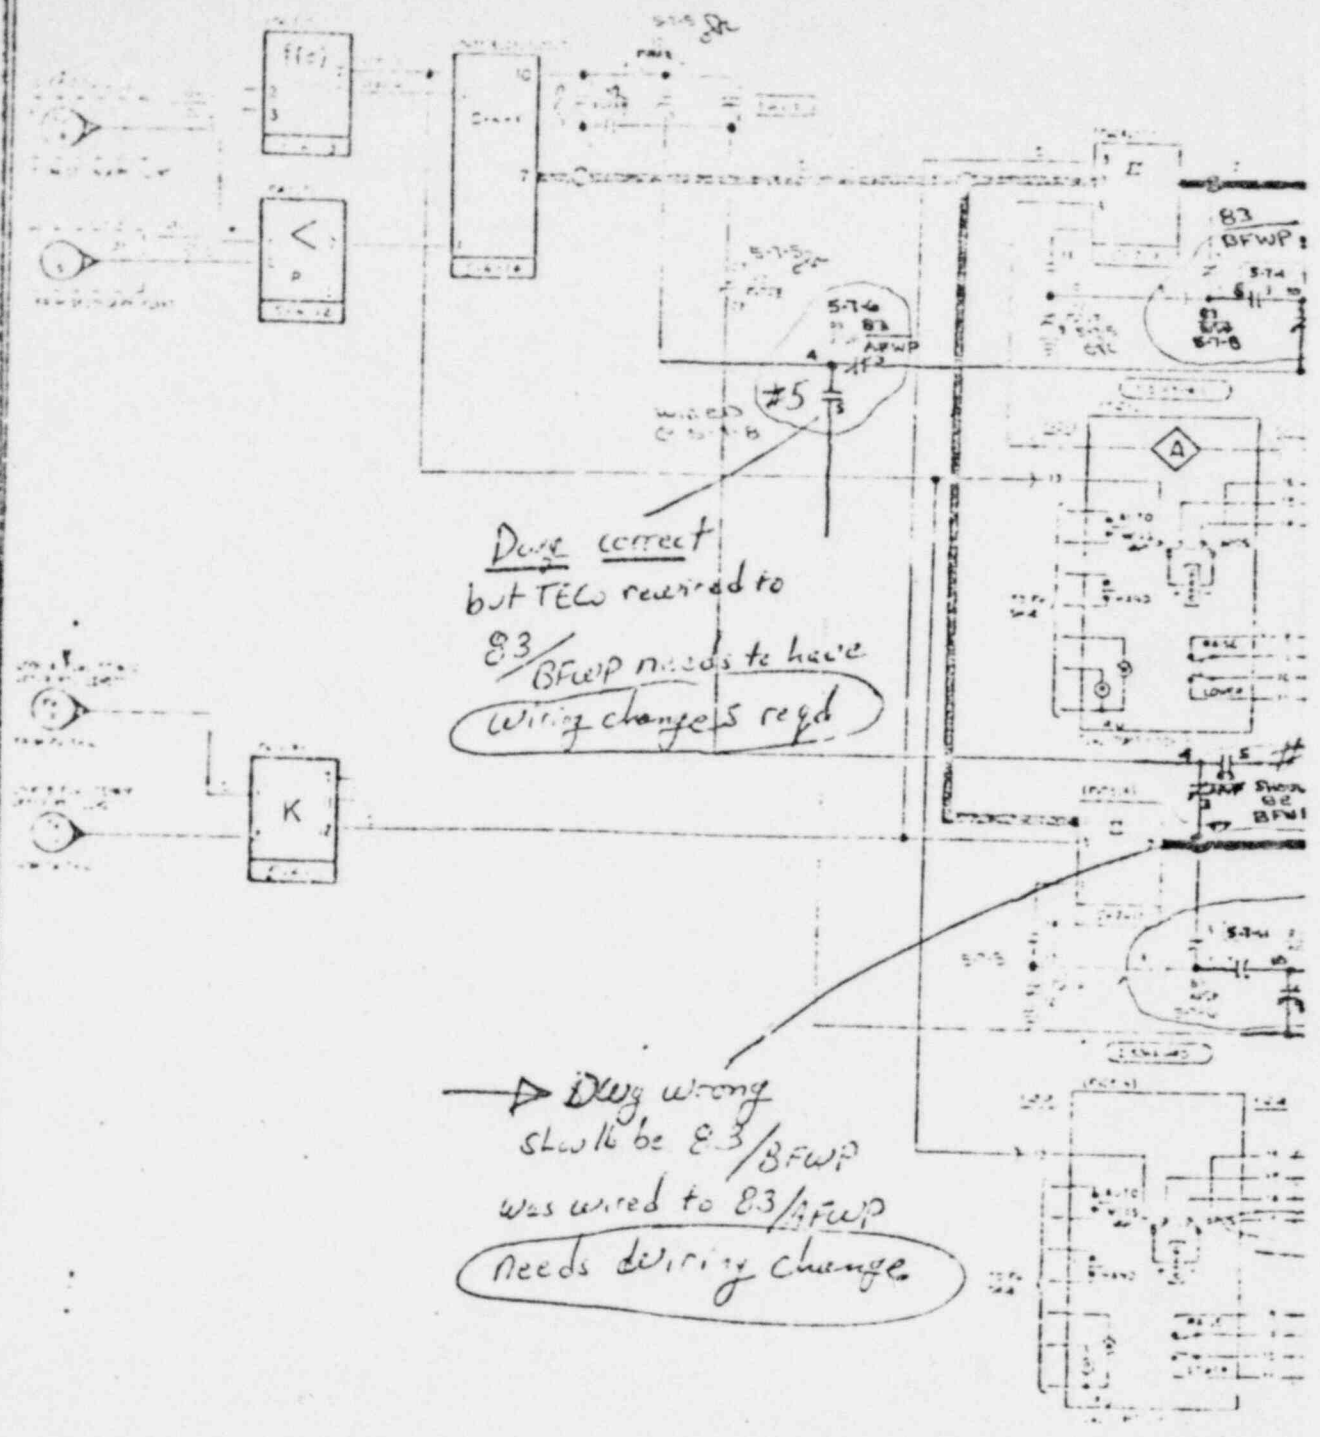
Checking logic makes it appear that the set towards the center of the drawing should be 83/BFWP, and the set towards the top left side should remain 83/AFWP. However, the wiring was found to be in the reverse of this order.

The wiring of contacts 6, 7, 8, 9, 10, and 11 of 83/BFWP were found connected to 6, 7, 8, 9, 10, and 11 of 86/BFWPT. The wires that the drawing shows as going to 6, 7 and 8 of 86/BFWPT were, in turn, connected to 12, 13 and 14 of 86/BFWPT. There were no wires on 6, 7, 8, 9, 10, and 11 of 83/BFWP.

Done correct  
 but TELC required to  
 83/BFWP needs to have  
wiring changes reqd

→ Done wrong  
 should be 83/BFWP  
 was wired to 83/AFWP  
needs wiring change

**RESOLUTION:** Drawing D8034800 Sheet 5 location SC relay 83/BFWP should be 83/BFWP. BMCo will correct drawing on final update. Other discrepancies noted between this drawing and actual wiring should be wired according to this drawing.

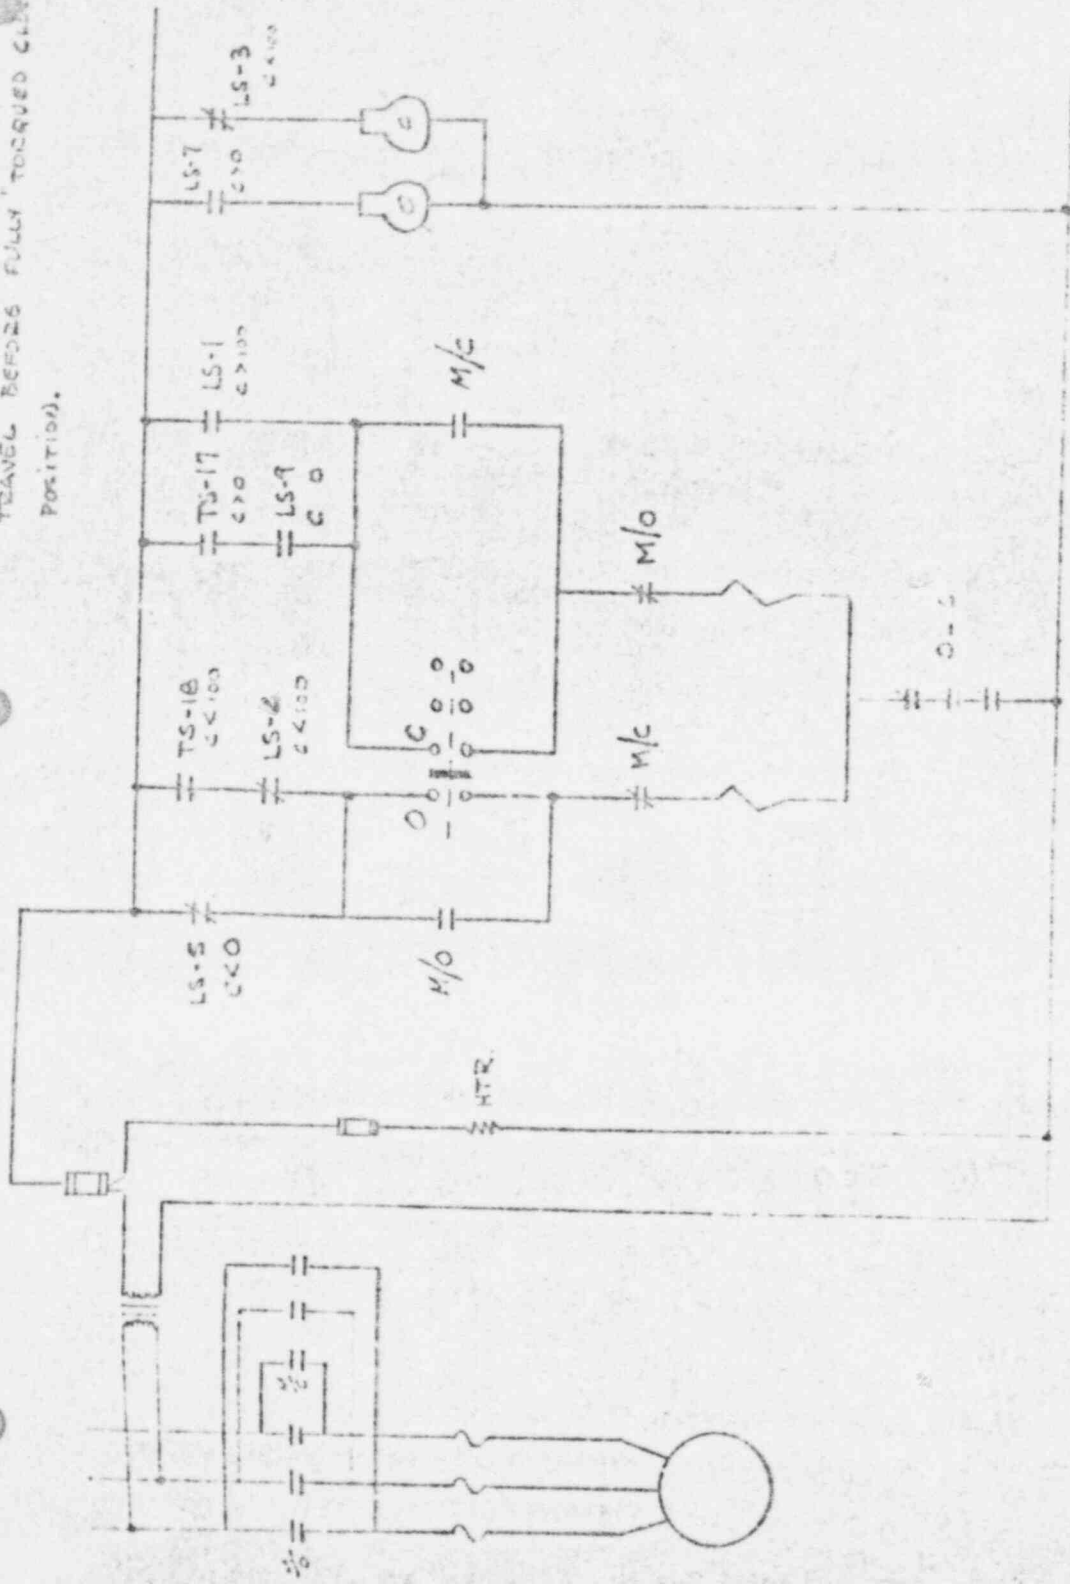
NOTE: LS-9 ADDED 12/19/73 TO STOP VALVE TRAVEL BEFORE FULLY TORQUED CLOSED POSITION.

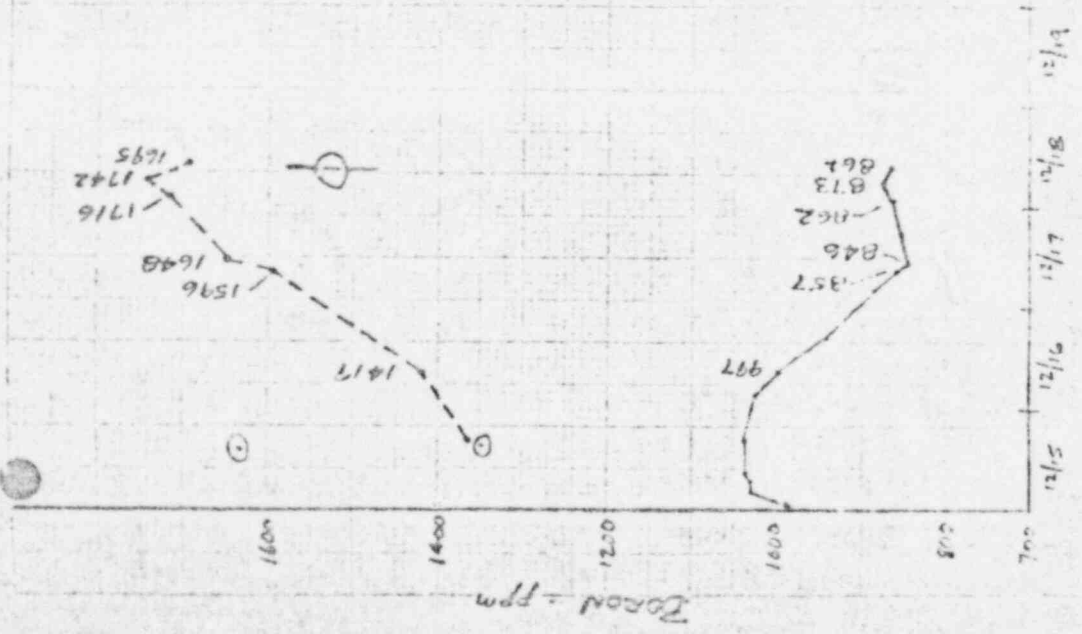
FIGURE 2

① STARTED VARYING FREE LEVEL BETWEEN 220" & 270" @ 0830 12/13/13

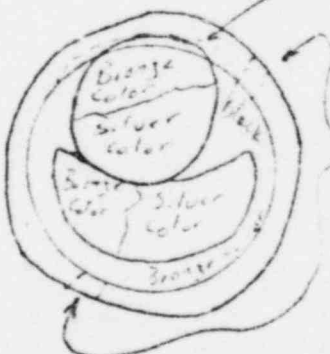
c. Under stem there is an area which could be the stellite bearing pushed and broken, or it could be the bottom of the stem,  $\approx$  1/32 of an inch thick. This piece is pushed into a groove in the body of the disk

*Holes through disk*

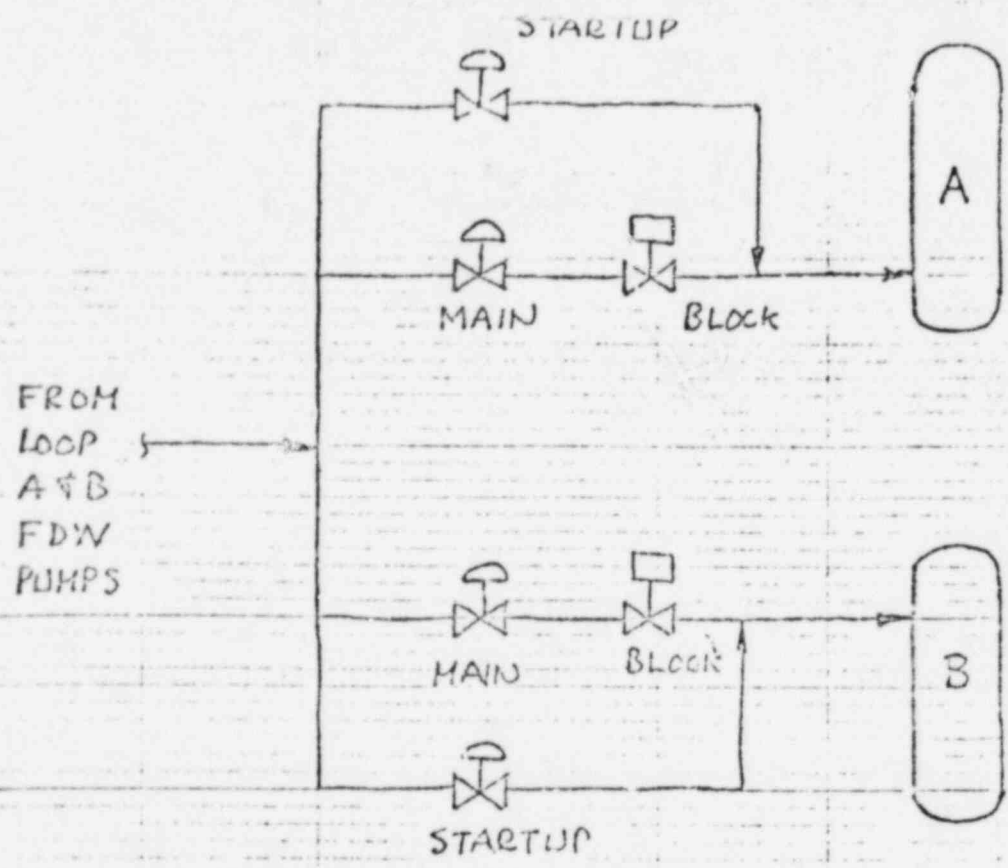
FIG 9

SCHEMATIC OF MAIN FEEDWATER SYSTEM AT SMUD

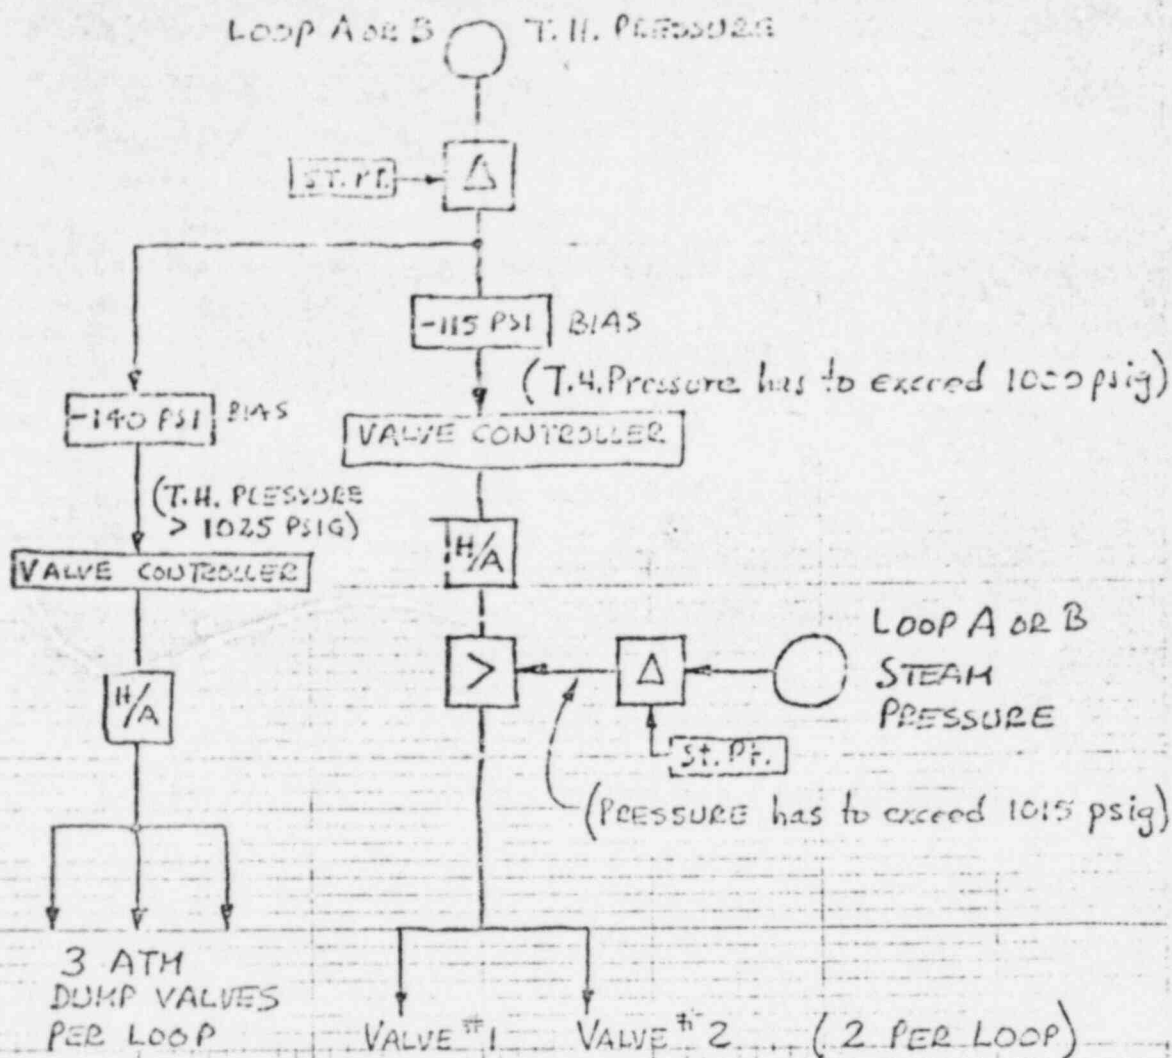
FIG 10

NOTE: ONLY 2 T.B. VALVES COULD HAVE OPENED BRIEFLY (LOOP A) DURING REACTOR TRIP TRANSIENT

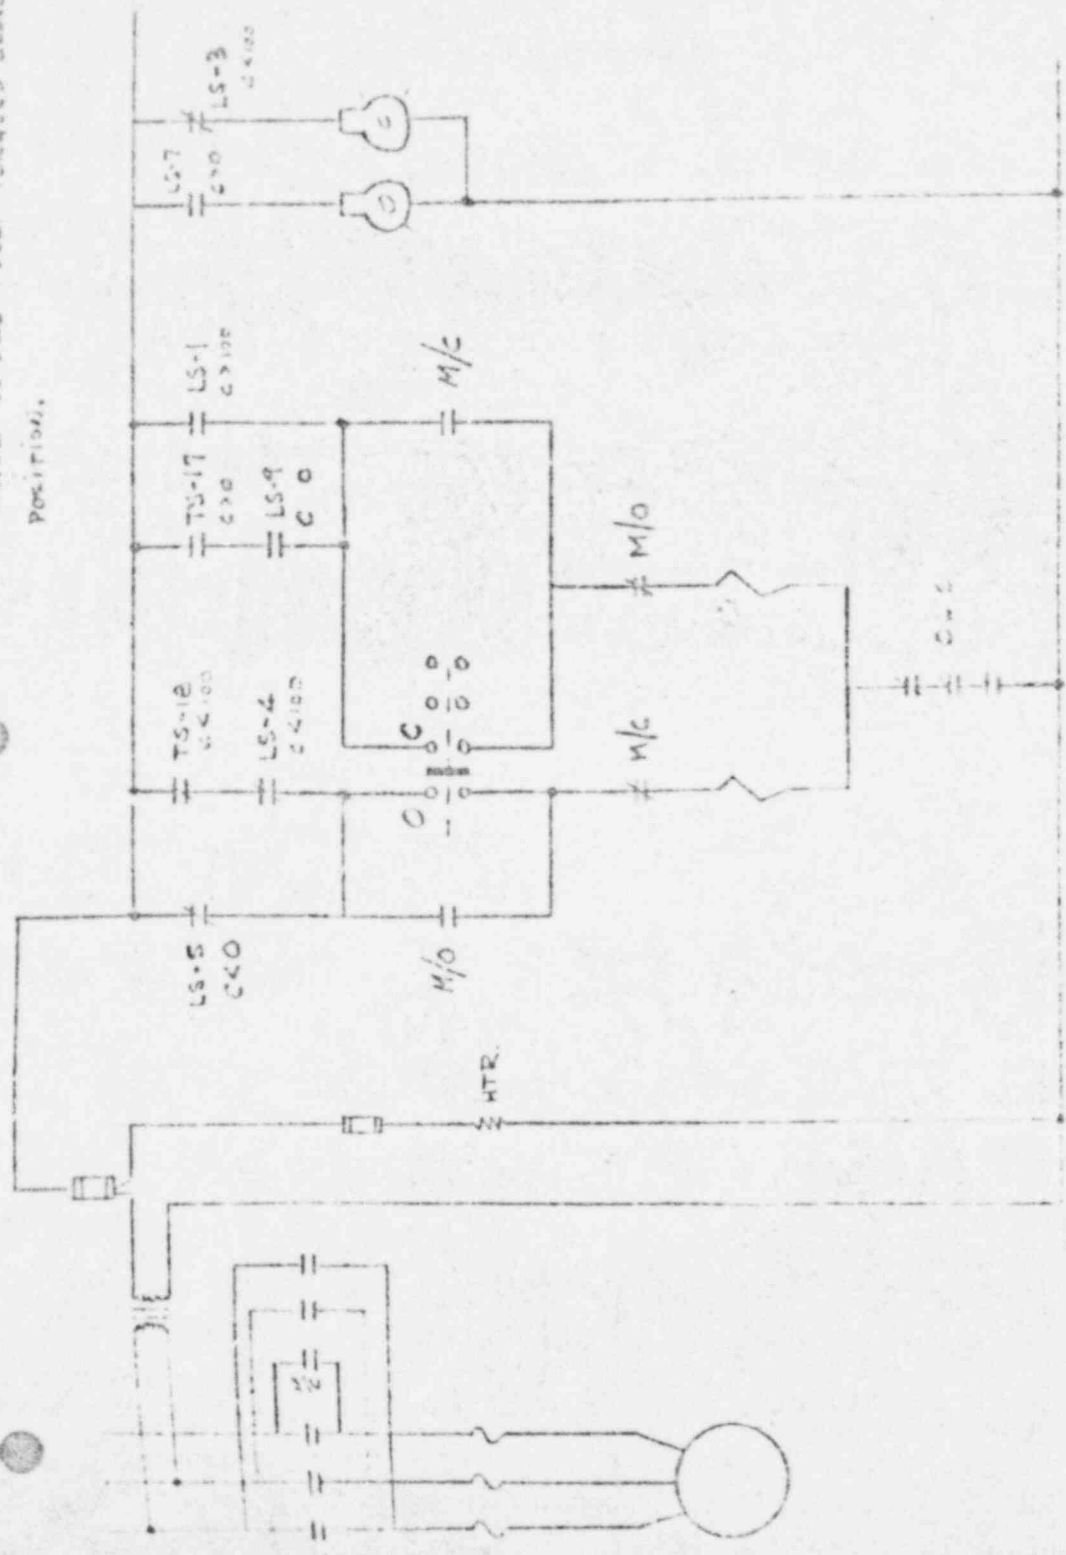
NOTE: LS-9 ADDED 12/13/75 TO STOP  
TRAVEL BEFORE FULLY "TOGGLED CLOSED"  
POSITION.

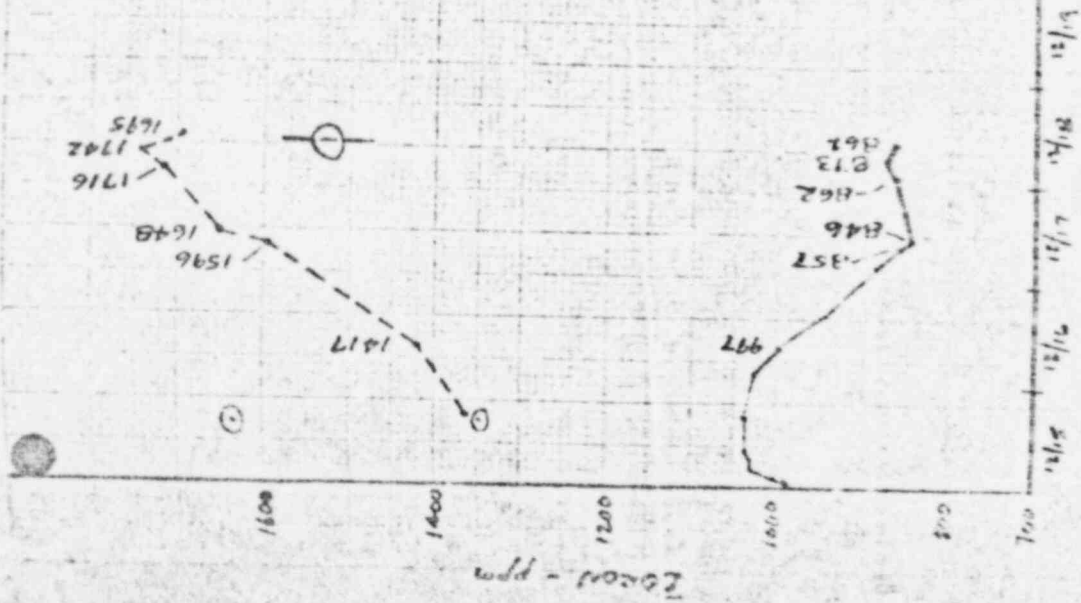
FIGURE Z

① STARTED VARIING PWR LEVEL BETWEEN 220" & 270" @ 0850 12/1/73
