SITE PROBLEM
REPORT TRANSMITTAL

FILE: 13-5-322
CONTRACT NO: 620-00 05
SPR 322 REV. 1
TITLE LOW PRESS.
LEVEL FOLLOWING
REACTOR TRIP
DATE: 6-25-76

SITE PROBLEM REPORT

TITLE LOW PRESSURIZER LEVEL FOLLOWING REACTOR TRIP

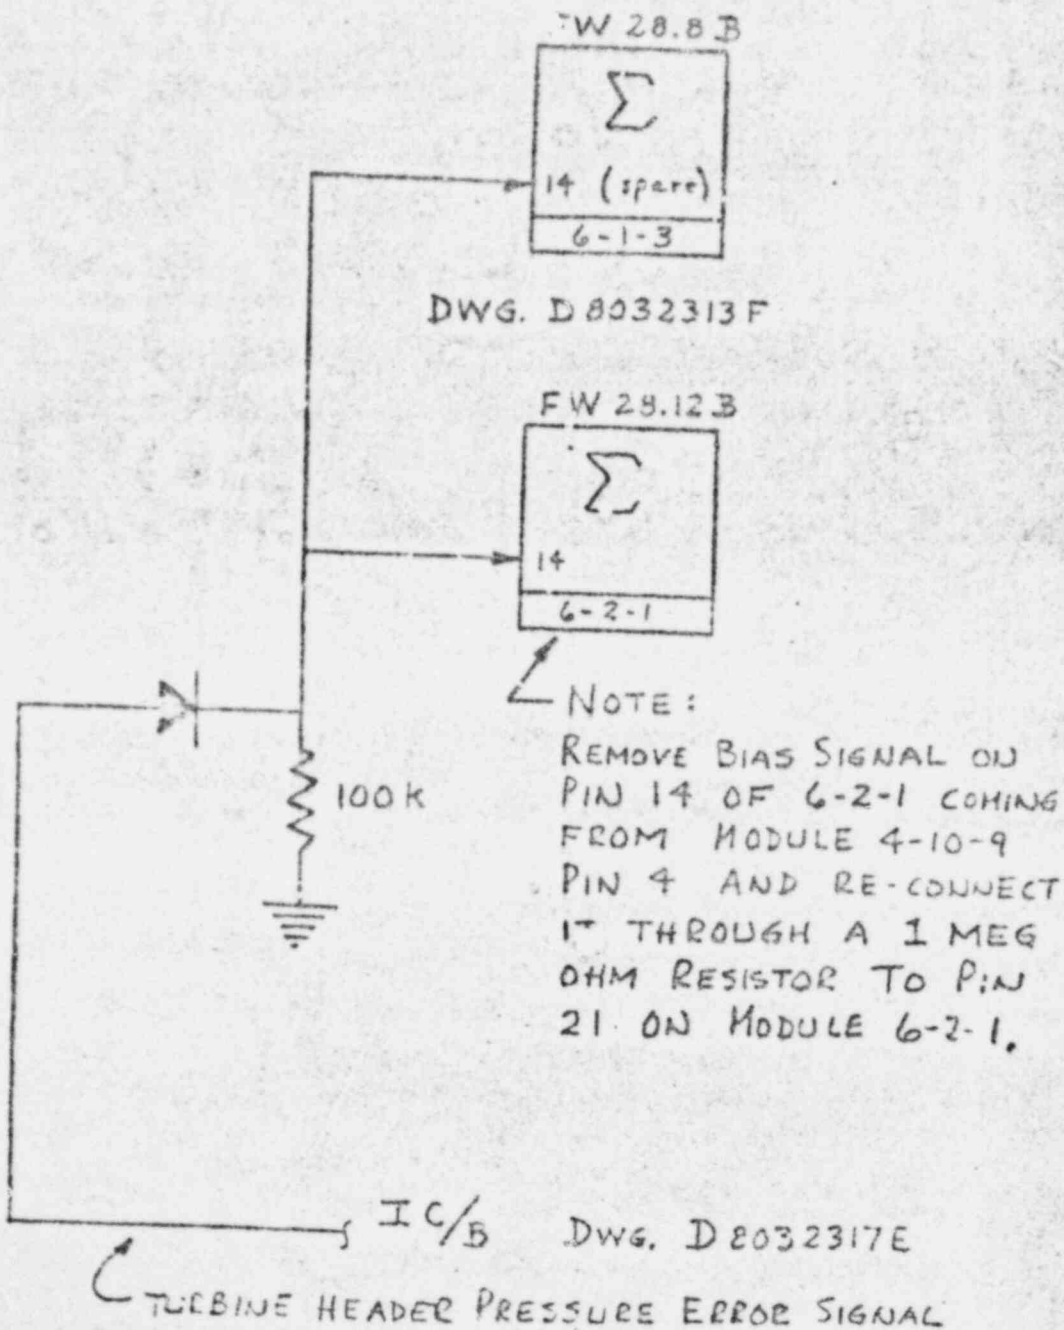
FEEDWATER PUMP SPEED "RICKER" MODIFICATION TO THE ICS

The purpose of the Pump Speed "Kicker" Circuit is to enable the feedwater flow control system to continue to deliver a high level of flow to each Steam Generator, even though the steam outlet pressure has suddenly increased approximately 150 psi. The modification originated and implemented at TMI-1 improved the overall plant performance by directly increasing feedwater pump speed more rapidly than could be accomplished by the combined action of the feedwater control valve and pump speed controllers in the ICS.

Route an additional wire from the turbine header pressure error signal (IC/B on Drawing Unit #1) to two summers which are shown on Drawing D80J2311F. The particular summers are FW28.8B(6-1-3) and FW28.12B(6-2-1) and the new signal is to be connected to each summer. In the new line also install a diode and a 100 k ohm resistor in a path to ground. Refer to the attached schematic.

- + 10 Volts = 300 psi above setpoint.
- + 0.5 Volts = 15 psi above setpoint.
- Any signal below 0.5 Volts will be blocked by the diode in the new line.

The gain for the turbine header pressure error signal on each summer will have to be calculated and set by Duke Power Company. The calculation used at TMI-1 is given below:

Assume (S_0) is 4500 rpm at 100% power. Then (S_1) is $4500 \times 1.089 = 4900$ rpm and ($S_1 - S_0$) = 400 rpm. Assume total speed range of feedwater pumps is 2700 to 5400 rpm or the total increase in pump speed is 2700 rpm. The gain at each summer is that which will cause a pump speed of 4900 rpm when the error in turbine header pressure is 165 psig.

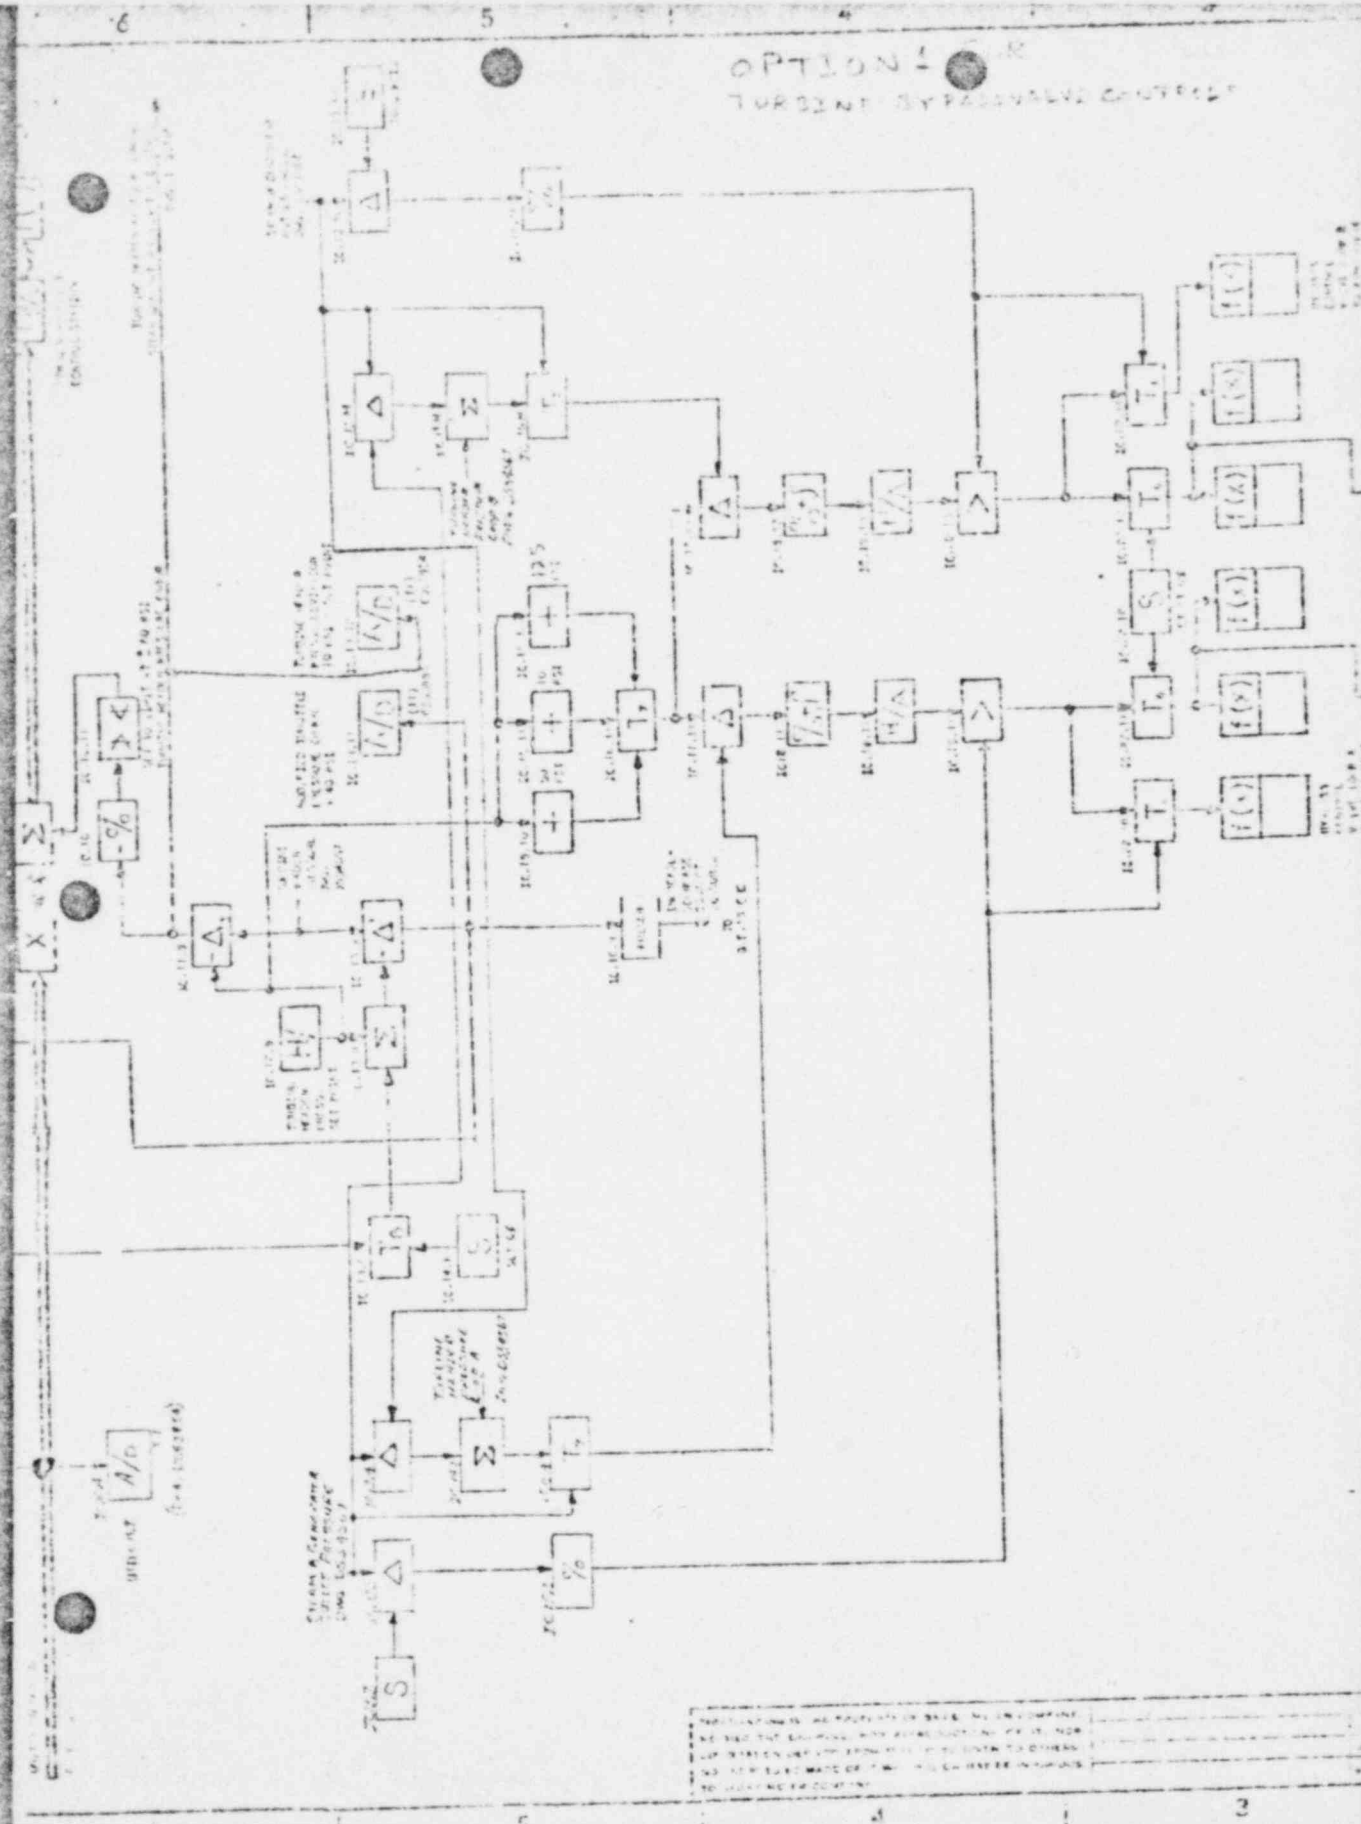
OPTION 1
TURBINE BYPASS VALVE CONTROL

The fact that the Turbine Header pressure remains higher for a time holds the Turbine Bypass Valves open longer than necessary. (AFTER The Safety Valves have closed)

It is believed that this area could be improved by having the turbine bypass valves modulate to control Steam Generator pressure when the reactor is tripped instead of turbine header pressure. Getting these valves closed sooner after a trip should keep the Steam generator pressure from dropping so low which would keep the steam generator temperature higher and therefore TAVE. This should then keep the pressurizer level from dropping so low because it would not have to make up as much volume in the RC system.

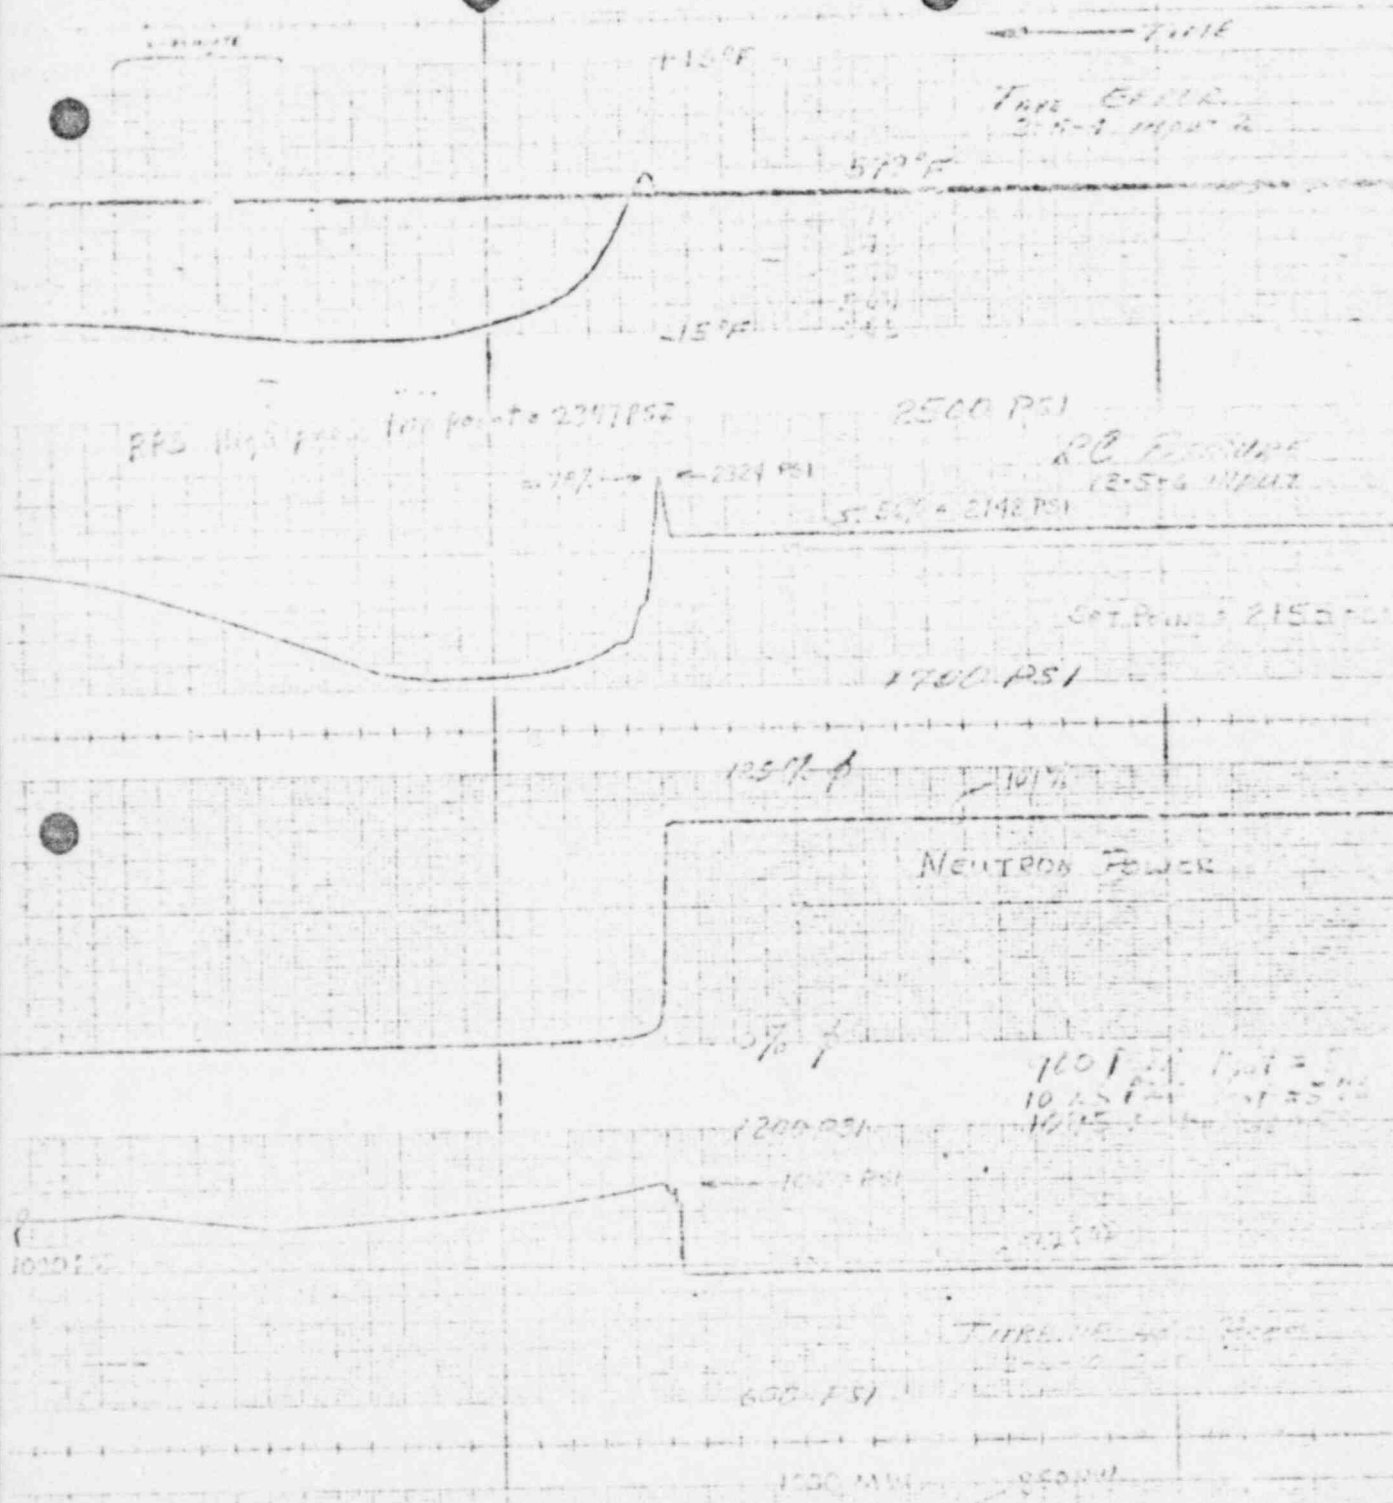
Generator Trip Test From 100% 2-13-72

Attached please find charts recorded during a generator trip test conducted 8-13-74 which resulted in a reactor trip. From these charts and table 1 it can be noted that while there was flow through the line there was a pressure drop i.e., SG pressure is 30 psi higher than THP, immediately after the trip with no pressure drop due to flow the pressures equalized. For the next 3.5 min. the SG pressure is less than THP. Also note the waves in the SG pressure recorded during the first minute are not present in the THP pressure. These conditions seem to be a good indication that the check valves did close.

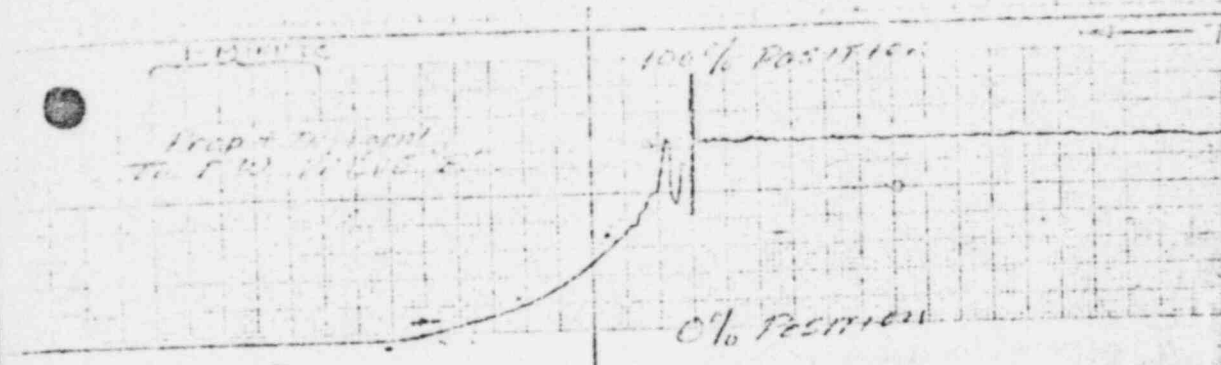
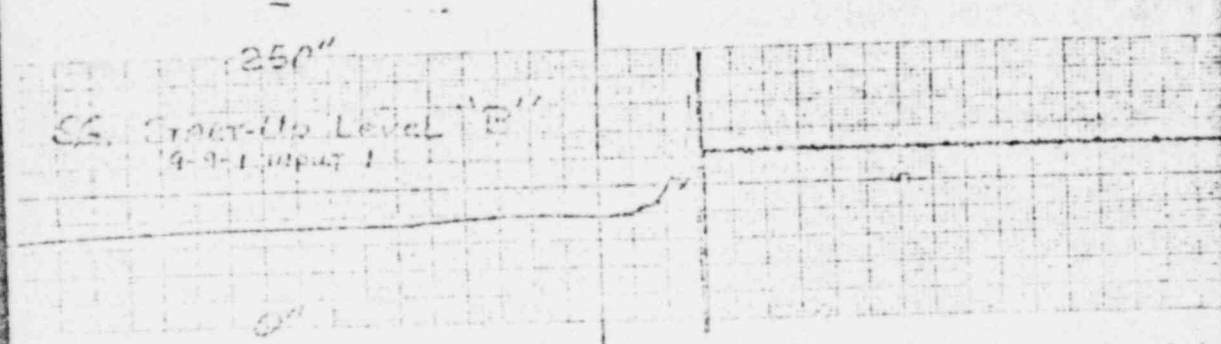
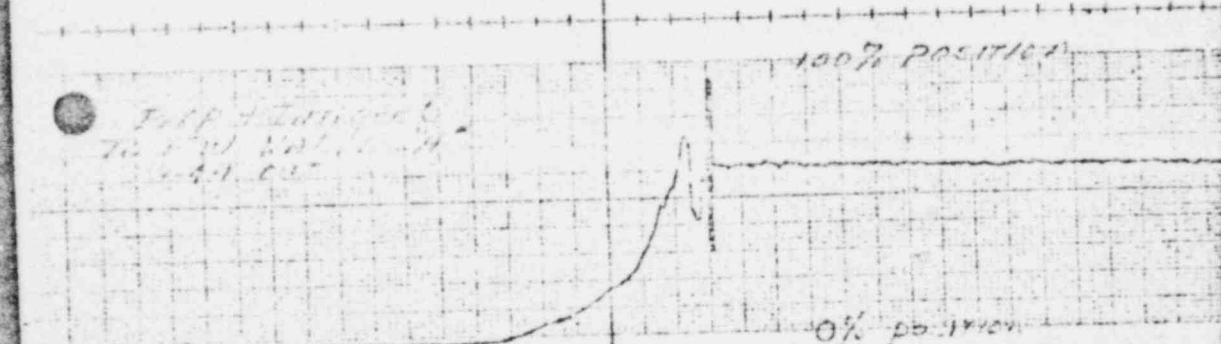
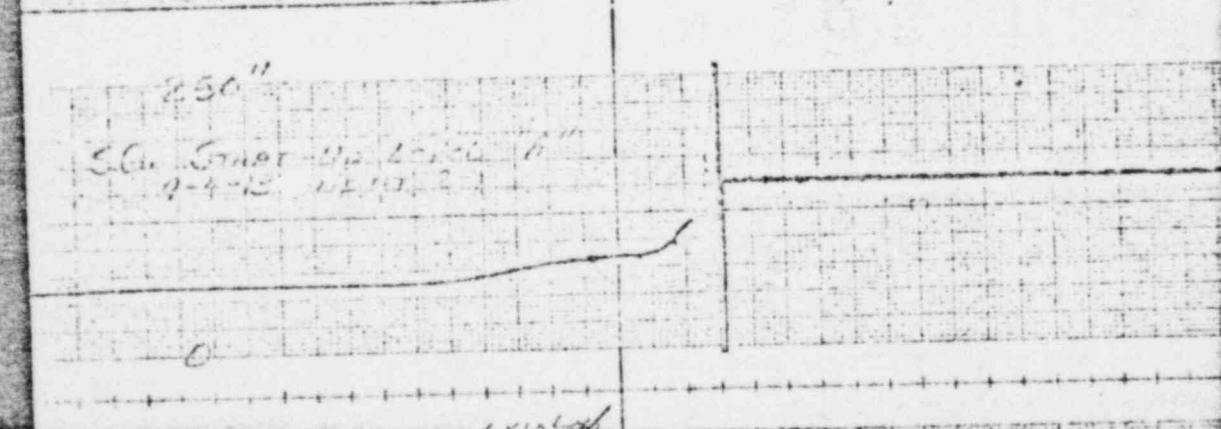
GENERATOR TOP TEST FROM 100% 4 8-1

Further examination of the reactor trip data revealed that immediately following the reactor trip the feedwater demand actually reduced to 20% instead of reducing to 5% (cross limit value as neutron power following the trip is zero).

20%
Should not
come back
up
