SITE PROBLEM REPORT

CUSTOMER Toledo Edison Company	ORIGINATOR F.R.Faist	DATE 11/2/77	DOC. NO. CONT. NO. 13 620-0014	SPR NO. 300
VENDOR Crosby	P.A. NO. 023 090 LS		PART NO./TAGG NO. 28/041/005	GROUP NO.
TITLE (MAX 30 CHARACTERS) Electromatic Relief Valve Modification			PROBLEM CONTACT J. E. Anderson

EQUIPMENT INSTRUMENT NAME AND NO. PRZR ELECTROMAGNETIC RELIEF VALVE RC2A

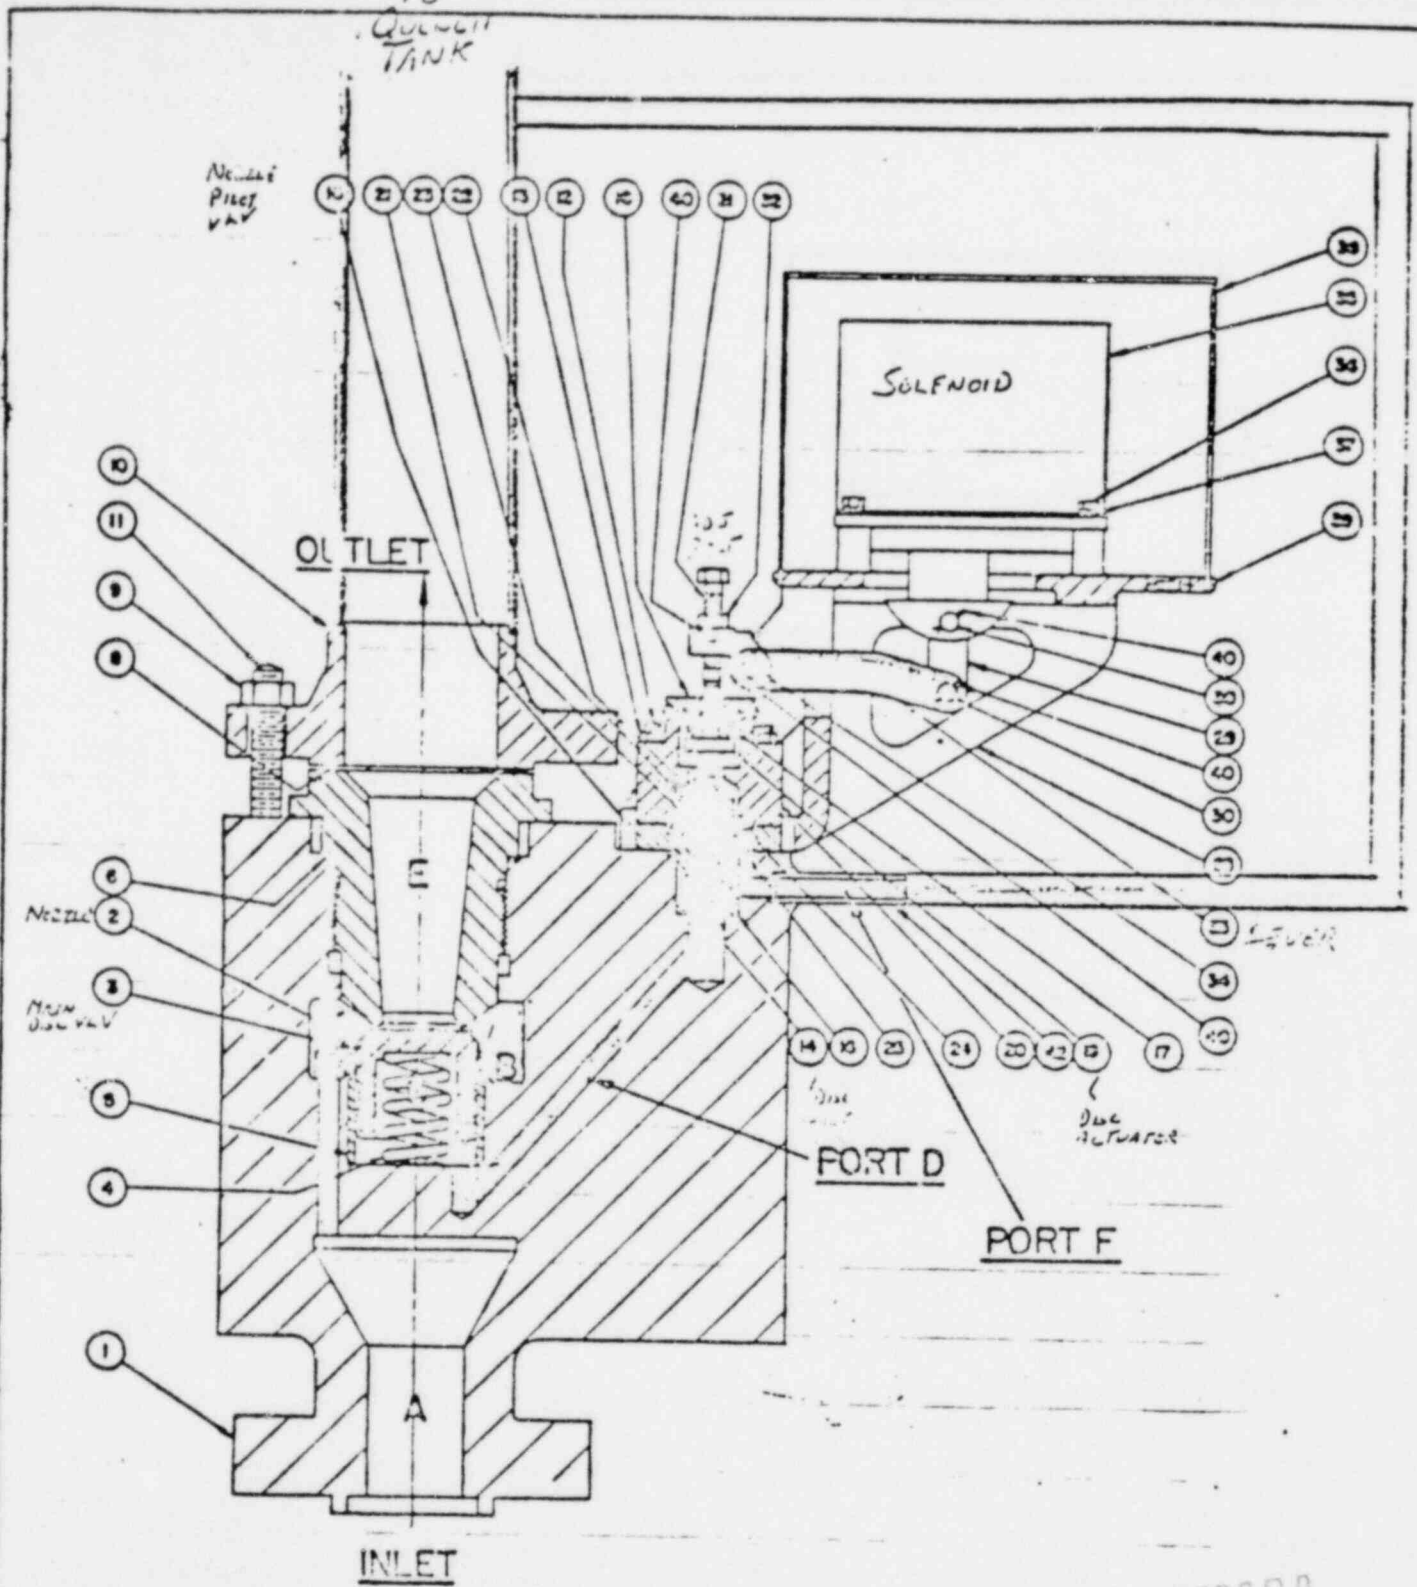
FIG. 1
ASSEMBLY OF PRESSURMATIC
VALVE STYLE HPV-SN

Crosby rep., Walt Conroy, arrived and the pilot valve assembly was removed from the main valve. Disassembly of the pilot valve revealed that the pilot valve stem had stuck open due to the close tolerance causing a binding condition between the O.D. of the stem and the I. D. of the pilot valve nozzle. Also, a small metal particle was found in the pilot stem/nozzle area. Subsequent cleaning of the inlet piping to the ERV revealed this same type of metal particles.

- Move the solenoid plunger to full stroke by pushing to the maximum position. The Disc Actuator Pilot Valve (19) will be depressed by the adjusting bolt (31) with the plunger in this position. If the adjusting bolt (31) were to be backed off a distance of approximately 5/32" (which could be accomplished by allowing the plunger to drop from its full upward position), the adjusting bolt (31) should be just beginning to make contact with the disc actuator pilot valve (19). Should the condition prevail, with the adjusting bolt (31) is making contact with, or is moving the disc pilot valve (19) below the free position, the adjustment is not correct and should be reset per instruction I-1115, Para. 4.2.2.2.

The Crosby representative furnished a detailed drawing of the pilot valve stem requiring a diameter of .374. This was changed to read .373 diameter .372.

by the Crosby rep., and the stem was modified accordingly by TECo Maintenance under the direction of the Crosby rep. This modification resulted in opening the clearance between the stem and the nozzle thus eliminating the binding. The nozzle was also reamed out with a reamer the same size, no material was removed.

All parts were cleaned and assembled. The solenoid linkage was adjusted to drop the adjustment bolt more squarely on the disc actuator. In addition, the adjustment bolt was positioned to move the pilot valve stem off the seat a maximum of .125". It had been moving off the seat some .375".

A critical adjustment is that described in step 4.2.2.2, Setting of the Adjusting Bolt (F/N 31). All adjustments should be made per the instruction manual, however, proper adjustment of the solenoid adjustment bolt can be further checked as follows:

Move the solenoid plunger to full stroke by pushing to the maximum position. The Disc Actuator Pilot Valve (19) will be depressed by the adjusting bolt (31) with the plunger in this position. If the adjusting bolt (31) were to be backed off a distance of approximately $5/32$ " (which could be accomplished by allowing the plunger to drop from its full upward position), the adjusting bolt (31) should be just beginning to make contact with the disc actuator pilot valve (19). Should the condition prevail, with the adjusting bolt (31) making contact with, or is moving the disc pilot valve (19) below the free position, the adjustment is not correct and should be re-set per instruction I-1115, Para. 4.2.2.2.

It is recommended that the "further checks" on the solenoid adjustment bolt stated above be included in the appropriate maintenance procedures for the power relief valve RC2A to minimize any misadjustments that may be overlooked.
