TECHNICAL REPORT ON BEZNAU UNIT ONE

INCIDENT OF AUGUST 20, 1974 : TG-1 TRIP/

REACTOR TRIP/SAFETY INJECTION ACTUATION.

September 2, 1974

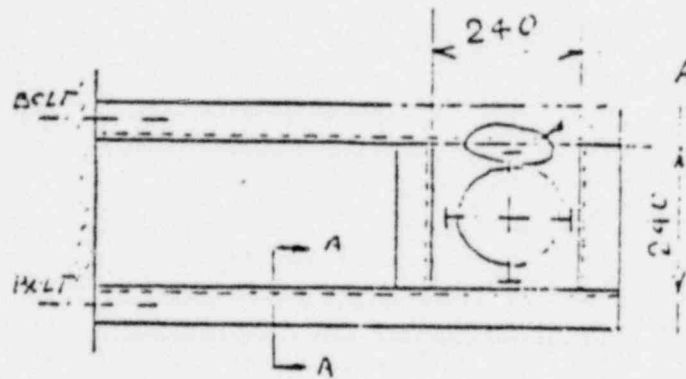
Figure 2 - Restraint R-1

The relief line to the power relief valves comes out of the pressurizer top and runs directly down (vertical run of 6.8 m). It passes through a grating floor. No impact evidence between the floor and the pipe insulation exists. (Gap about 25 mm). At the bottom of the vertical run there is a console type restraint. (Location 1 in fig. 1). The main dimensions are given in fig. 2. There is contact evidence, as shown on the figure, but no damage.

Damage : - no general distortion
- no rubbing evidence
- contact evidence in A

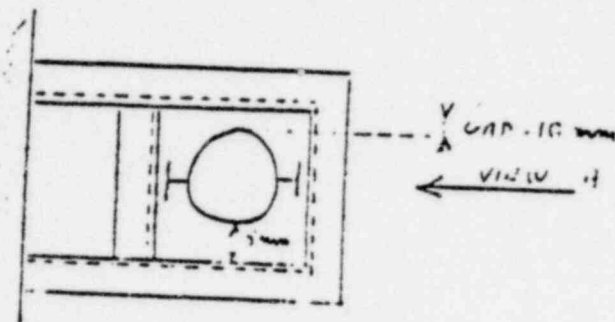
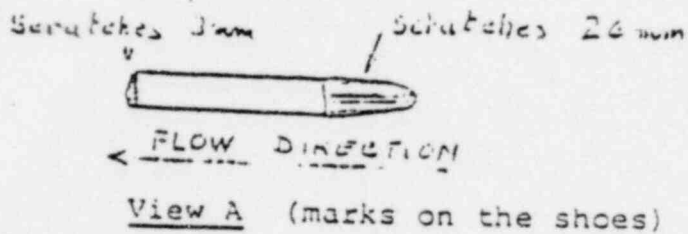
Figure 3 - Restraint R-2

The pipe then runs horizontally to the restraint 2 (fig. 1). This restraint limits motion of the pipe in a horizontal direction, perpendicular to the pipe axis (See fig. 3). Scratches on the shoes indicate that the pipe moved about 26 mm axially. The top part of the insulation is slightly smashed (See fig. 3).

The two bolts on the right side on figure 3 were strained about 3 mm. The two bolts on the left side were also strained but only to the point of getting loose.

- Damage :
- top of insulation slightly smashed
 - scratches on shoes as shown on view A

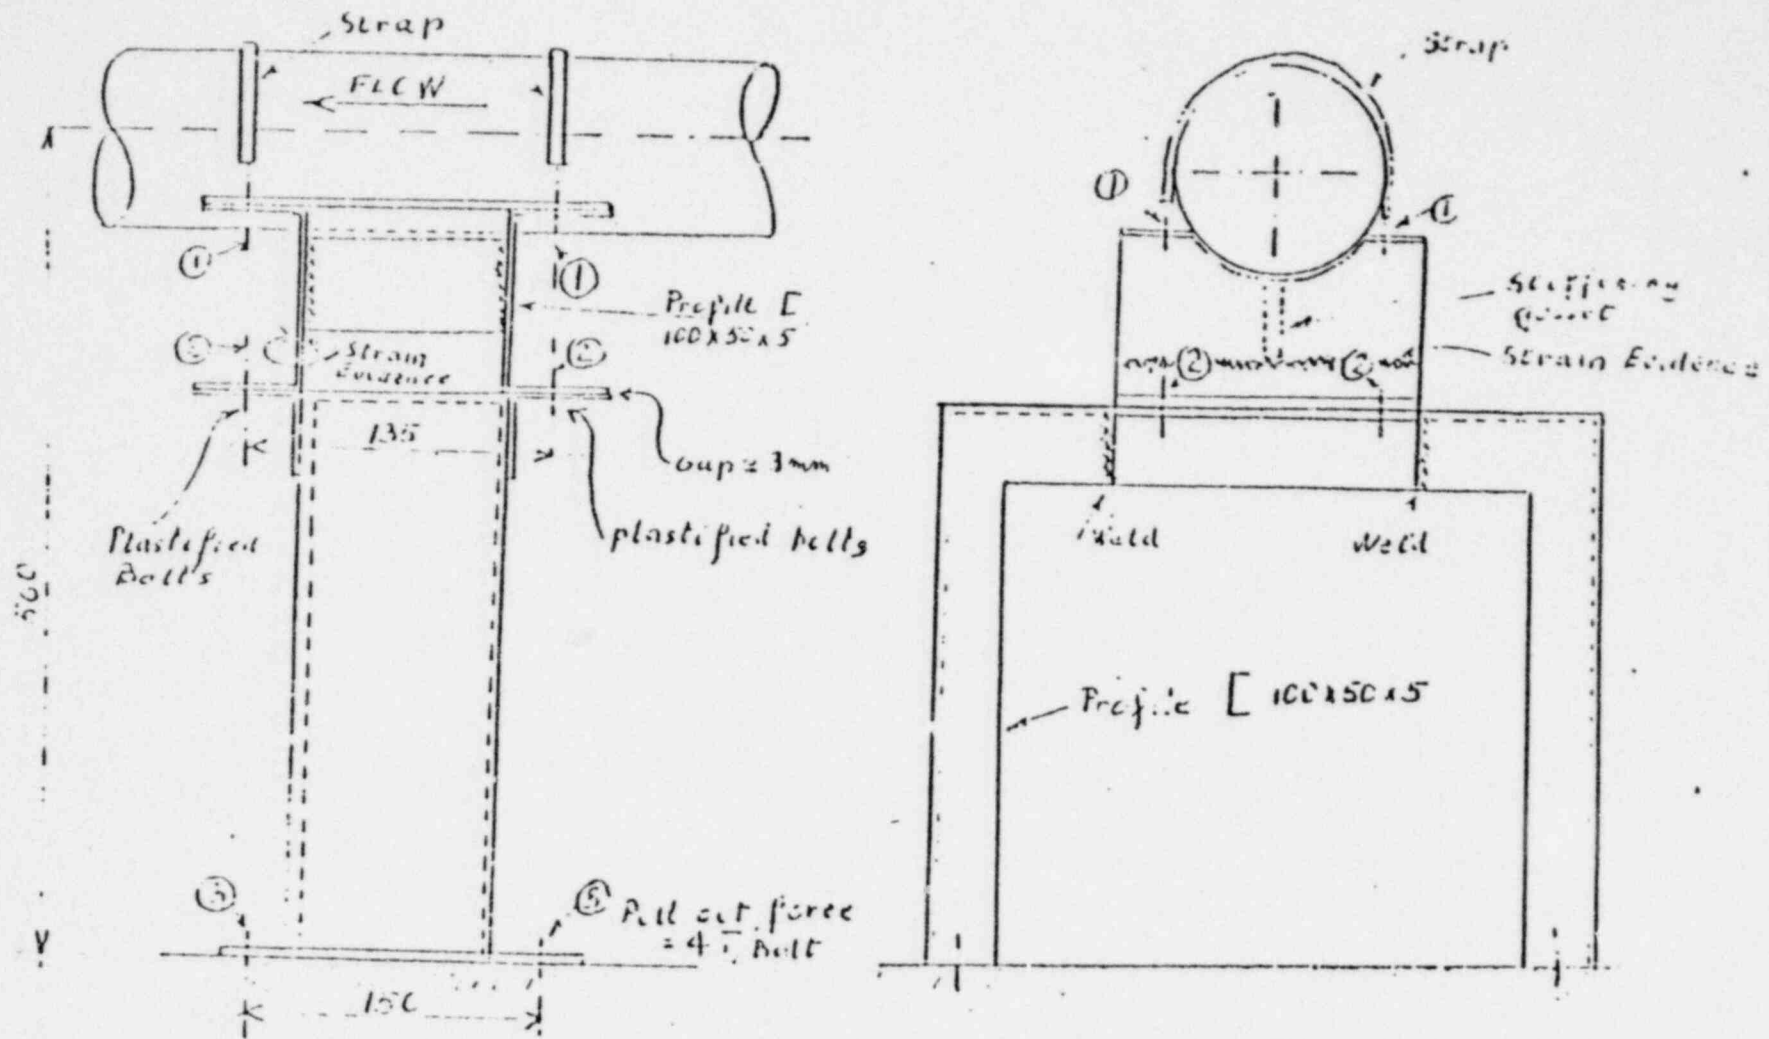
Figure 4 - Restraint R-3

Fig. 6 and 7 show the pedestal of the support between the two valves. Fig. 4 is a sketch of the support and details the damage.

The damage corresponds to a rotation of the pipe around a horizontal axis perpendicular to the pipe axis. No evidence of translation has been found. Considering fig. 7, the back bolts were strained much more than the front ones.

- Damage :
- no evidence at straps, pipe and bolts (1) and (3)
 - all 4 bolts (2) have been strained
 - gap measured as shown
 - strain evidence in the [profile as shown

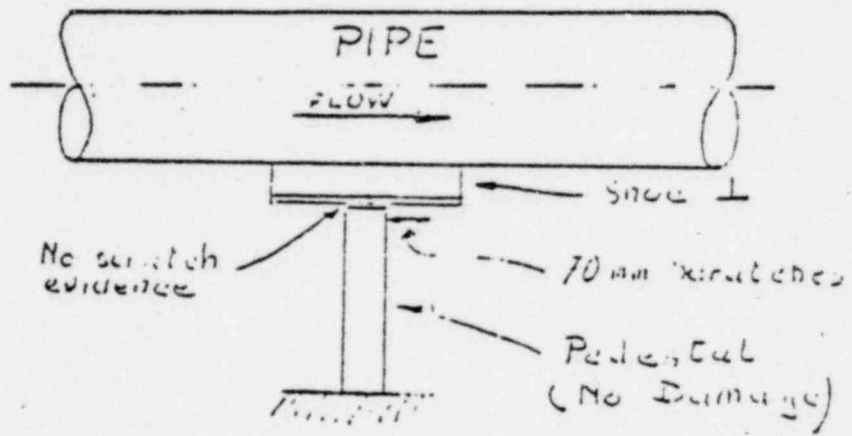
Figure 5 - Restraint R-5 Motion Evidence

Restraint R5, which is only a column supporting a sliding shoe, shows a motion of 70 mm as shown in fig. 5.

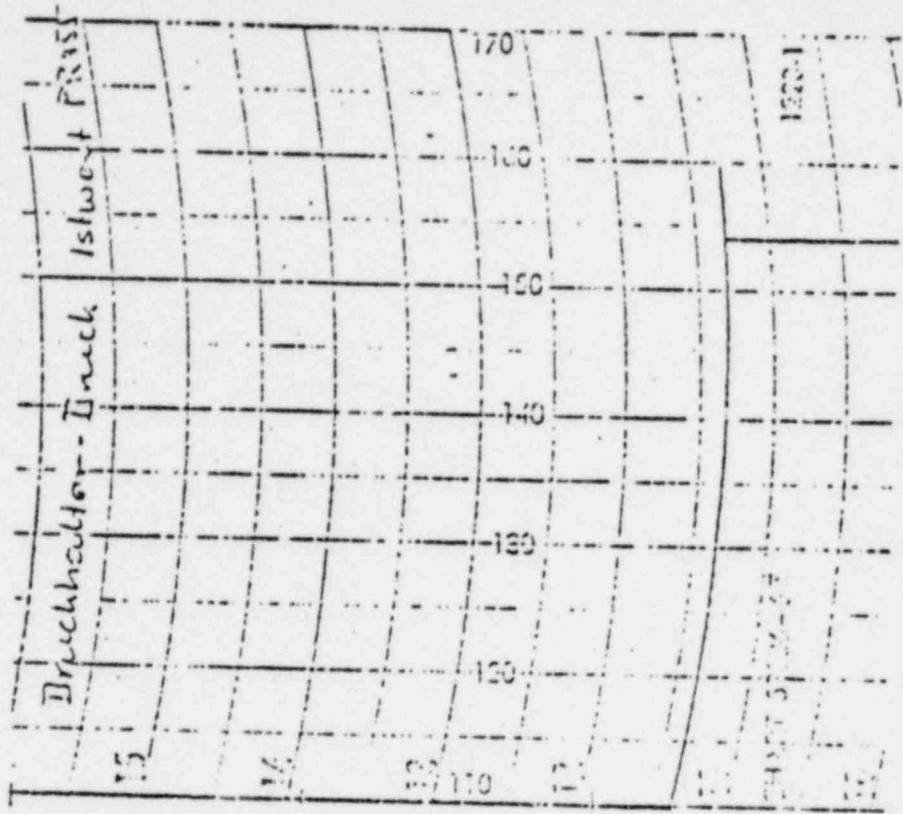
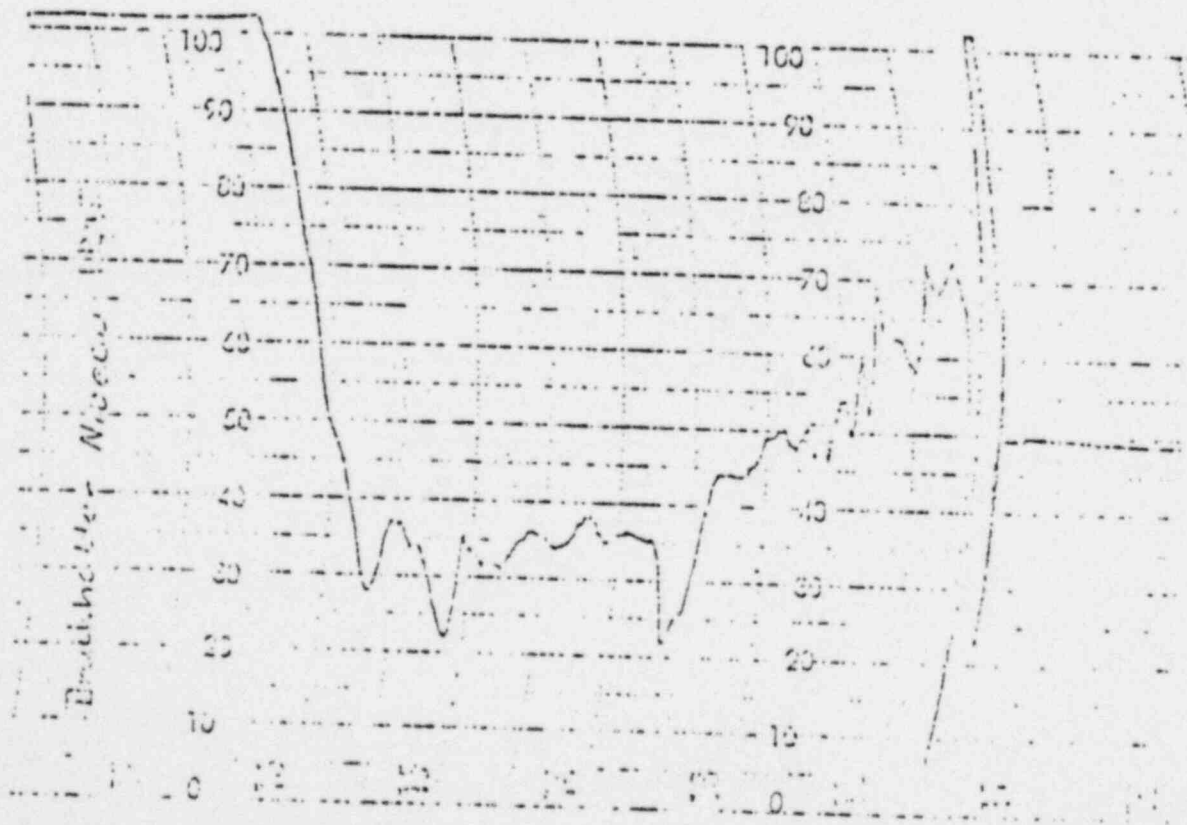
Figure 18 : Record of Pressurizer Pressure and Level Transients following incident initiation.

Fig. 18 shows the record of pressurizer pressure and level transients following incident initiation.
