Inspection Report 50-346/78-06 (Enclosure 1) was issued in April, 1978, presenting results of inspections conducted at Davis-Besse in December, 1977 and March, 1978. The report covers a number of subjects, including a loss of pressurizer level indication which was experienced during a transient at Davis-Besse on November 29, 1977. The discussion of loss of pressurizer level indication, due to volumetric contraction of water with reduced temperature ("shrink") following the reactor trip in November, appears on pages 2 and 3 under the section "Further Review of Reactor-Turbine Trip with Loss of Offsite Power".

TOLEDO EDISON COMPANY  
DAVIS-BESSE UNIT ONE NUCLEAR POWER STATION  
SUPPLEMENTAL INFORMATION FOR LET NP-20-77-14

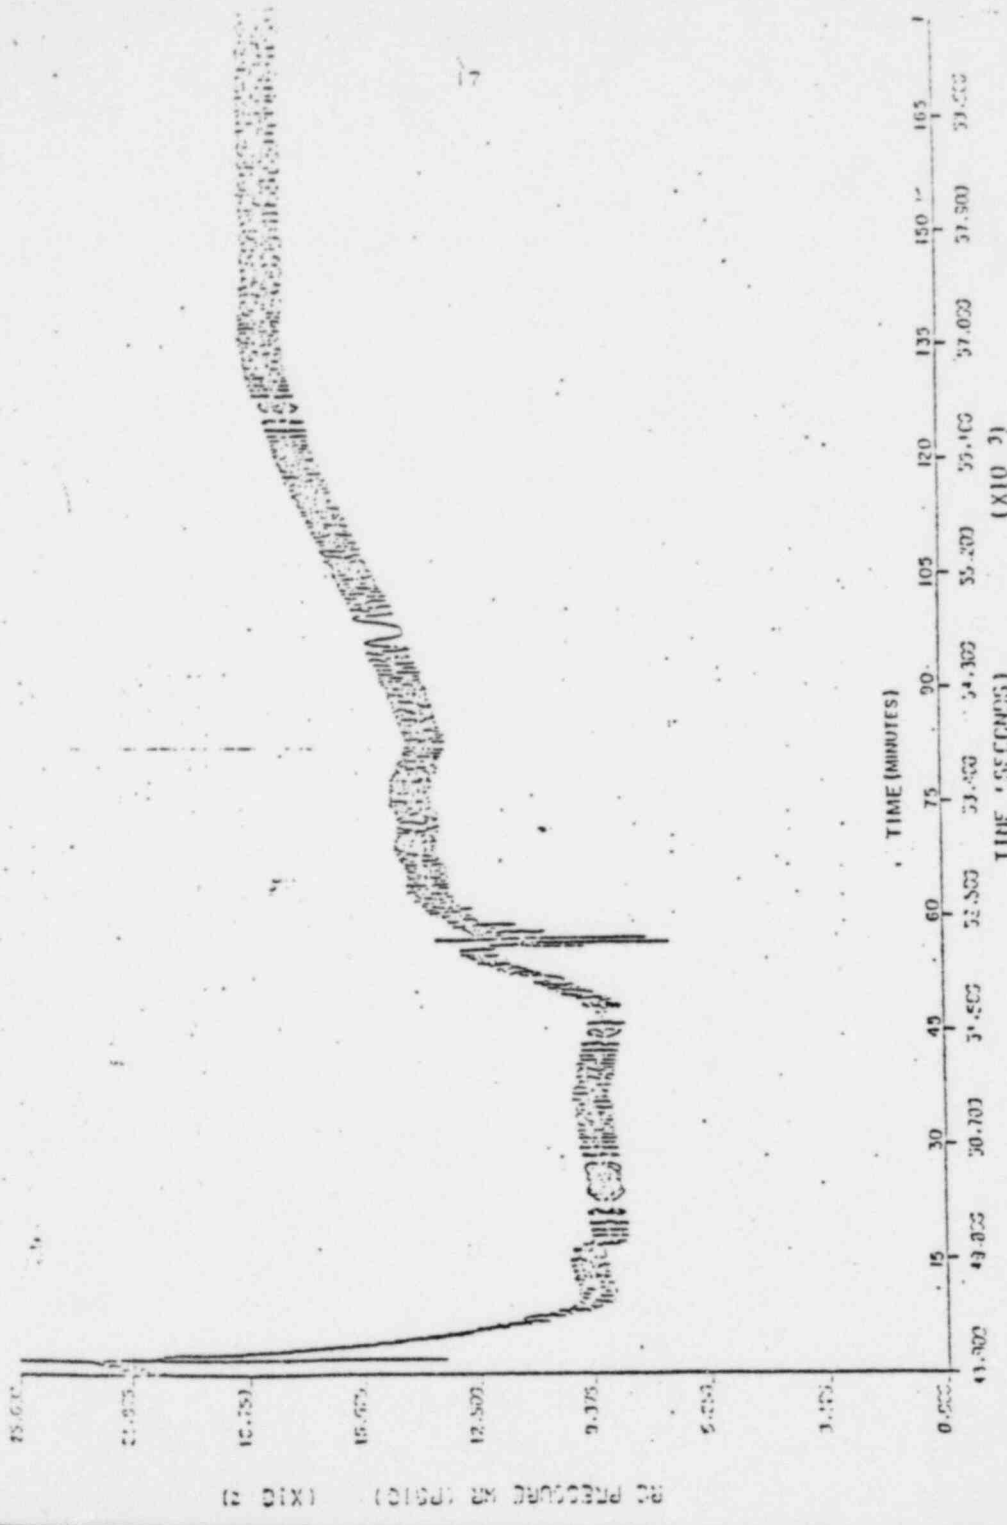
FIGURE 4-1

REACTIMETER PLOT TSN=71

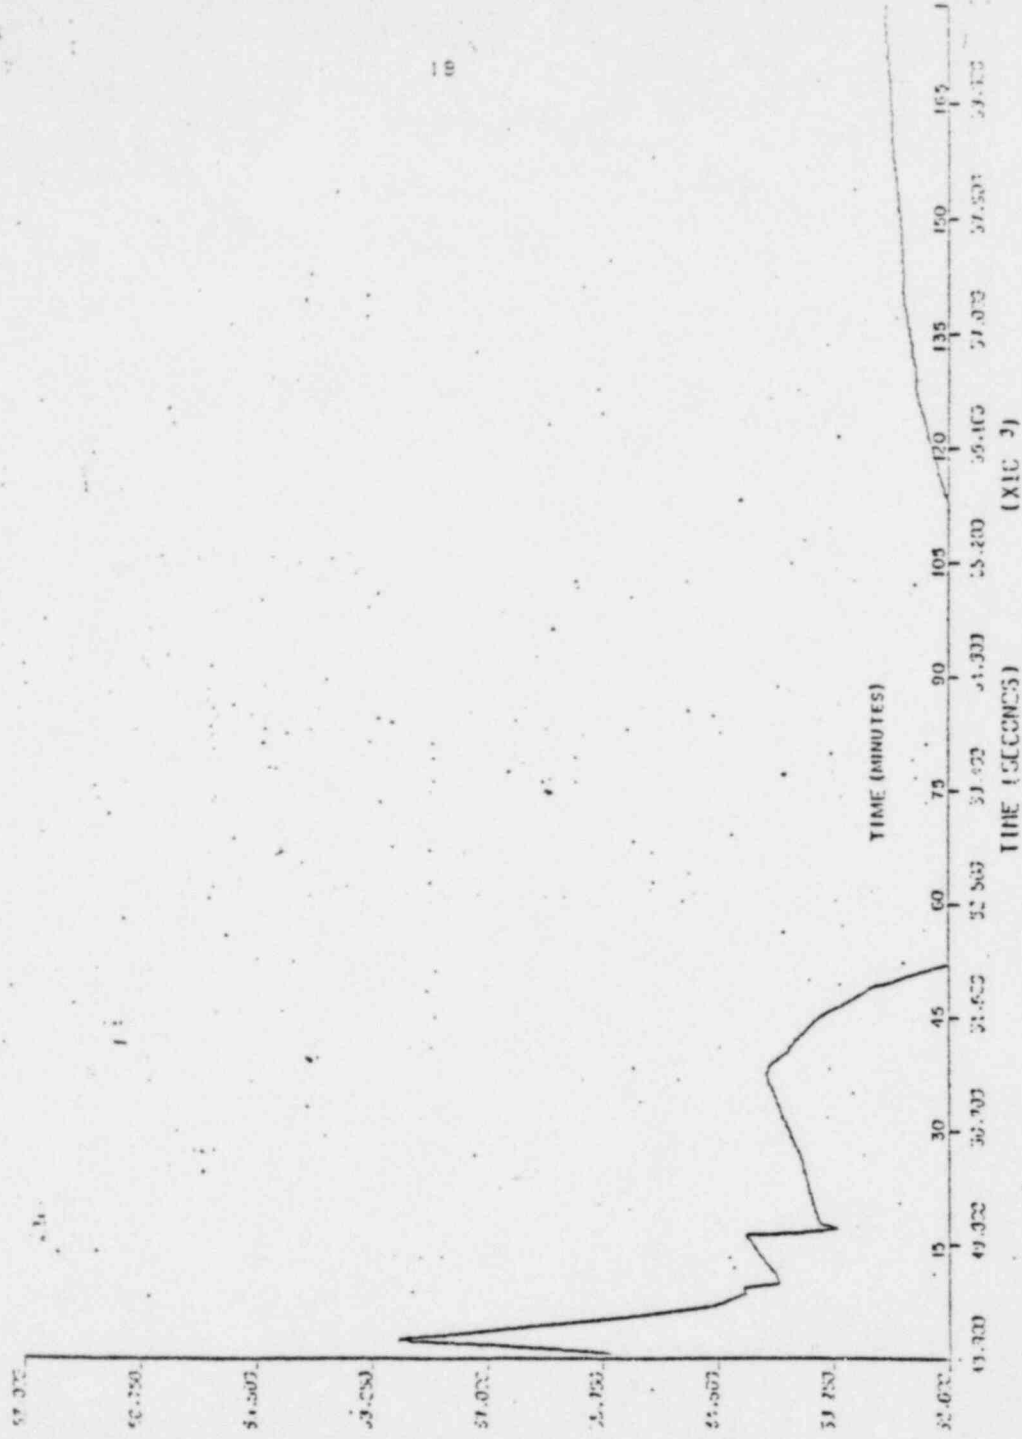
FIGURE 4-2

PC INLET TP 12-18 (CORRECTED)

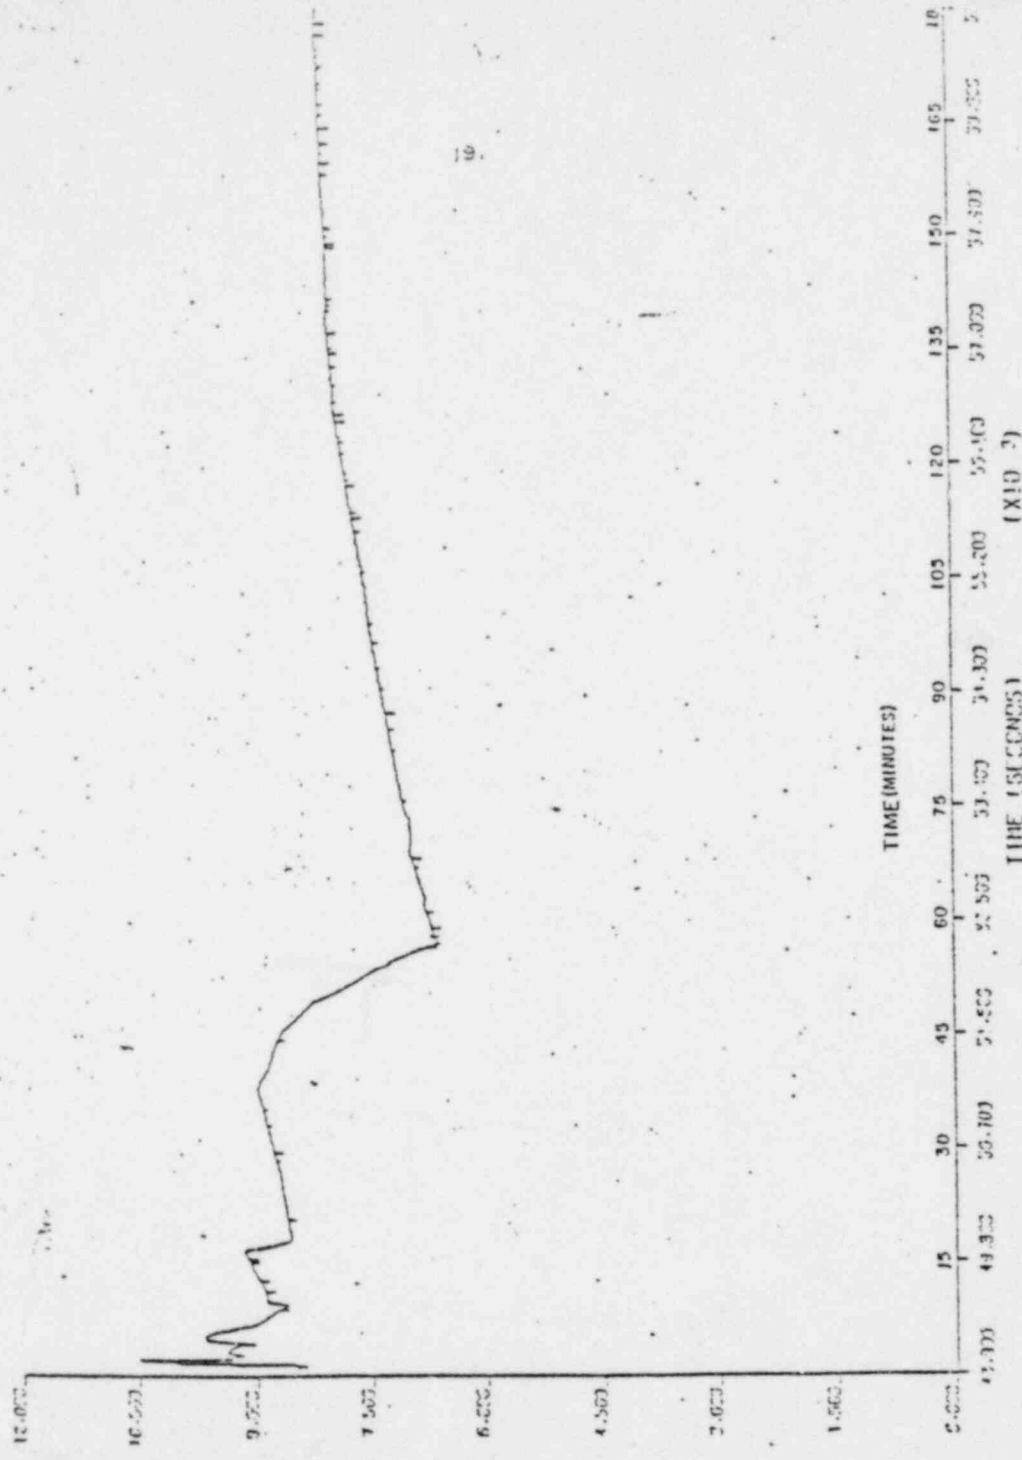
FIGURE 4-3

REACTIMETER PLOT TSN=71

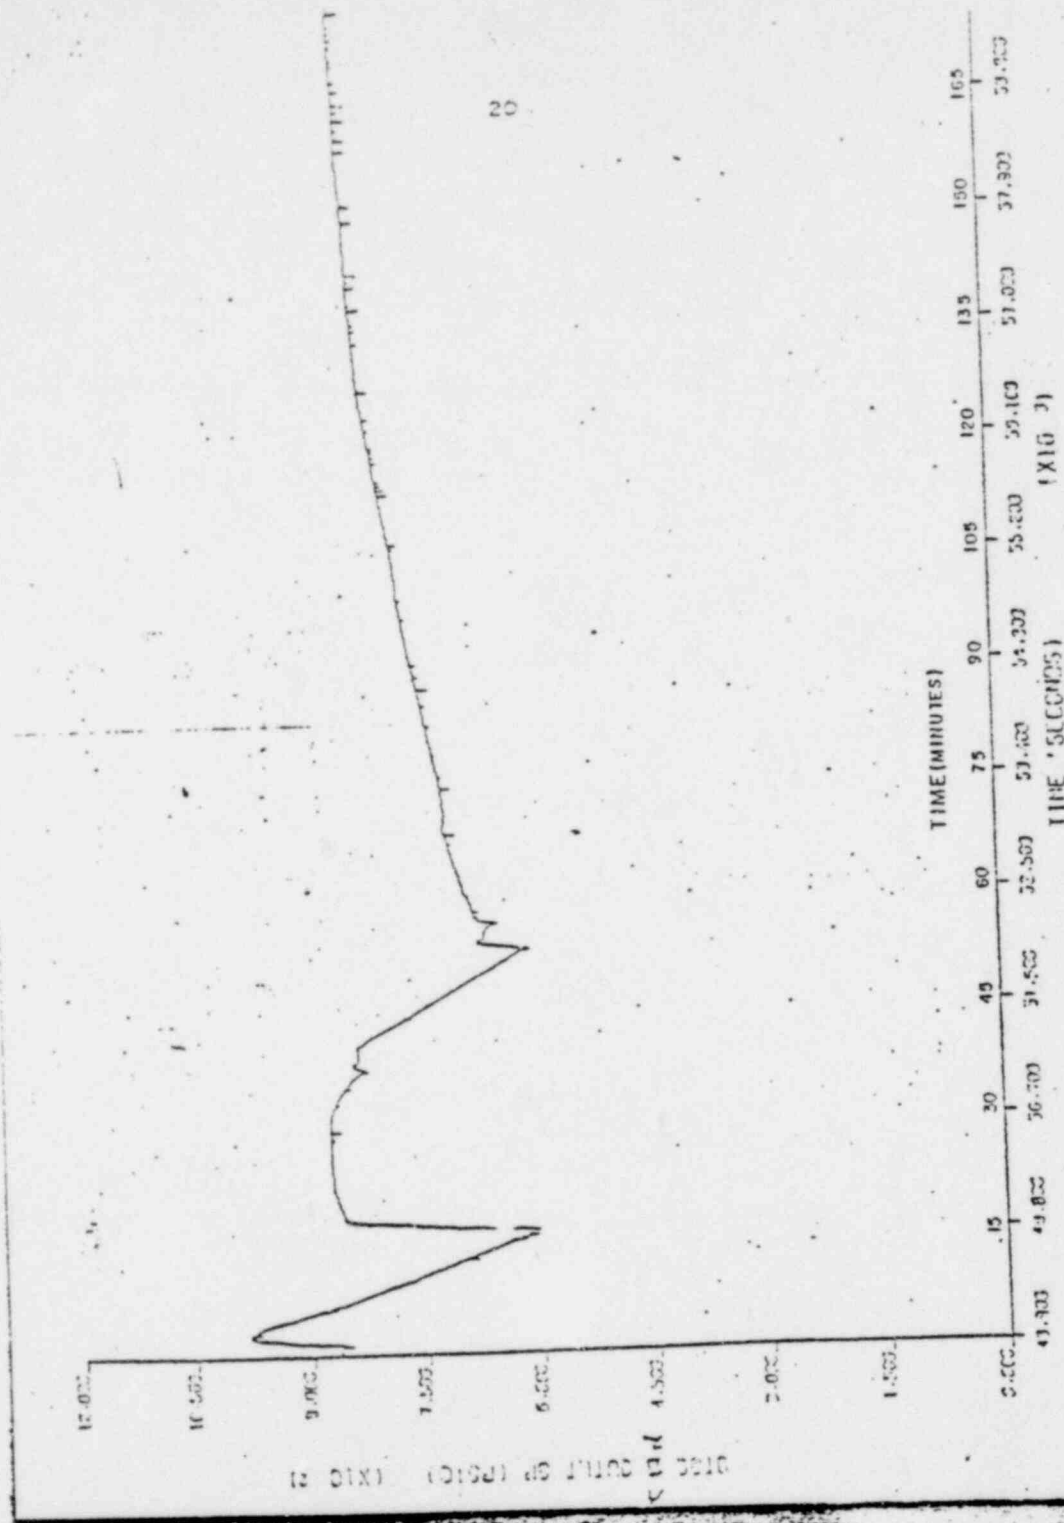
FIGURE 4-4

REACTIMETER PLOT TSN=71

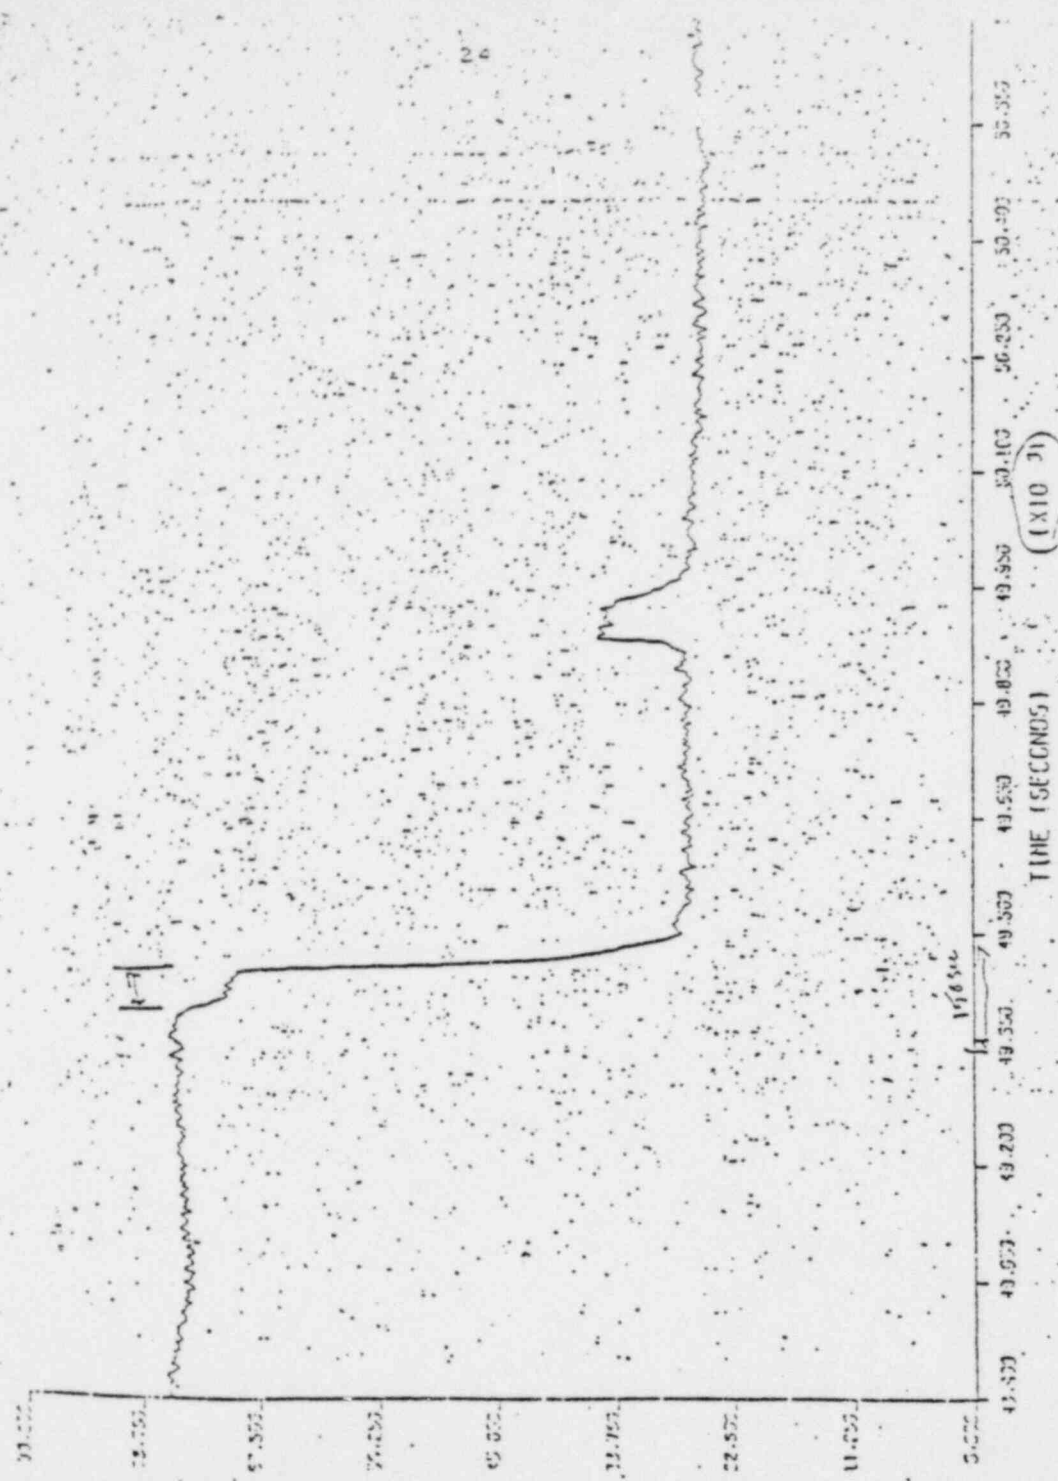
FIGURE 4-8

REACTIMETER PLOT TSN=71

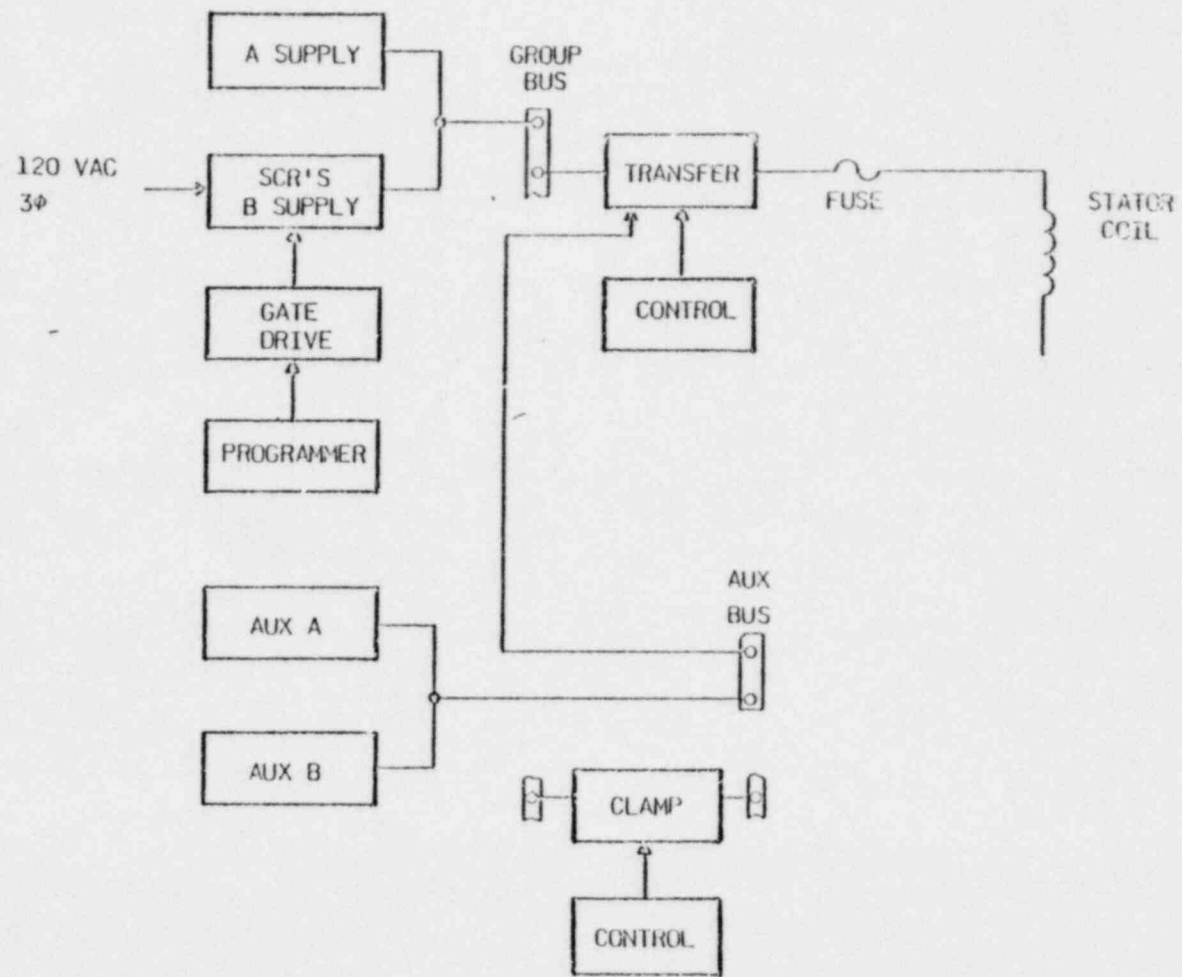
RATCHET  
TRIP

THE CONDITION THAT OCCURS WHEN A CRDM STATOR IS  
MOMENTARILY DE-ENERGIZED AND QUICKLY RE-ENERGIZED  
AGAIN BEFORE THE CRDM LEADSCREW TRAVEL IS  
COMPLETE.
