NIAGARA MOHAWK POWER CORPORATION

SUBJECT: Abnormal Occurrence Report No. 50-333 /75- 24  
(10 Day Letter)

Report No.: 50-333 /75- 24

All drywell high pressure switches found isolated.

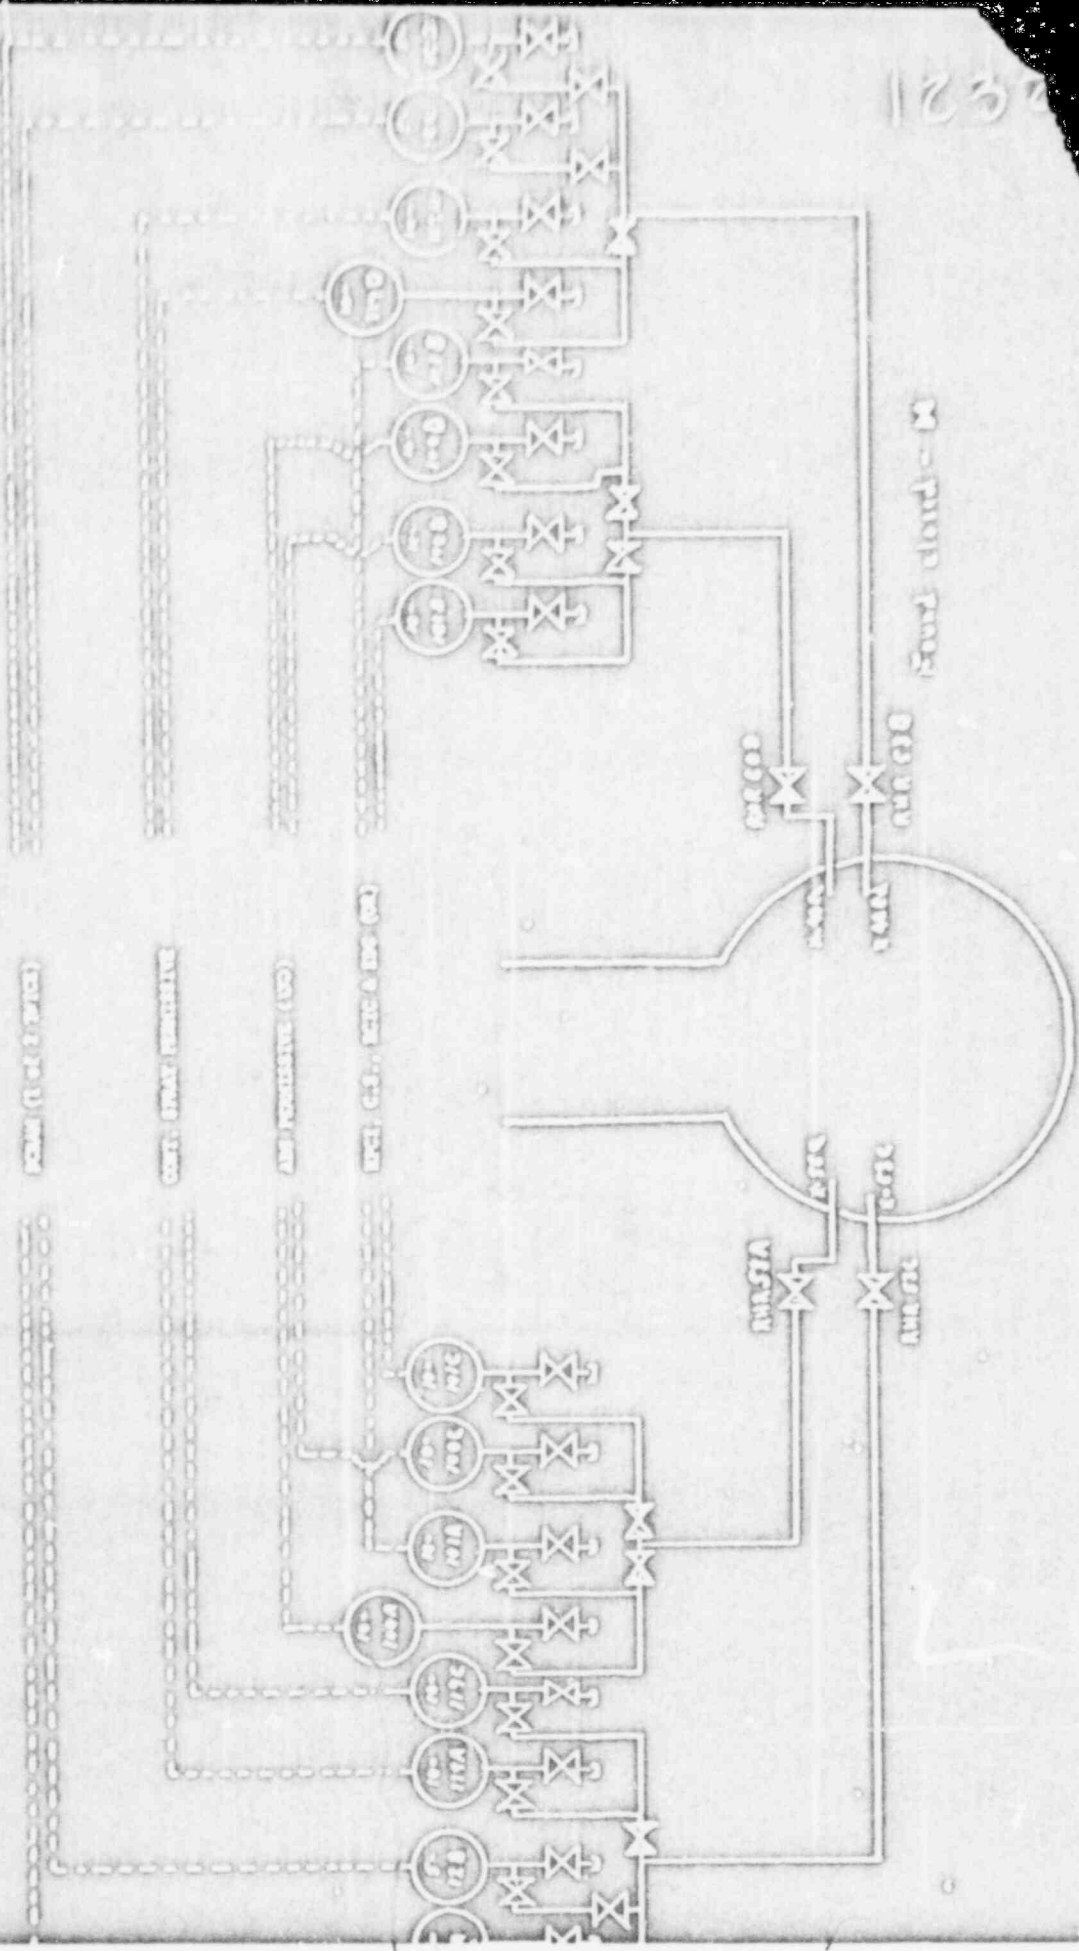
# DRYWELL HIGH PRESSURE

During routine surveillance testing, an instrument technician discovered that the rack isolation valves for drywell high pressure (instrument 5-12, 10-100, 10-101 and 10-119) in both safety systems were closed. Further investigation revealed that the associated root valves, RIR-53A, B & C and RIR-60D at drywell penetrations 55a, 40Ed, 53C and 40Ec were also closed. Due to the fact that the closed valves at the rack are not used in surveillance testing and that the root valves at the penetrations are not on a valve line-up sheet, this isolation is assumed to have occurred in August 1974 when these valves were scheduled to be re-opened following completion of the ILRT. A valve check at the instrument racks made in December 1974, indicated these valves open, however, the fact that the root valves were closed still negated the design function of the drywell high pressure instrument.

Drywell high pressure indication is used as one of the logic inputs for permissive operation of many of the engineered safeguard systems. However, the high drywell pressure instrumentation is a diverse signal for malfunctions to the water level instrumentation. The water level instrumentation, which was full operable, initiates protection for the full spectrum of loss of coolant accidents. (LOCA) During a LOCA it is assumed that the reactor is operating at design power when a complete circumferential rupture instantly occurs in one of the two recirculation suction lines. The analysis assumes a high drywell pressure scram occurs (instrument 5-12) in less than one second. However, the analysis further states that reactor low level (scram) is reached in about 0.5 seconds. The transient analysis further explains that either the low water sensor or high drywell pressure will initiate the ECCS (Core Spray and LPCI). Therefore, high drywell pressure instruments would not be needed in the LOCA transient. The drywell sprays are manually operated from the control room provided that high drywell pressure signal is on to the logic. This signal would not be present and the operator would have to bypass or jumper this switch operation. The operator would have an analog signal of drywell pressure

The isolated valves were immediately opened and are being sealed to prevent an occurrence of this nature again. In addition, the root valves and other isolated valves are being added to valve check-off list for both operations and instrument and control surveillance. These will be checked both prior to plant startups and during instrument surveillance testing. All other RPS rack and root valves as well as other instrument valves were inspected. Four other valves supplying only variable monitoring, no safety significance, were found and opened. As a result of this failure, Nine Mile Point #1 will also be checked for closed valves and valve line-up check sheets.
