SITE PROBLEM REPORT

CUSTOMER MET ED	CONTRACT NO. 620-0005	SPR NO. 289	REV. NO. 0
VENDOR BMO	P.O. NO.	TASK NO. 21	GROUP NO. 01
SITE ENGINEER S. P. MAINGI	REQ'D. RESOL. DATE	REQ'D. COMP. DATE

TITLE ICS RESPONSE DURING TURBINE TRIP

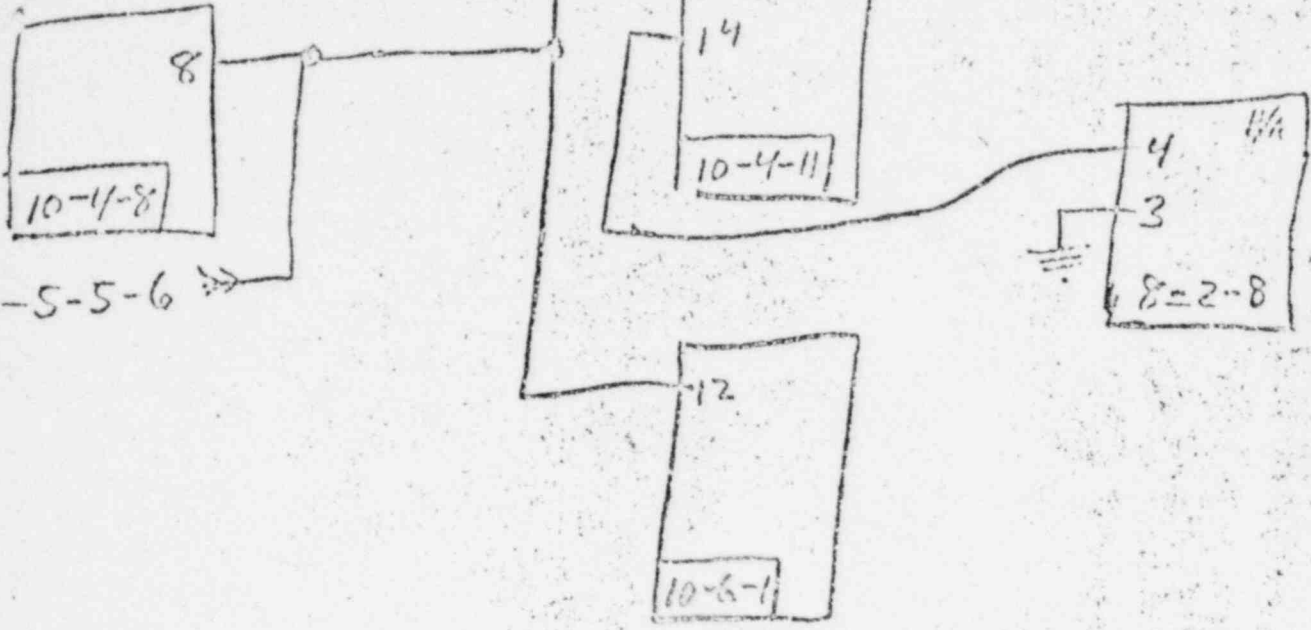
ENCLOSURE-1

Fuel pump speed

1. Add a feed forward from turbine header press to feed pump speed control.

1. Add a feed forward from turbine header pressure to feed pump speed control to raise speed demand when the header pressure jumps up on turbine trip. Present 35 PSI ΔP across FW valve train is lost when the header jumps up by 170 PSI.
2. Review BTU Limit operation during this transient to see if its action was correct. In other words, do we want to immediately step FW flow down on a turbine trip.

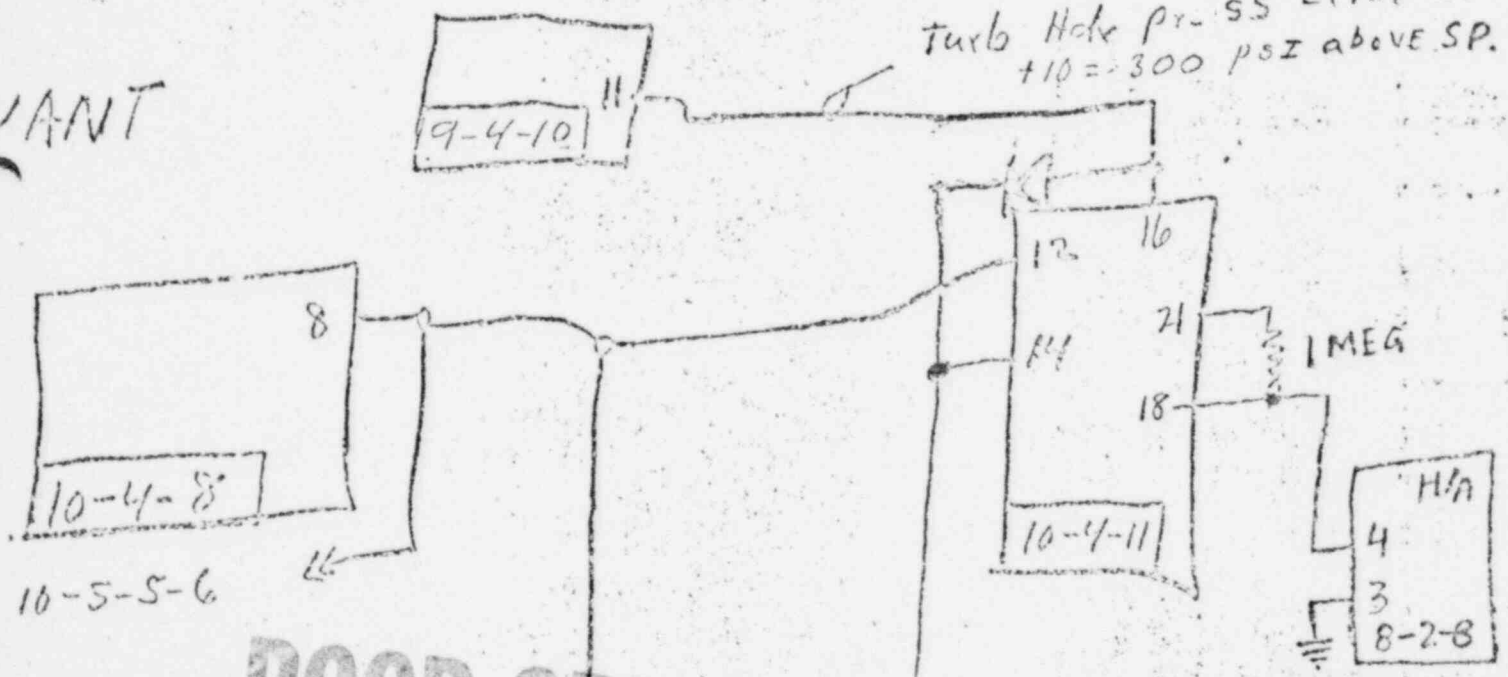
ENCLOSURE-2

Turb Hole pr-SS Error
+10 = 300 psz above SP.

psI psI
1050 - 885 = 165 = $\Delta 27.5\%$ to change FPS
20% E. Gain = 0.727

recommended for installation & test
