MEMORANDUM FOR: Ernst Volgenau, Director, IE  
FROM: Thomas J. McTiernan, Director, OIA  
SUBJECT: SURRY UNIT NO. 1 NEUTRON SHIELD TANK

EXHIBIT B

NO RECORD OF ENGINEERING APPROVAL FOR THE REMOVAL OF THE BACKING STRIP

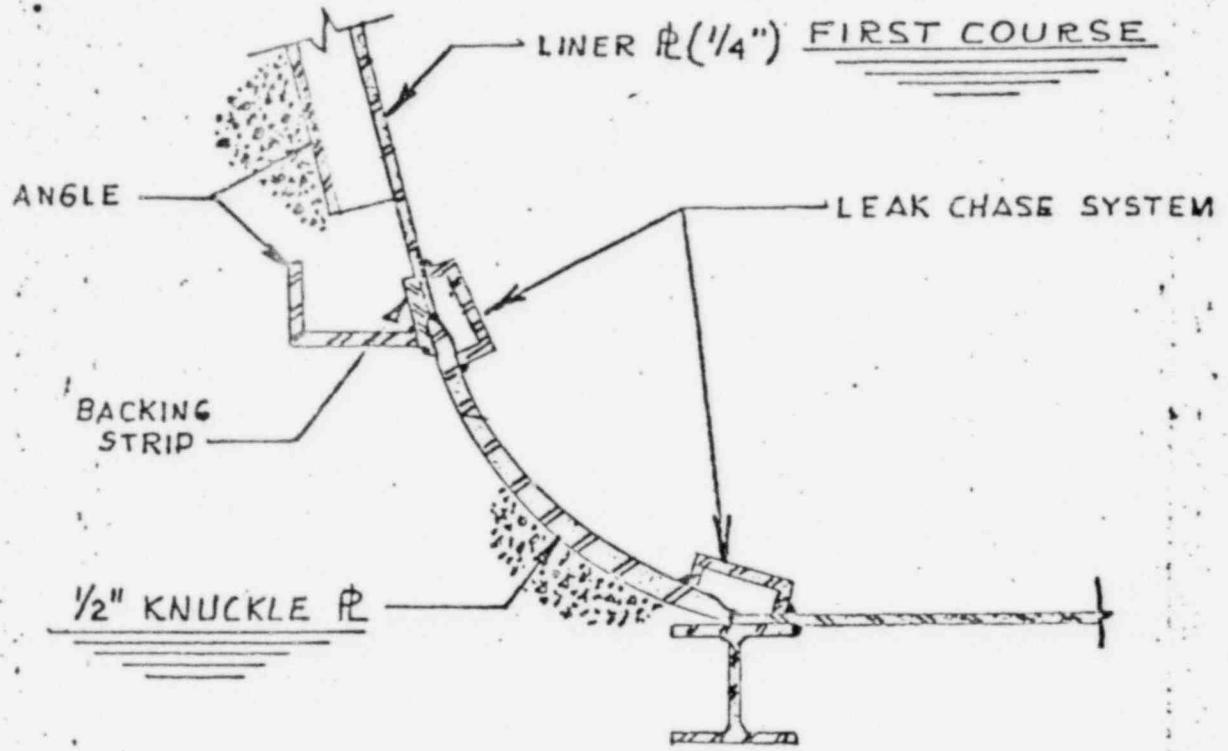
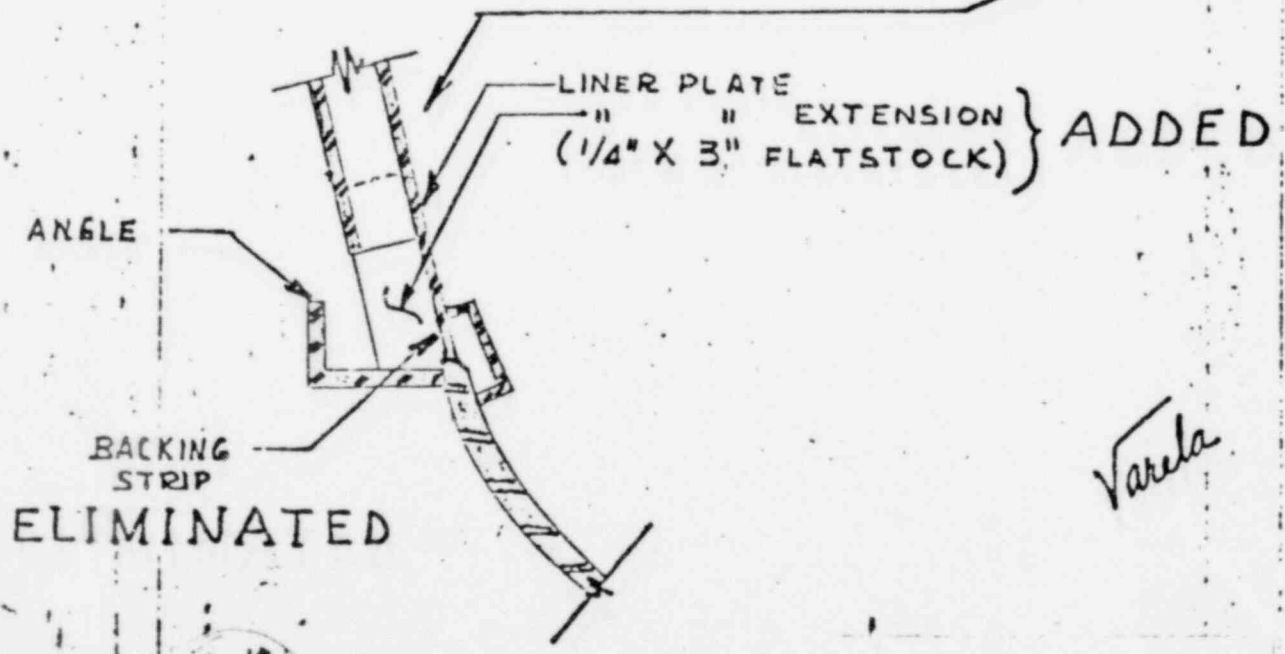
ABOVE FIGURE 11.2.25-1 IN PSAR - BELOW - AS-BUILT.

- 2. The liner assembly joint where the 1/4-inch plate is welded to the 1/2-inch knuckle section does not have a backing strip as shown on Supplement No. 4, Figure 11.2.25-1 of the PSAR. ~~This appears to present no problem to this inspector,~~ but is considered as a deviation from the PSAR only. AP&L states that the discrepancy will be corrected by PSAR supplement as the above items were corrected.
