Report to Congress on Abnormal Occurrences

July - September 1979

U.S. Nuclear Regulatory
Commission

Date Published: February 1980

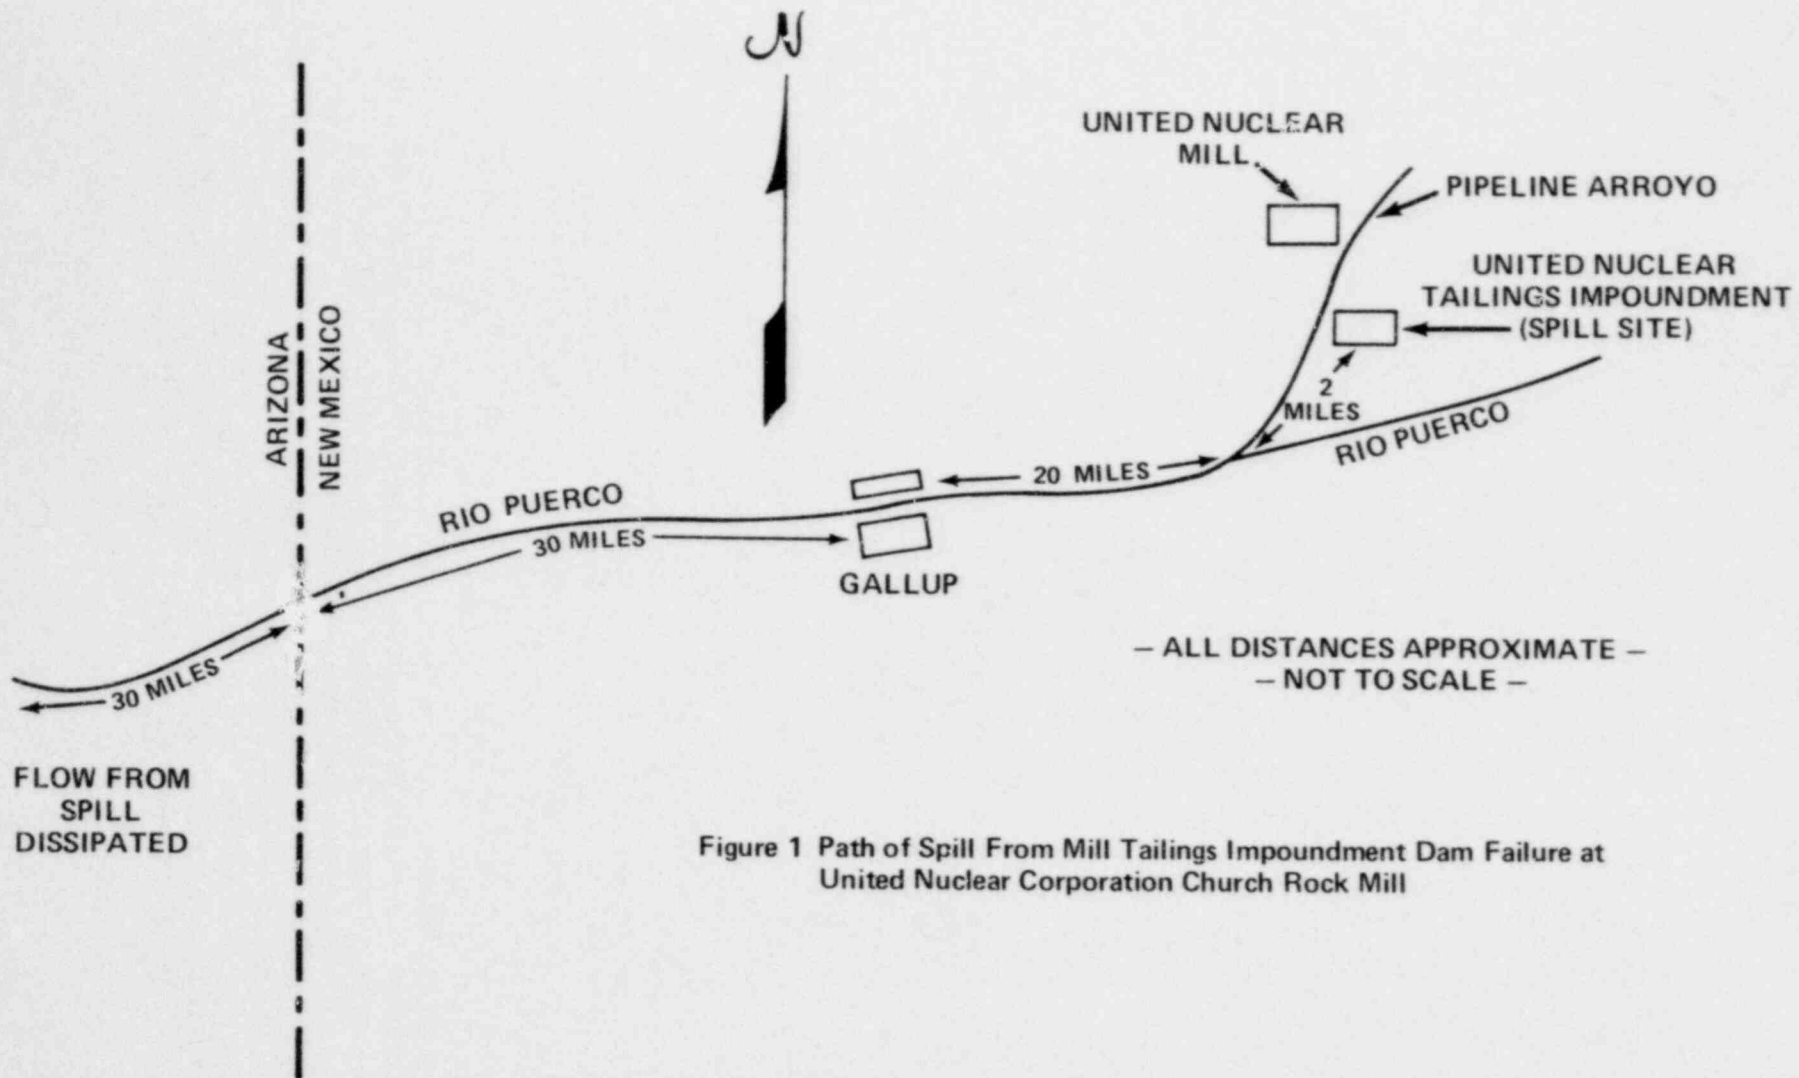
Nature and Probable Consequences - As a result of the dam failure, mill tailings solution and solids poured through the break into a catchment area below the dam. The catchment embankment was subsequently breached and tailings solution flowed into an arroyo (water-carved gully) and on into the Rio Puerco River which flows past Gallup, New Mexico.

The break in the dam allowed approximately 100 million gallons of tailings solution and 1100 tons of tailings solids (sand) to flow out of the impoundment before it could be closed. Most of the solids were deposited in an area very near the impoundment in a backup containment area on United Nuclear Corporation property and in an adjacent stream, the "Pipeline Arroyo." The tailings solutions travelled in the Pipeline Arroyo to the Rio Puerco which flows through Gallup, New Mexico, a town about 20 miles southwest of the mill site, and into Arizona. The spilled solutions eventually dissipated at a point estimated to be about 30 miles into Arizona. (See Figure 1.)

Figure 1 Path of Spill From Mill Tailings Impoundment Dam Failure at United Nuclear Corporation Church Rock Mill

Cause or Causes - The tailings impoundment dam failed as a result of differential settlement and direct exposure of the dam to tailings solutions. The first factor was the result of the manner in which the dam was constructed; the second factor was the result of failure of the operator to maintain a buffer of mill tailings between the dam and the tailings solutions.

The dam is located on a site containing alluvial soils overlying bedrock having an irregular surface. Depths of this relative? loose soil ranged from less than 20 feet up to a maximum of 100 feet. During design and construction of the dam, tests were conducted to determine how much the alluvial soil would compress under a load. These tests indicated that settlement of about 5 percent would result from the loading of the embankment under dry conditions. With water in the impoundment, additional settlement ranging from 1-1/2 percent to 13 percent was experienced due to collapse of the soil structure. As a result of this high compressibility of the alluvial soil and the irregular bedrock surface, large differential settlement of the dam occurred. As a result of differential settlement, cracks developed in the embankment. These cracks coupled with the lack of a buffer of solid tailings between water and the dam allowed tailings water to penetrate and weaken the embankment.

Licensee - The United Nuclear Corporation (UNC) performed an evaluation of the dam failure and examined the serviceability of the remaining portions of the dam. UNC is also performing a study of alternate sites for the tailings impoundment. UNC is conducting cleanup operations to standards established by the State of New Mexico and the NRC. Cleanup of contamination has been completed in the most heavily affected areas near the mill. Cleanup in the remaining sections of the Arroyo will probably take several more months to complete.
