VOLUME **II** Part 2

three mile island

**A REPORT TO THE
COMMISSIONERS
AND TO THE
PUBLIC**

**NUCLEAR REGULATORY COMMISSION
SPECIAL INQUIRY GROUP**

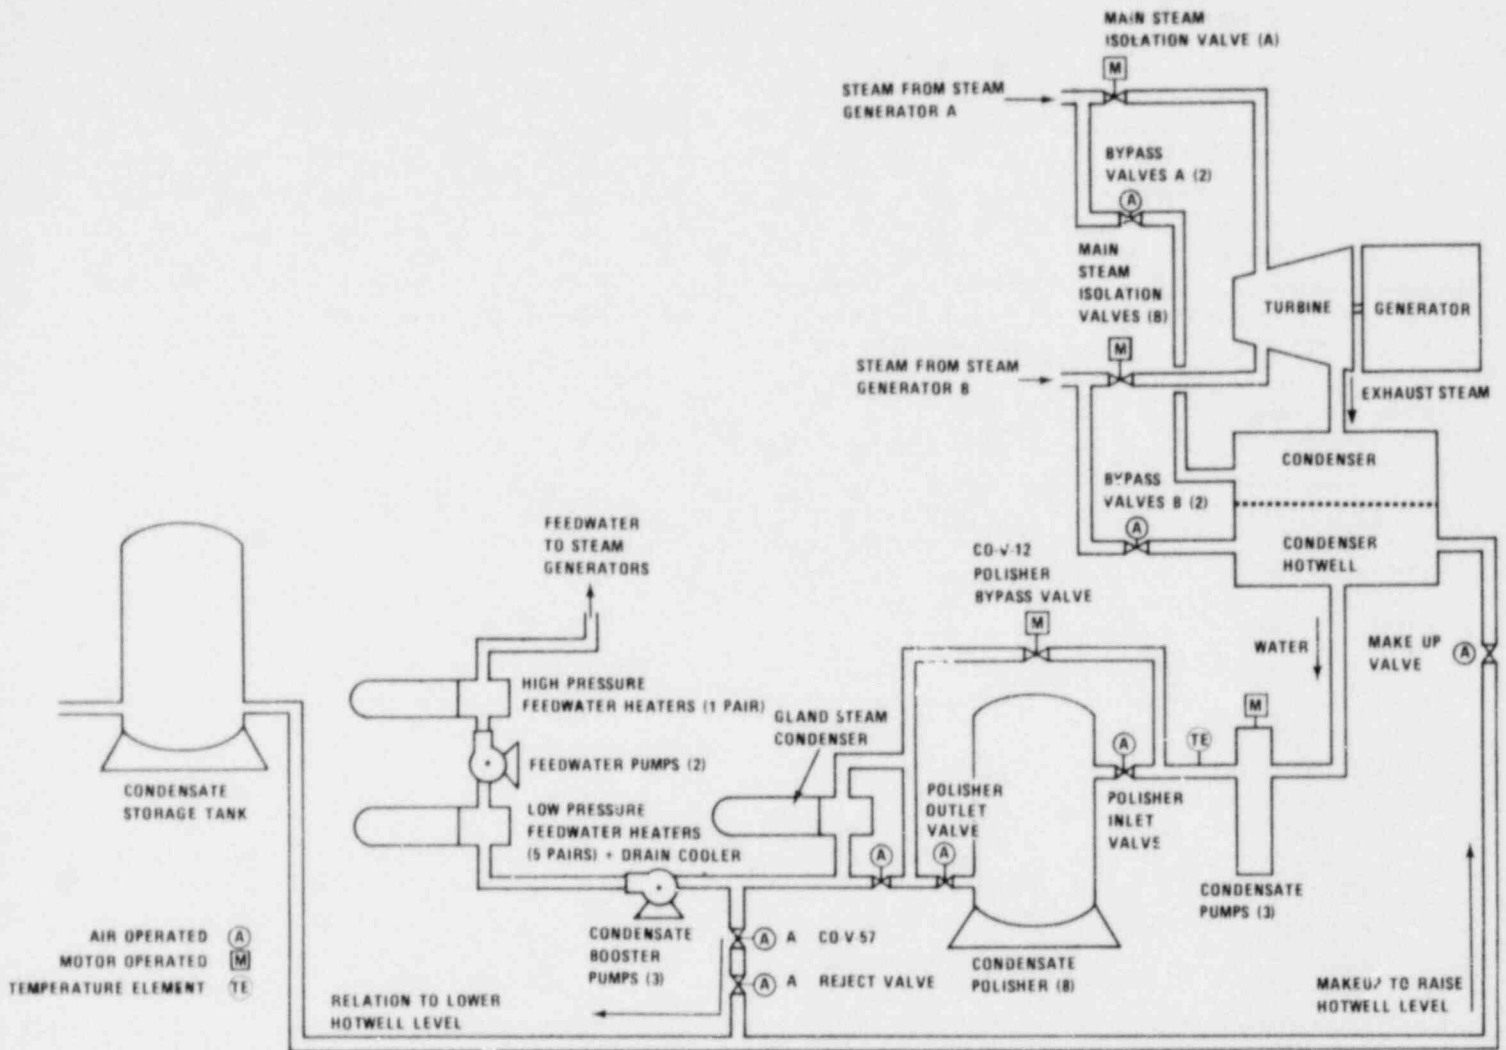
FIGURE II-1. The Condensate and Feedwater System

It has been postulated that the water in the air piping caused the polisher inlet or outlet valves, or both, to close.¹ [Problems with the valves in the

polisher system are discussed in Section II.C.1.d.) Closure of either the inlet or outlet valves would interrupt the flow of feedwater and cause the condensate pumps and condensate booster pumps to trip, that is, to be automatically shut down. Tripping of these pumps causes tripping of the main feedwater pumps, which in turn, causes tripping of the main turbine and electrical generator.

In the accident at TMI-2, it has not been definitely determined what caused the condensate pump to trip, although it is a reasonable inference that the operations on the polisher were somehow involved. It has been established that condensate pump 1A tripped and that both main feedwater pumps then tripped almost simultaneously. Approximately 1 second later, the turbine and generator tripped.

Meanwhile, the condenser hotwell (Figure II-1) was undergoing some expected level fluctuations, first dropping to 21.7 inches, then rising to normal. At 1 minute 13 seconds, the condensate level had reached the high level alarm point at 37.8 inches. [These initial fluctuations were not unexpected.] Unknown to the operators, however, an air line to the hotwell level controller was broken, apparently by a "water hammer" during the initial transient.⁵ The operators were unable to regain control of hotwell level.

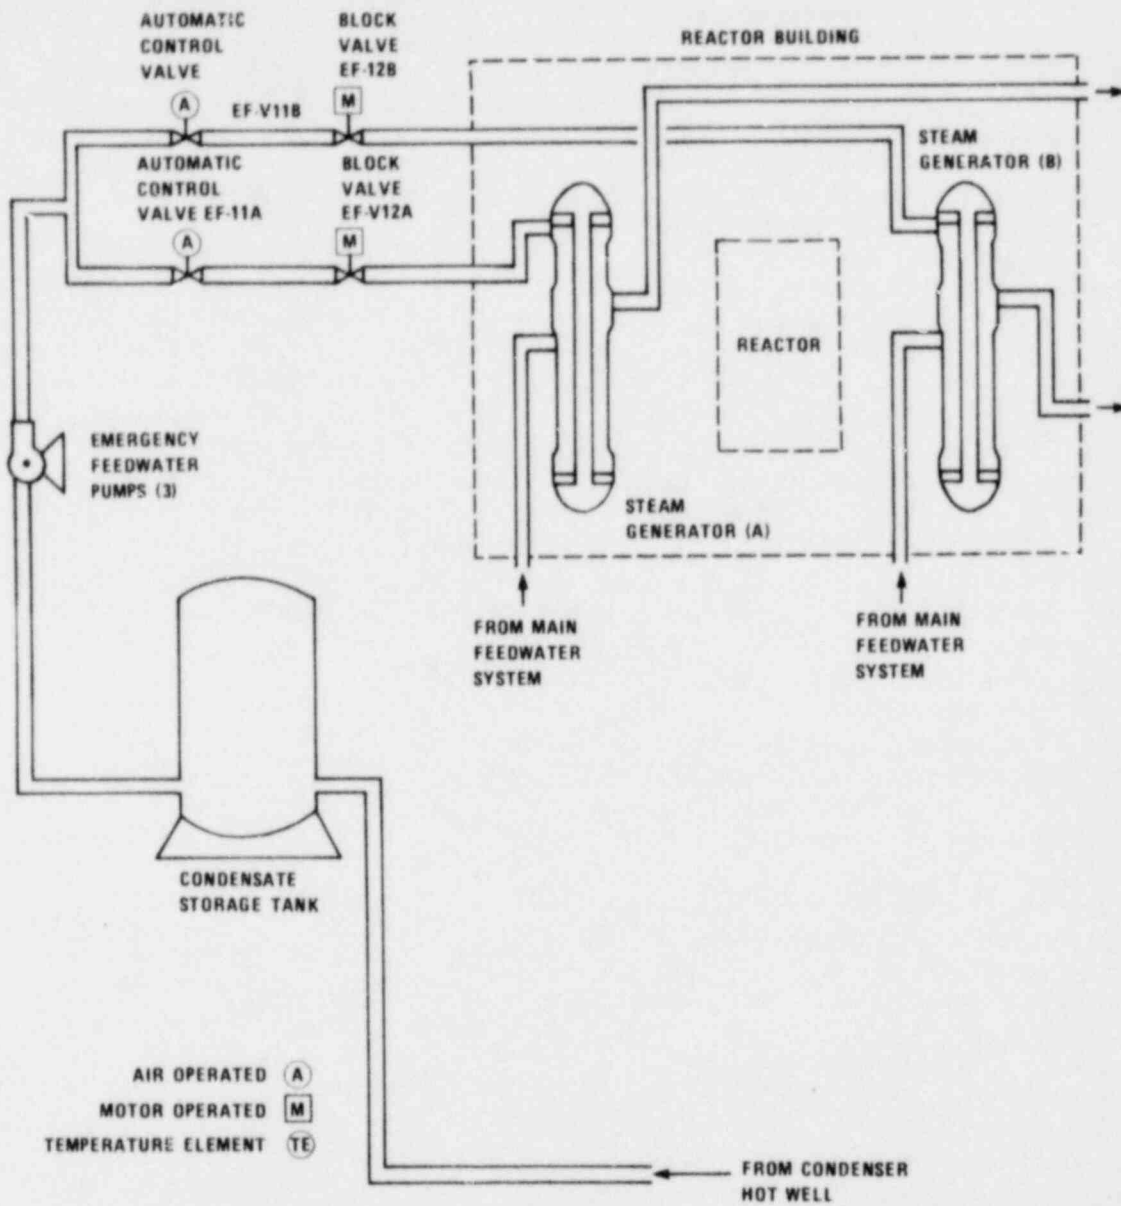
FIGURE II-2. The Emergency Feedwater System

Three emergency feedwater pumps (two electric, one steam driven) are started automatically on loss of the main feedwater pumps (Figure II-1). The emergency feedwater pumps take suction from the condensate storage tank; in an emergency, they can also take suction directly from river water. The automatic control valves will open (a) when the discharge pressure of the emergency feedwater pumps is high enough and (b) when the water level in the steam generators falls to 30 inches or less. Until both conditions are satisfied, the control valves remain closed. The block valves should have been open at all times; however, at the time of the accident these valves were closed. When the conditions were met, the control valves slowly opened, but no water was admitted to the steam generators because the block valves were still closed. About 8 minutes after the start of the accident, the operator discovered that the block valves were closed, and opened them. This admitted water to the steam generators.

The block valves can be operated by switches in the control room, by switches in the auxiliary building, and manually at the valves. It is not known from which point nor when the valves were closed.

At 8 minutes after turbine trip, the operator discovered that the emergency feedwater block valves were closed and opened them. Opening these valves caused a rapid increase in steam pressure, which had previously dropped when the steam generators boiled dry, and a drop in RCS temperature. Steam generator level, however, did not recover noticeably for another 14 minutes. [The reason for the lag in recovery of the steam generator level is that emergency feedwater is sprayed directly onto the hot tubes and evaporates immediately (Figure II-5). Evaporation raises steam pressure, but

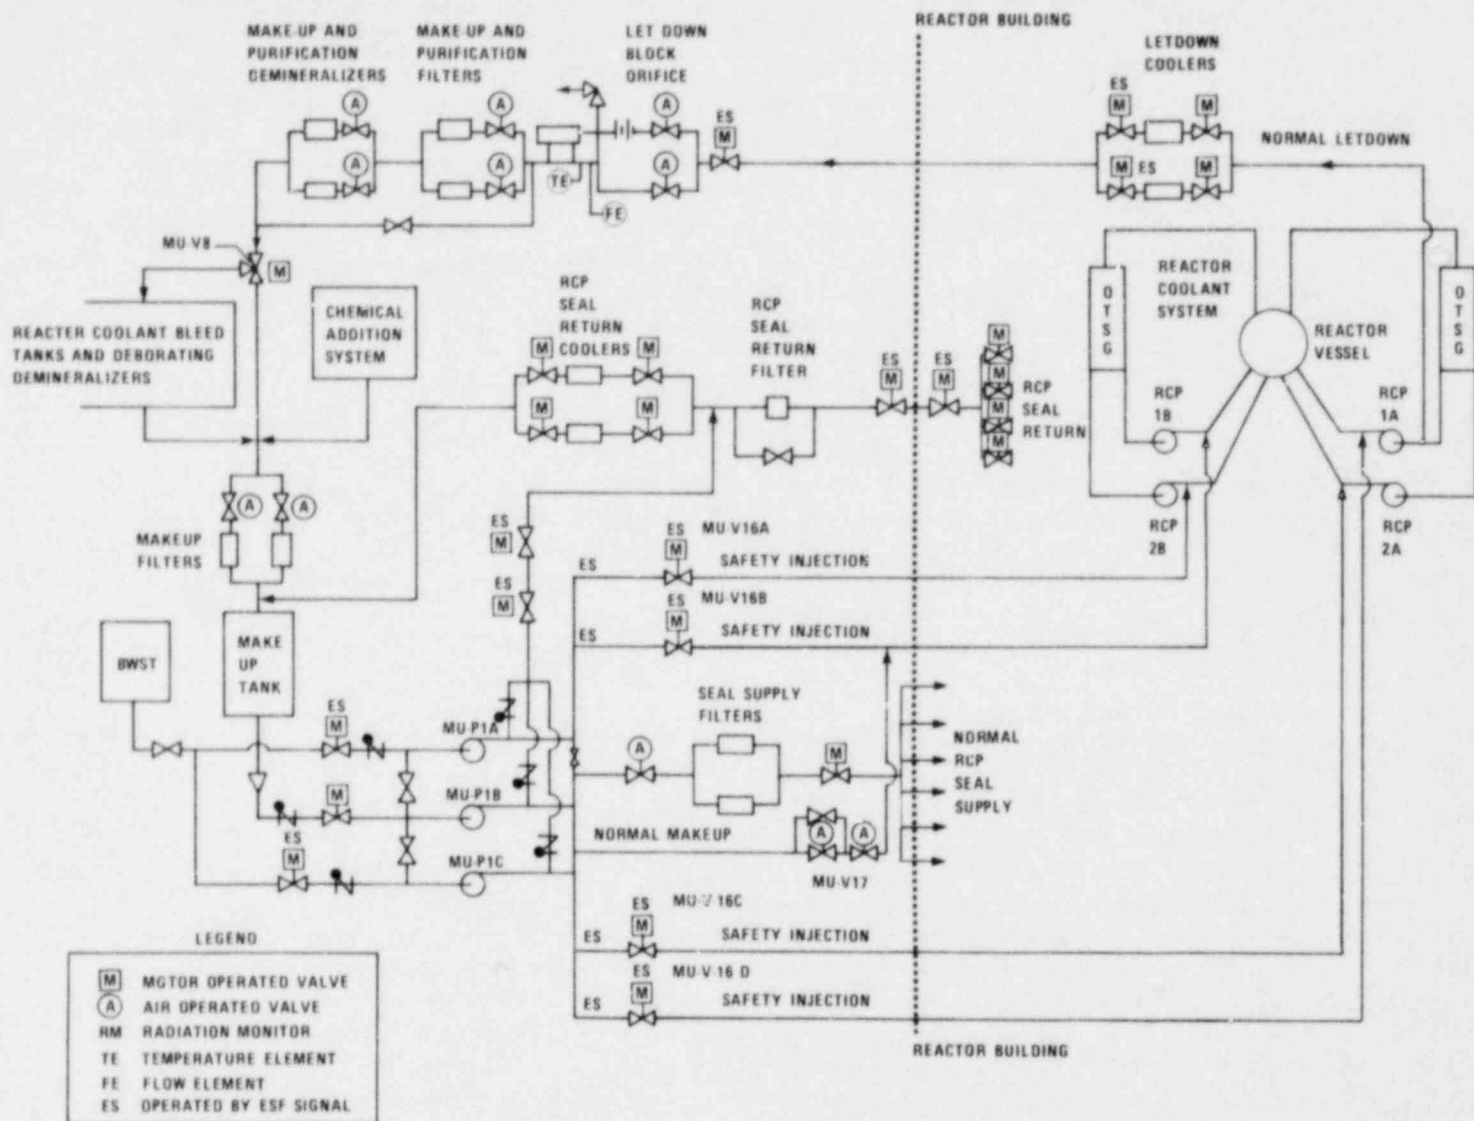
FIGURE II-3. The Makeup and Letdown System

During normal operation, water is removed from the reactor coolant system (RCS) near the suction of the reactor coolant pump (RCP-1A). The water removed is purified and cooled and can be sent either to the reactor coolant bleed tanks or to the makeup tank. At least one makeup pump is always operating; this supplies water to the reactor coolant pump seals. A small amount of the seal water leaks out and is returned to the makeup tank through the seal return system; the remainder enters the RCS. Any additional water required to maintain the correct inventory in the RCS is regulated by valve MU-V17 and enters the discharge line of RCP-1A. In the high pressure injection mode (when the engineered safeguards are actuated), two makeup pumps (normally 1A and 1C) take water directly from the borated water storage tank, and pump through valves MU-V16A, 16B, and 16D—which are wide open—to all four RCS cold legs. Letdown is stopped during engineered safeguards operation.

sion of plant operation with leaking valves can be found in Section II.C.1.b.] Leakage from the PORV went to the reactor coolant drain tank (RCDT) where it was condensed and was then pumped to the reactor coolant bleed tanks. The buildup of water in the bleed tanks was then being transferred periodically to the makeup tank.

If not compensated for, the expected shrinkage of reactor coolant on cooldown could cause an excessive change of volume. To reduce the rate of volume change, therefore, letdown is stopped and makeup is increased. Thirteen seconds after the turbine trip, the operator stopped letdown. He also attempted unsuccessfully to start a second makeup pump. This operator has testified that the pump did not start because the switch was not held in position long enough. The pump was started later, however, by another operator. (The operation of the makeup pump is discussed further in Section II.C.1.c, in which it is concluded that only momentary switch contact is required to start the makeup pumps.)

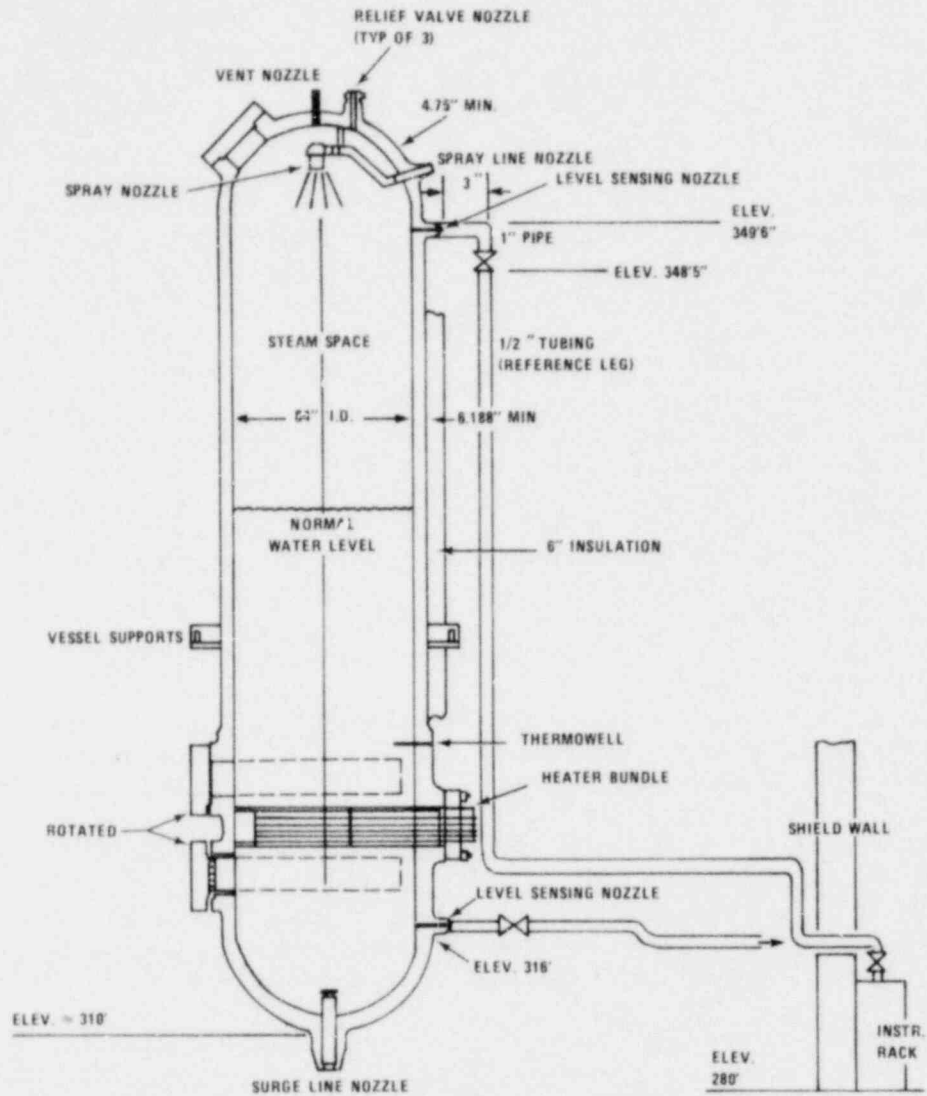
FIGURE II-4. The Pressurizer

Fifteen seconds after turbine trip, the pressurizer level reached a maximum of 255 inches (from an operating level of about 220 inches). Contraction of the coolant then caused a rapid drop in pressure, as was expected. [The operators expected to reduce the amount of contraction by adjusting makeup and letdown flows.] [By 28 seconds after turbine trip, the two conditions for admission of emergency feedwater to the steam generators had been met, and the automatic valves should have begun to open. Because the block valves were closed, of course no water could be admitted to the steam generators even with the automatic valves open. It appeared to the operator that the automatic valves were opening at an unusually slow rate, and the slow opening of these valves was initially attributed to the delay in feeding the steam generators.]

[If the PORV had not been opened, it could now be expected that increased flow of makeup water into the system would accelerate the rate of rise of the pressurizer level (Figure II-4) and cause the RCS pressure to begin to climb again. Uncontrolled filling of the pressurizer might cause it to fill completely (pressurizer "solid"). Control of RCS pressure is lost with a solid pressurizer, and a very small temperature increase in the totally filled system could cause the pressure to rise to the point where the safety valves would open. If this were to happen, it is possible that the plant would have to be shut down. The safety valves might have to be repaired, because it is not unusual for safety valves to leak after being lifted. Operators are trained to avoid this situation. Operating procedures require them to switch to manual control and reduce makeup as soon as the pressurizer regains a normal level. (This practice is necessitated by a preexisting design deficiency discussed in Section II.C.1.c.)]

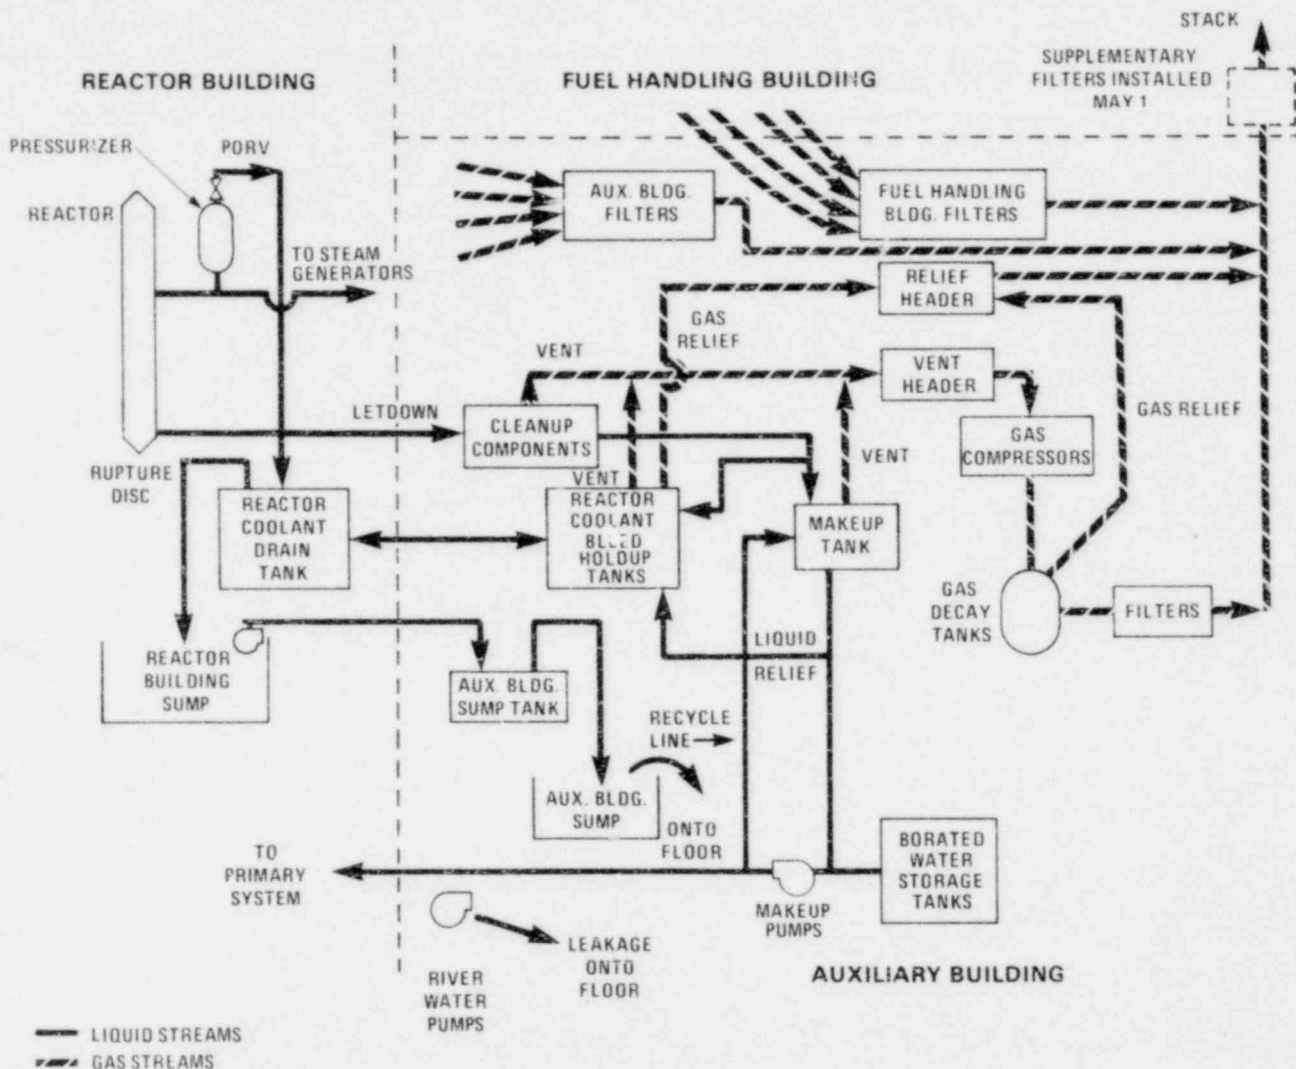
FIGURE II-12. Release Pathway

Problems with the waste gas system compressor have already been discussed. A postaccident examination of compressor B found a hole approximately the size of a quarter. The operation of the compressor at any pressure would be considered a significant release path.²³ However, compressor B was off line from March 28 until March 29.²⁶ In addition, the design of the waste gas system includes a pressure regulator (WDG-V-59) that limits the inlet pressure to the compressors to approximately 1 inch of water gauge. This prevented any high pressures in the vent header from reaching the

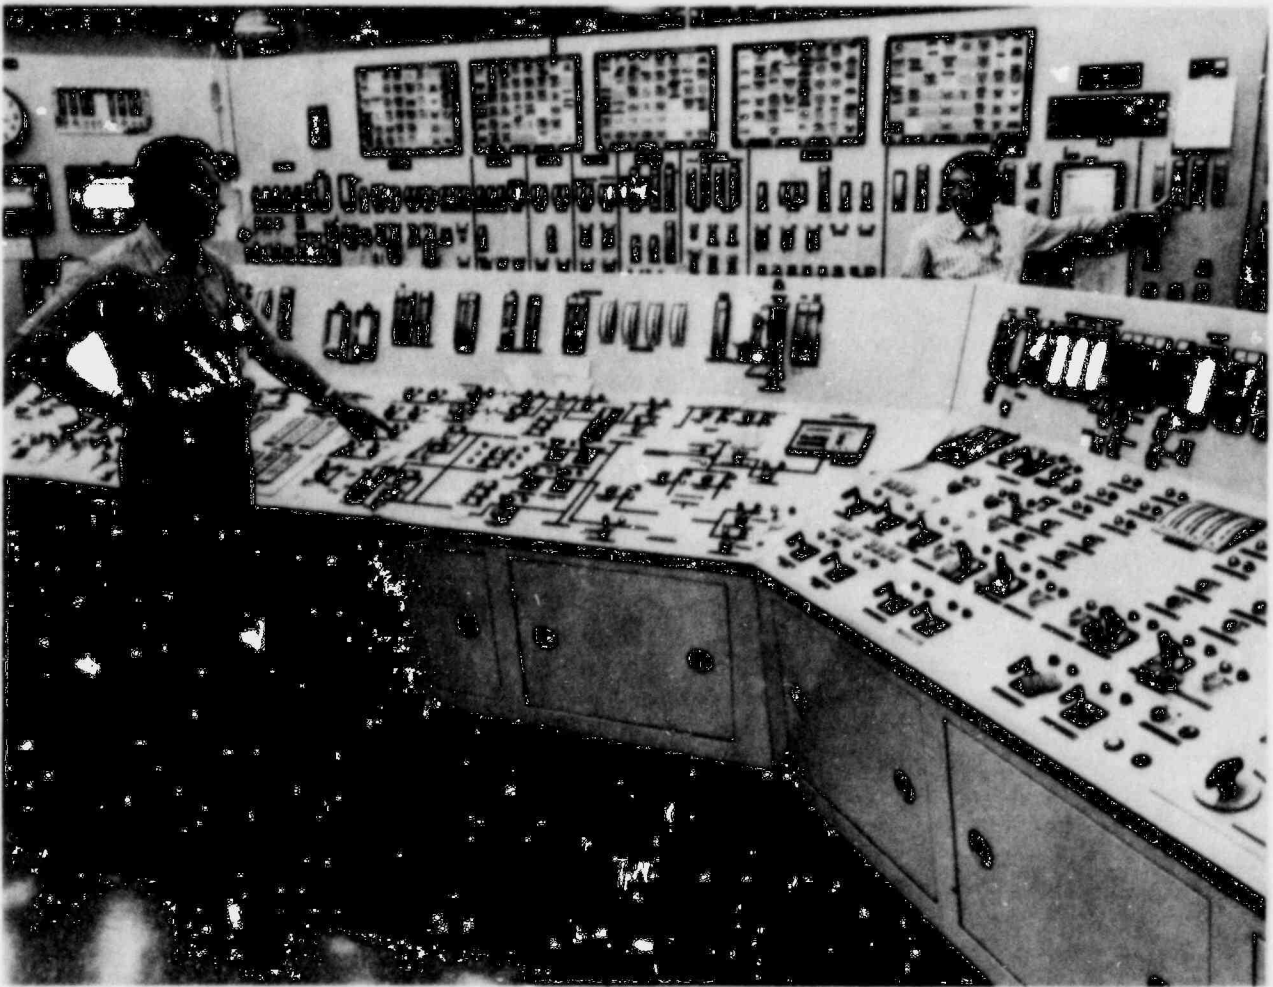
FIGURE II-49. Visual Scan Necessary for Operator (on Left) Controlling Makeup To Monitor Makeup Flow (Operator on Right)

A critical design requirement for the nuclear powerplant control room is the effective display of information to the operator. This requirement is most pronounced during emergency conditions

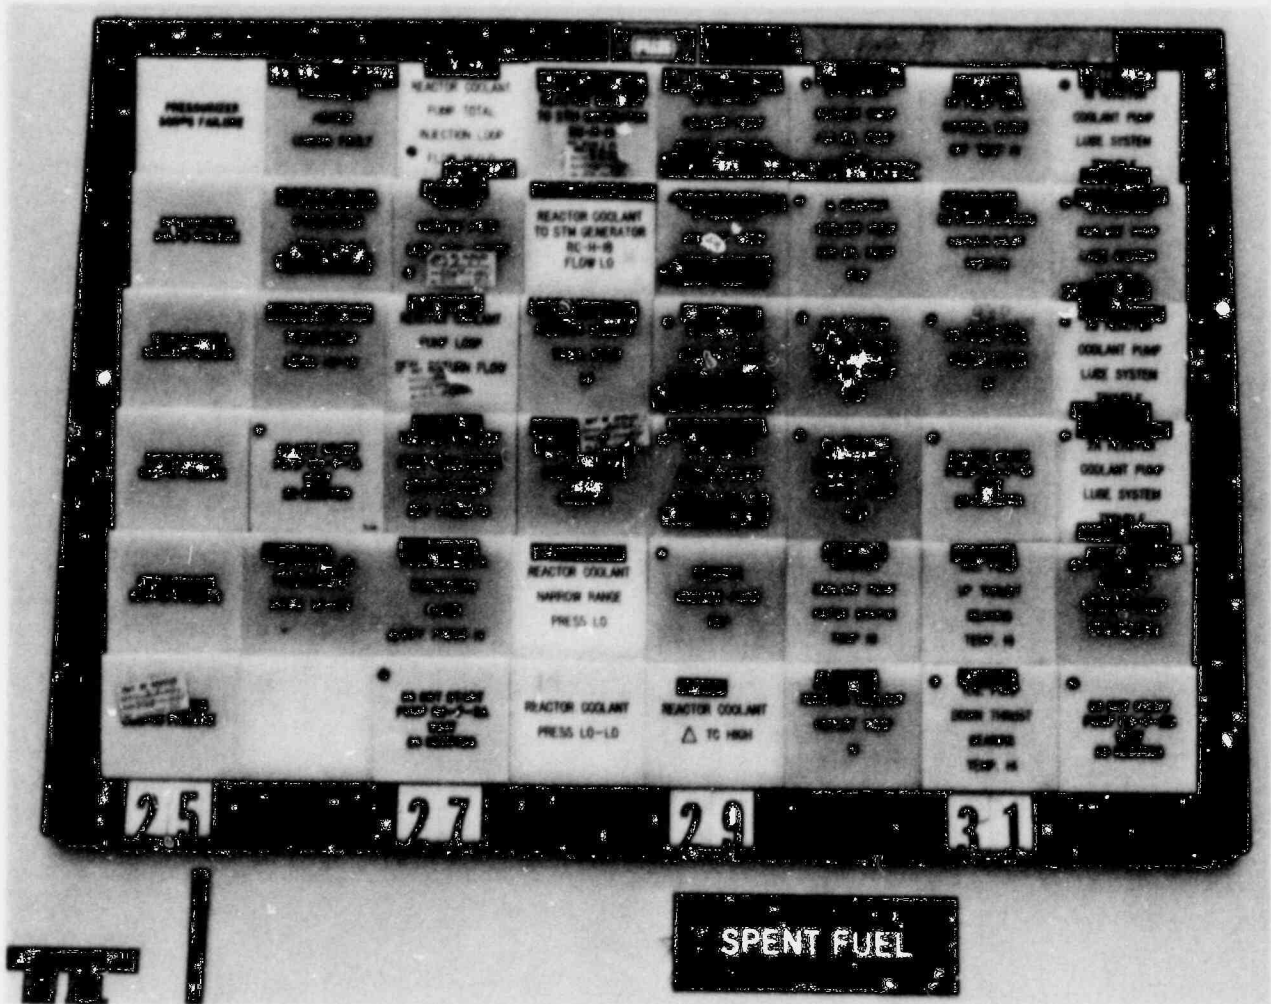
FIGURE II-53. Typical TMI-2 Alarm Panel

- 470 indicator lights
- 24 legend switches
- 3 control display units
- 3 vertical indicators
