Written Report on the
Reportable Deficiency
Concerning
Unconsolidated Concrete
in the
Fuel Handling Building

SOUTH TEXAS PROJECT
April, 1978

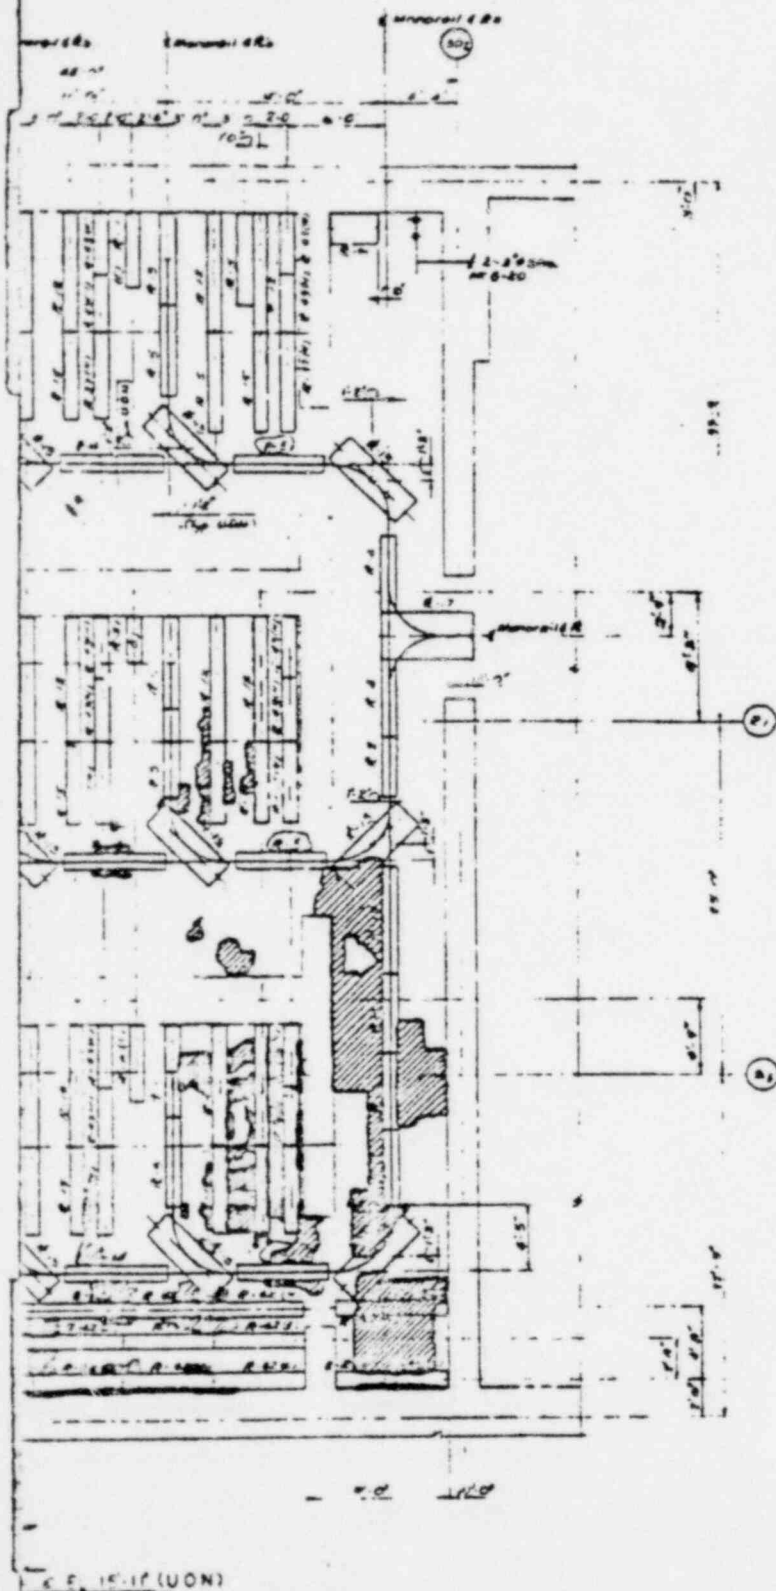
FIGURE 2
 DWG. NO. 1-C-3105-2

ECCS PUMP CUBICLES
 CONCRETE DEFECT MAPPING

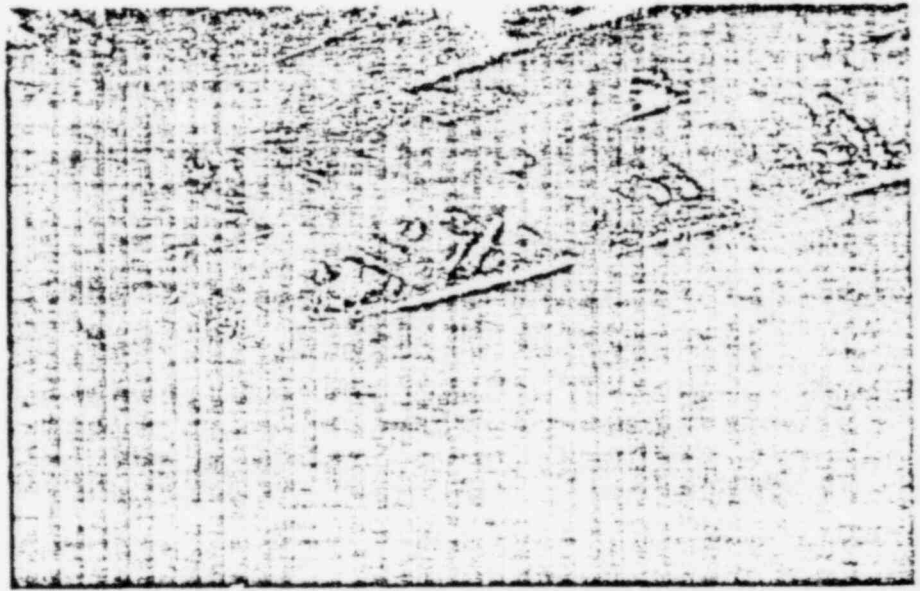
FIGURE 3

REPRESENTATIVE DEFECT AREAS
