UNITED STATES  
NUCLEAR REGULATORY COMMISSION  
WASHINGTON, D. C. 20555

May 15, 1980

## CRACKING IN LOW PRESSURE TURBINE DISCS

SUBJECT: MEETING WITH GENERAL ELECTRIC RELATED TO TURBINE DISC  
CRACKS

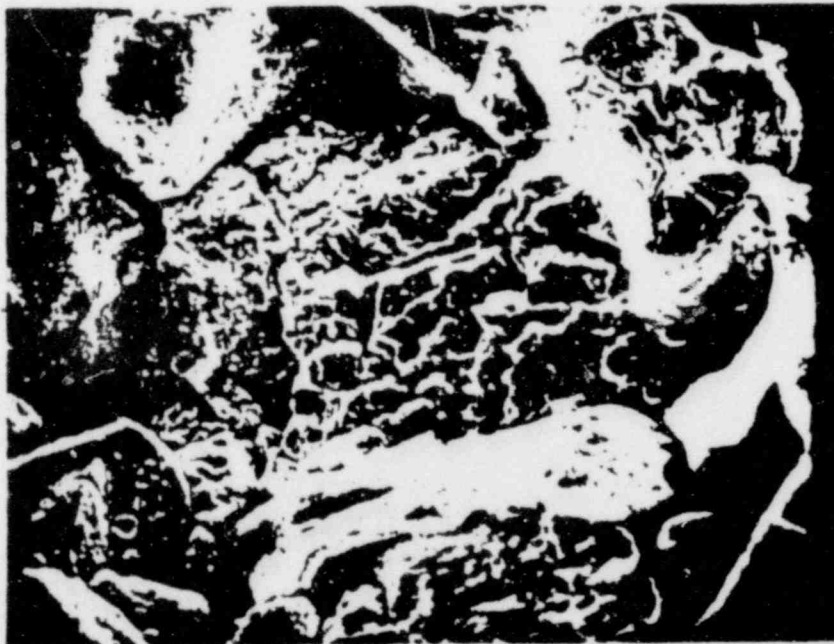
A considerable number of testing procedures have been utilized to investigate the resistance of NiCrMoV steels to stress corrosion cracking. Figure 1 shows results from dead weight load tests performed in caustic solutions under various conditions. Figure 2 illustrates the test apparatus with the environmental container removed so the smooth tensile type specimens can be observed. Scanning electron micrographs of a wheel material tested to failure in caustic are shown in Figure 3.

Figure 3: Scanning electron micrographs of NiCrMoV sample. Micrograph (a) shows intergranular SCC near edge. Micrograph (b) shows transgranular tear at center of micrograph (a).

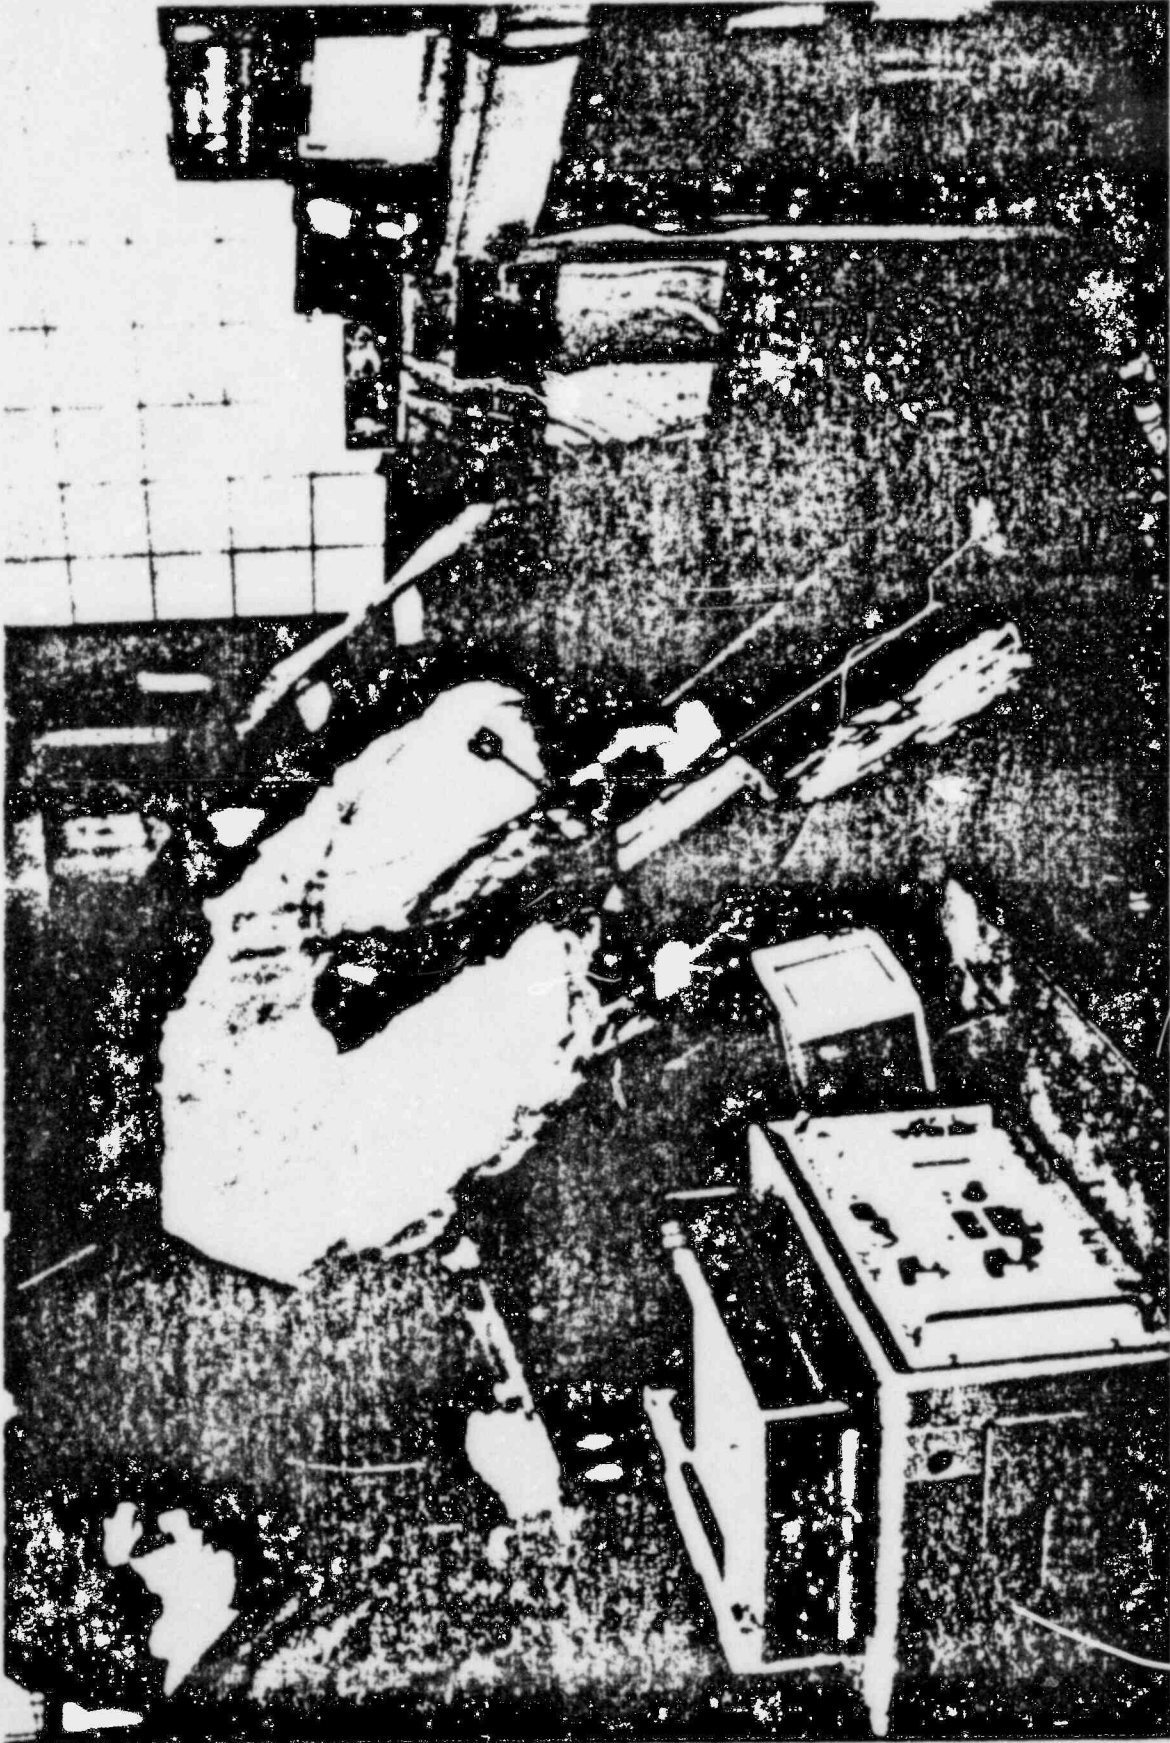
FIGURE 15

An extensive program of producing stress corrosion cracks in full size wheels (Figure 15) and large ring specimens (Figure 16) was undertaken to verify the test method. Stresses near yield were generated by shrinking the wheels on to a stub shaft which was heated to further create an additional source of stress. The rings were stressed with a hydraulic jack. A 40% NaOH solution at 100°C was circulated through the wheel and ring keyways to produce stress corrosion cracks. The potential of the solution was controlled to accelerate corrosive attack.

CRACKING A FULL SIZE WHEEL

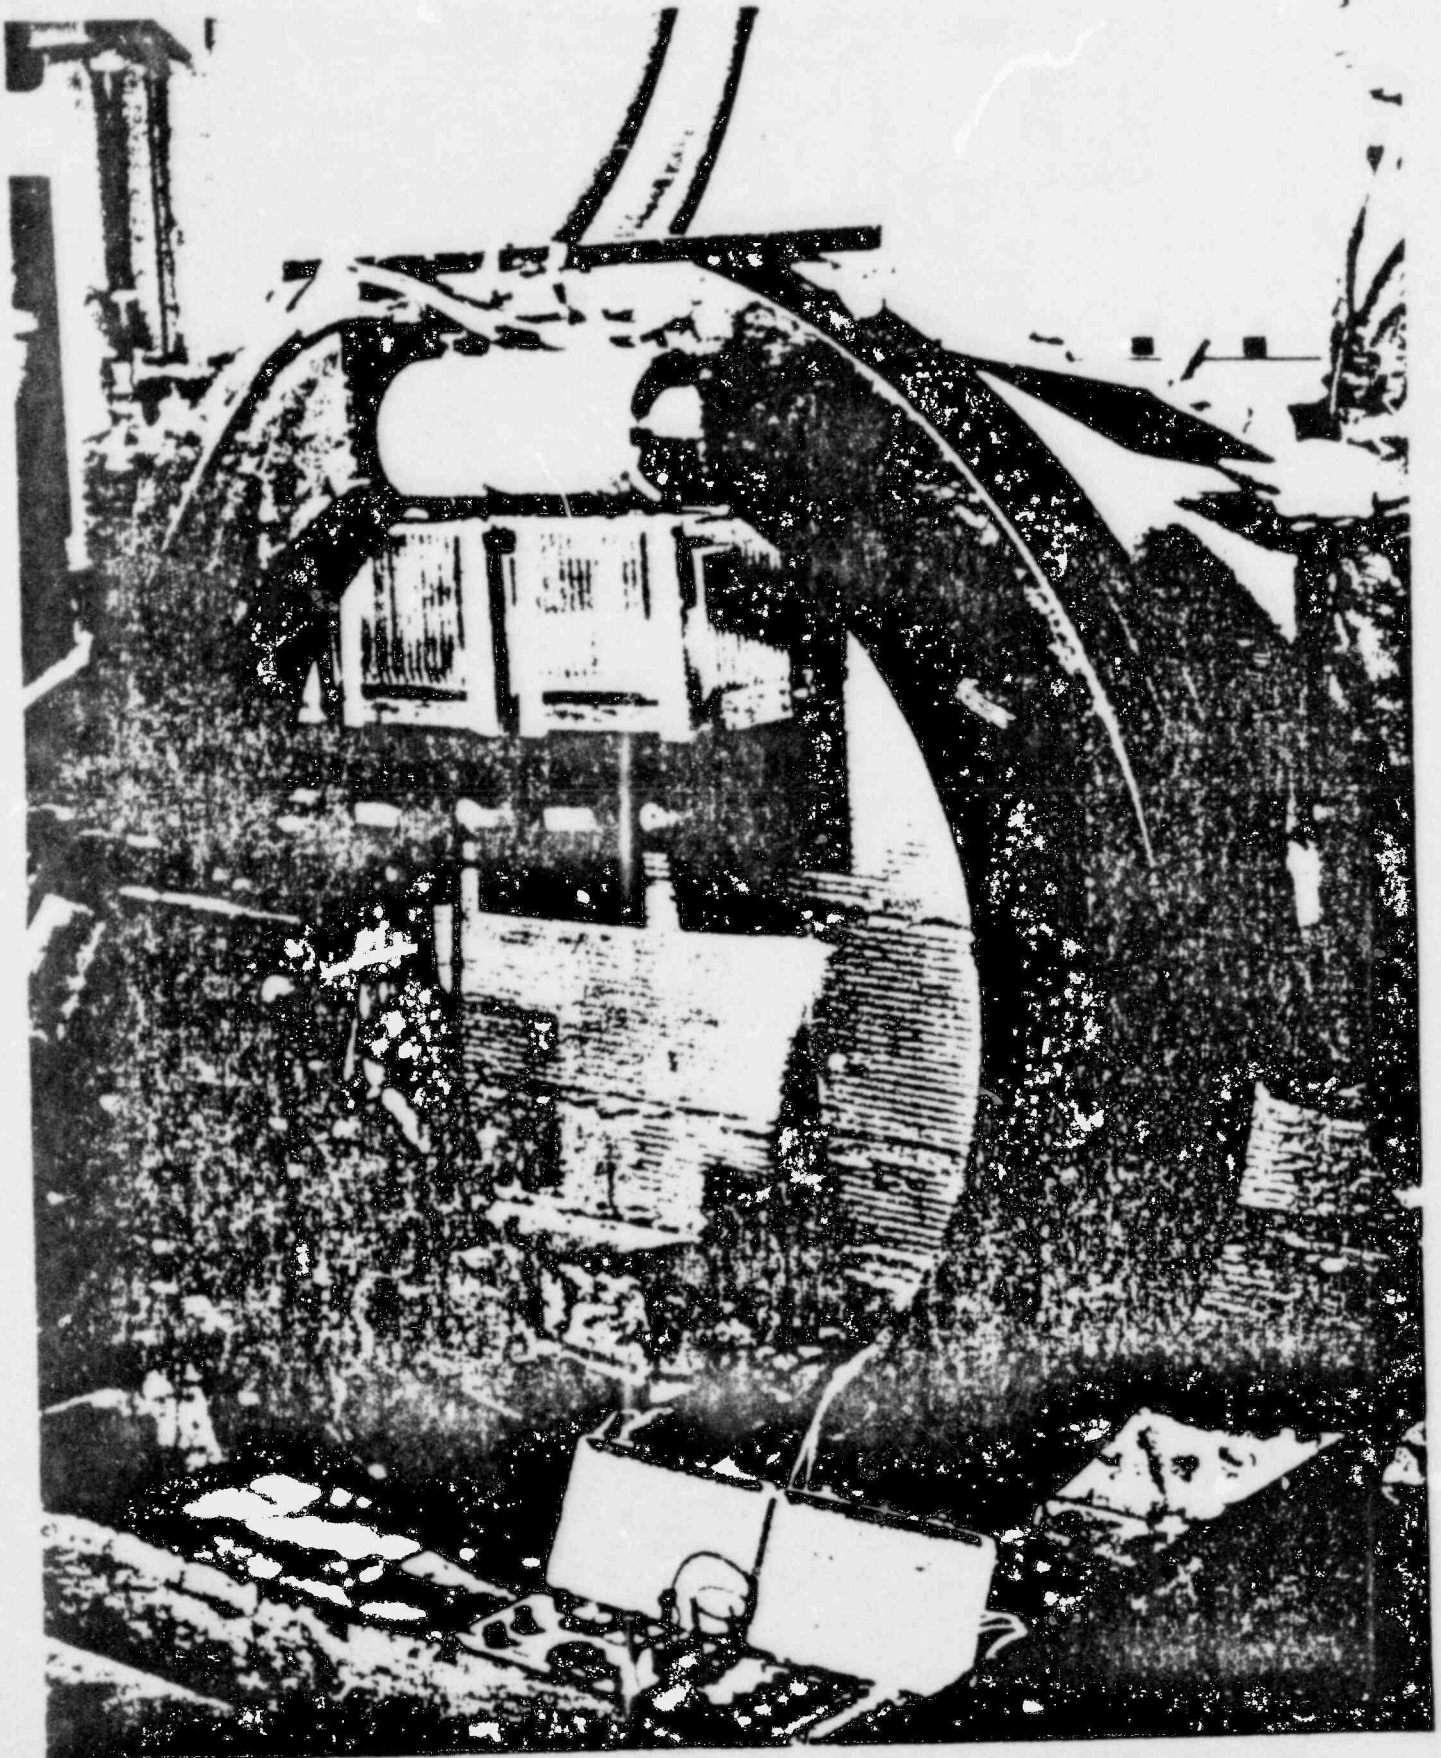
FIGURE 16

CRACKING A LARGE RING SPECIMEN

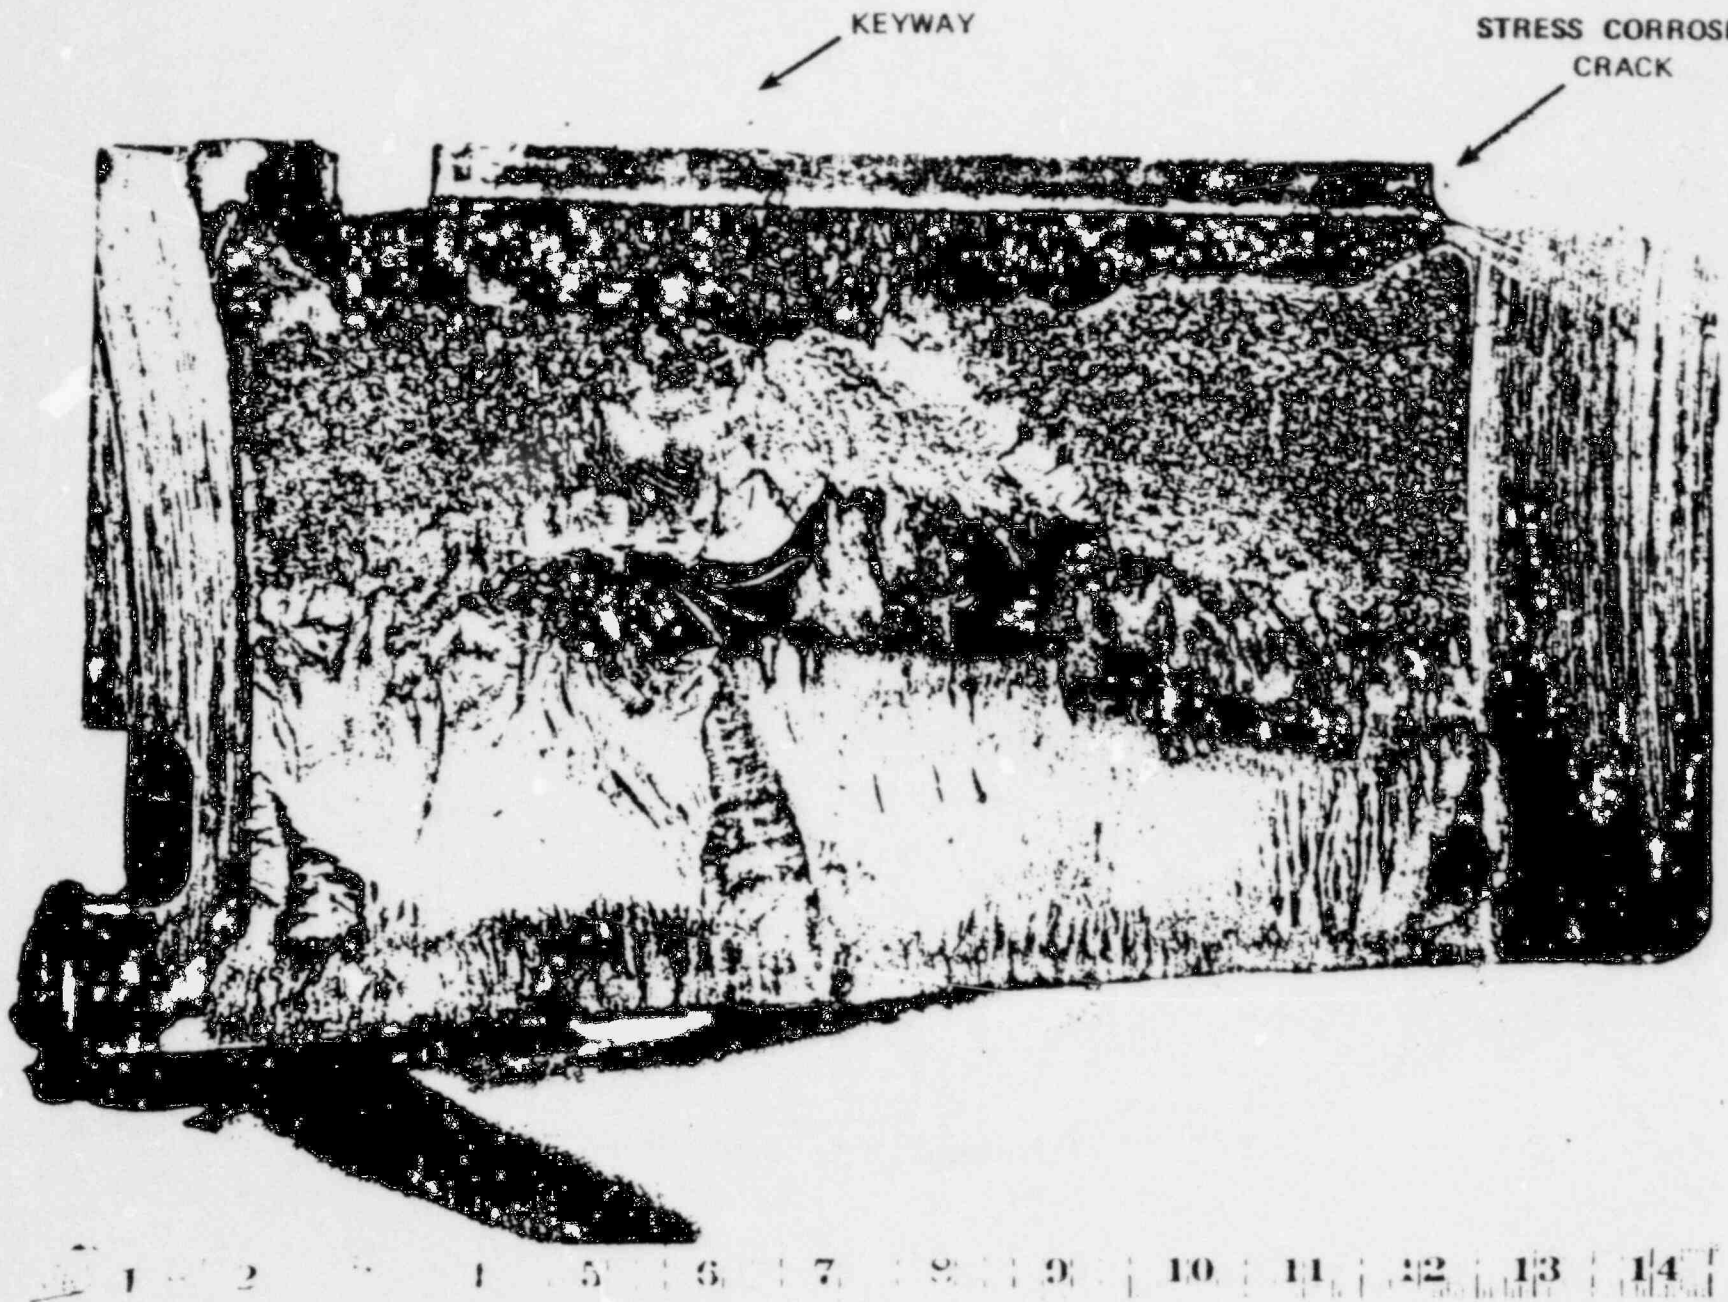
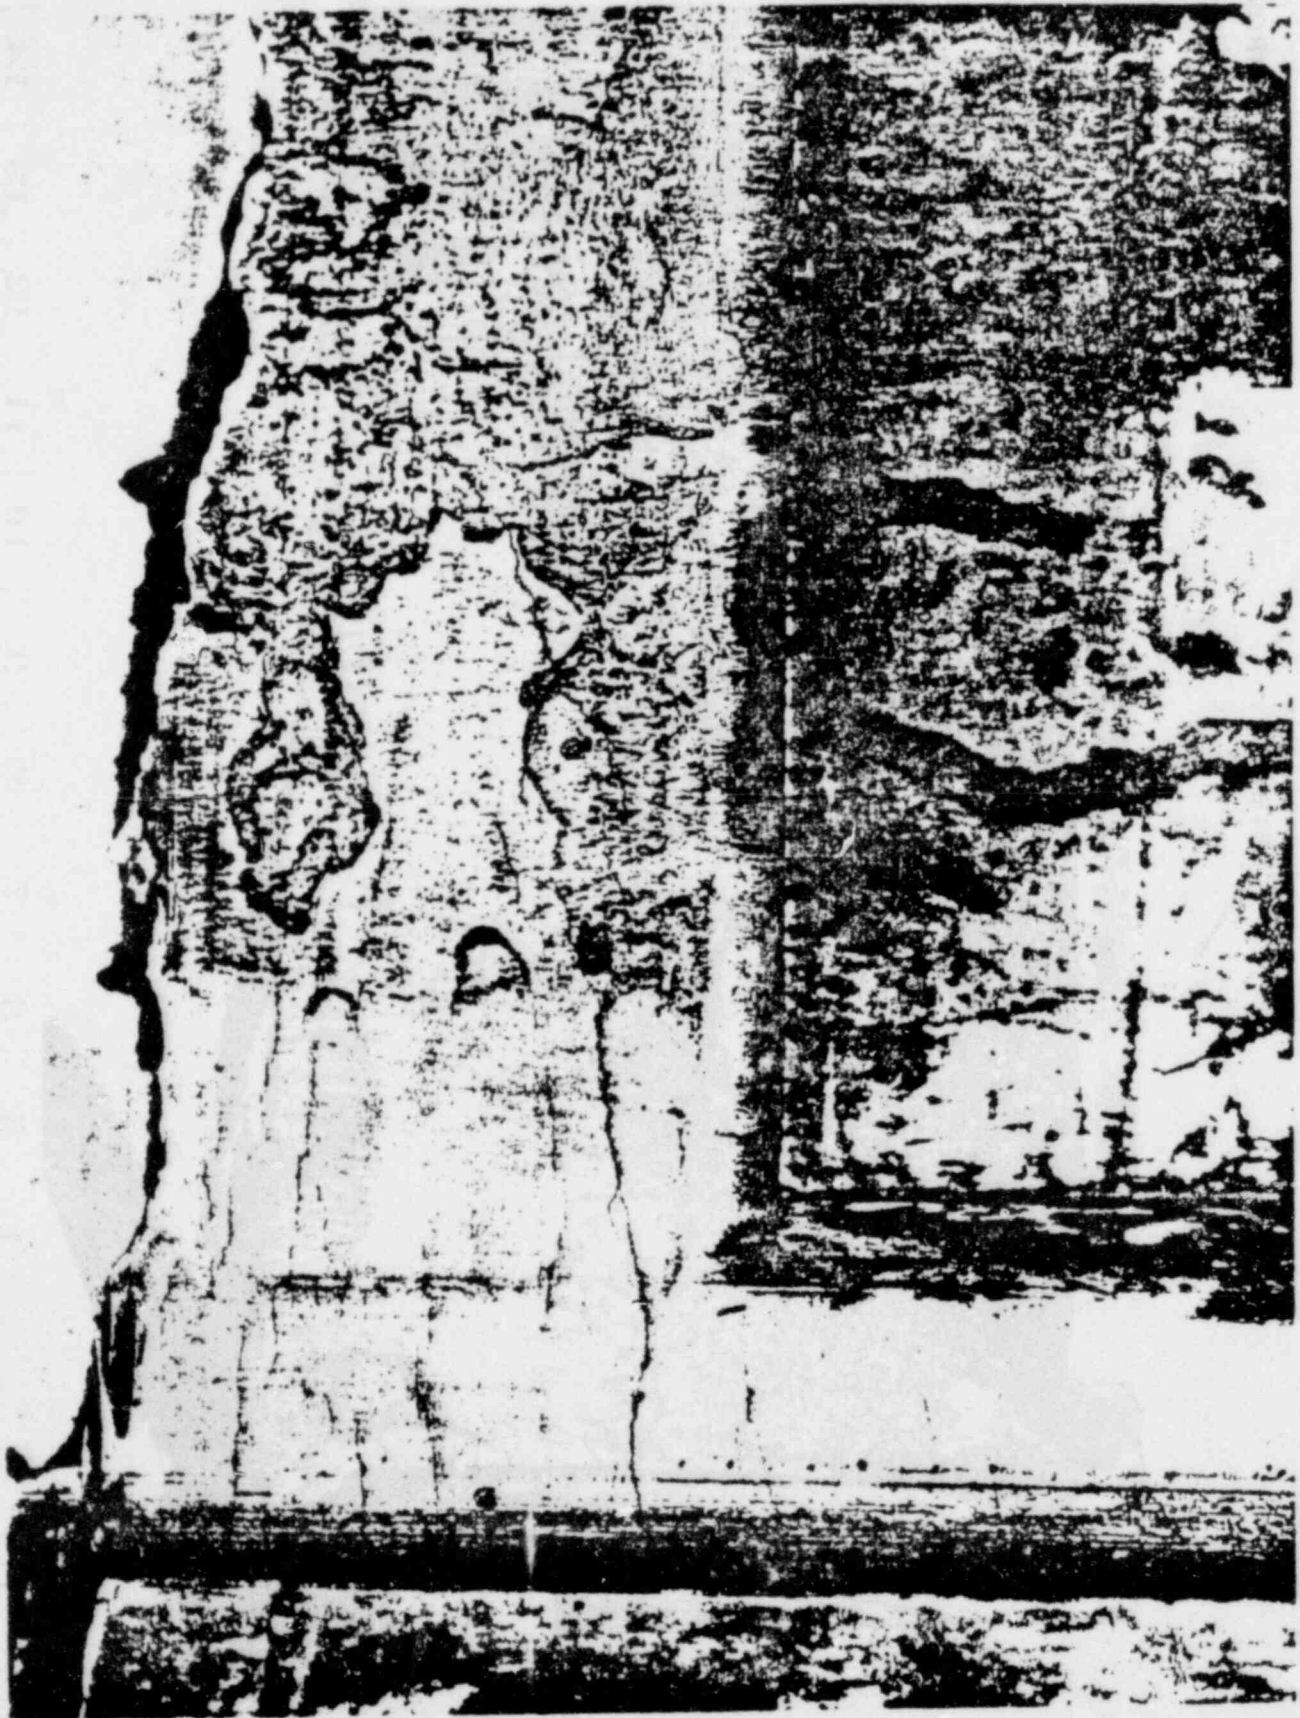
FIGURE 17

To date, a total of three wheels and two large rings have been artificially cracked. The first wheel was exposed to 40% caustic for approximately one year and later broken open (Figure 17 and 18). Ultrasonic indication amplitudes equal to that of the keyway itself were observed from these cracks as shown in Figure 19 and 20. The deepest crack in this wheel was 1 1/4 inch (32 mm). Numerous smaller cracks with approximately 1/4" (6.4 mm) depth were also present near the axial end of the keyway and were detected from the wheel hub.

STRESS CORROSION  
CRACK

WHEEL CRACK EXPOSED

STRESS CORROSION CRACK IN KEYWAY

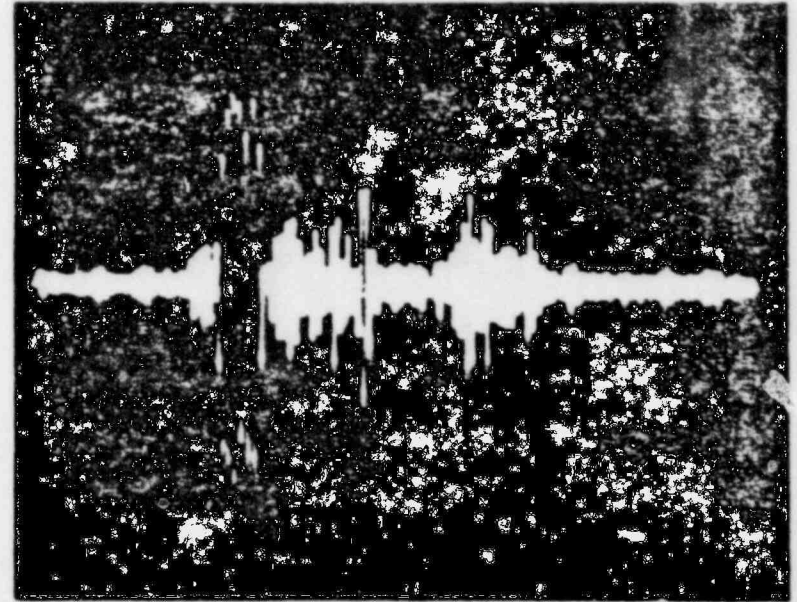
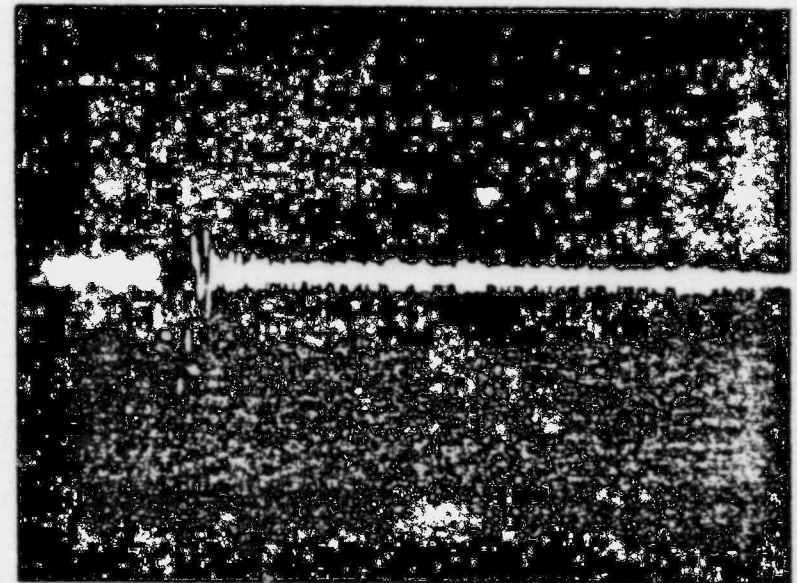
exposure, ultrasonic tests of the wheel revealed significant cracking (Figure 21). A section containing the keyway was removed and magnetic particle tested (Figure 22) revealing an extensive network of cracks.

10/16/78  
CONDITION

BASE CONDITION

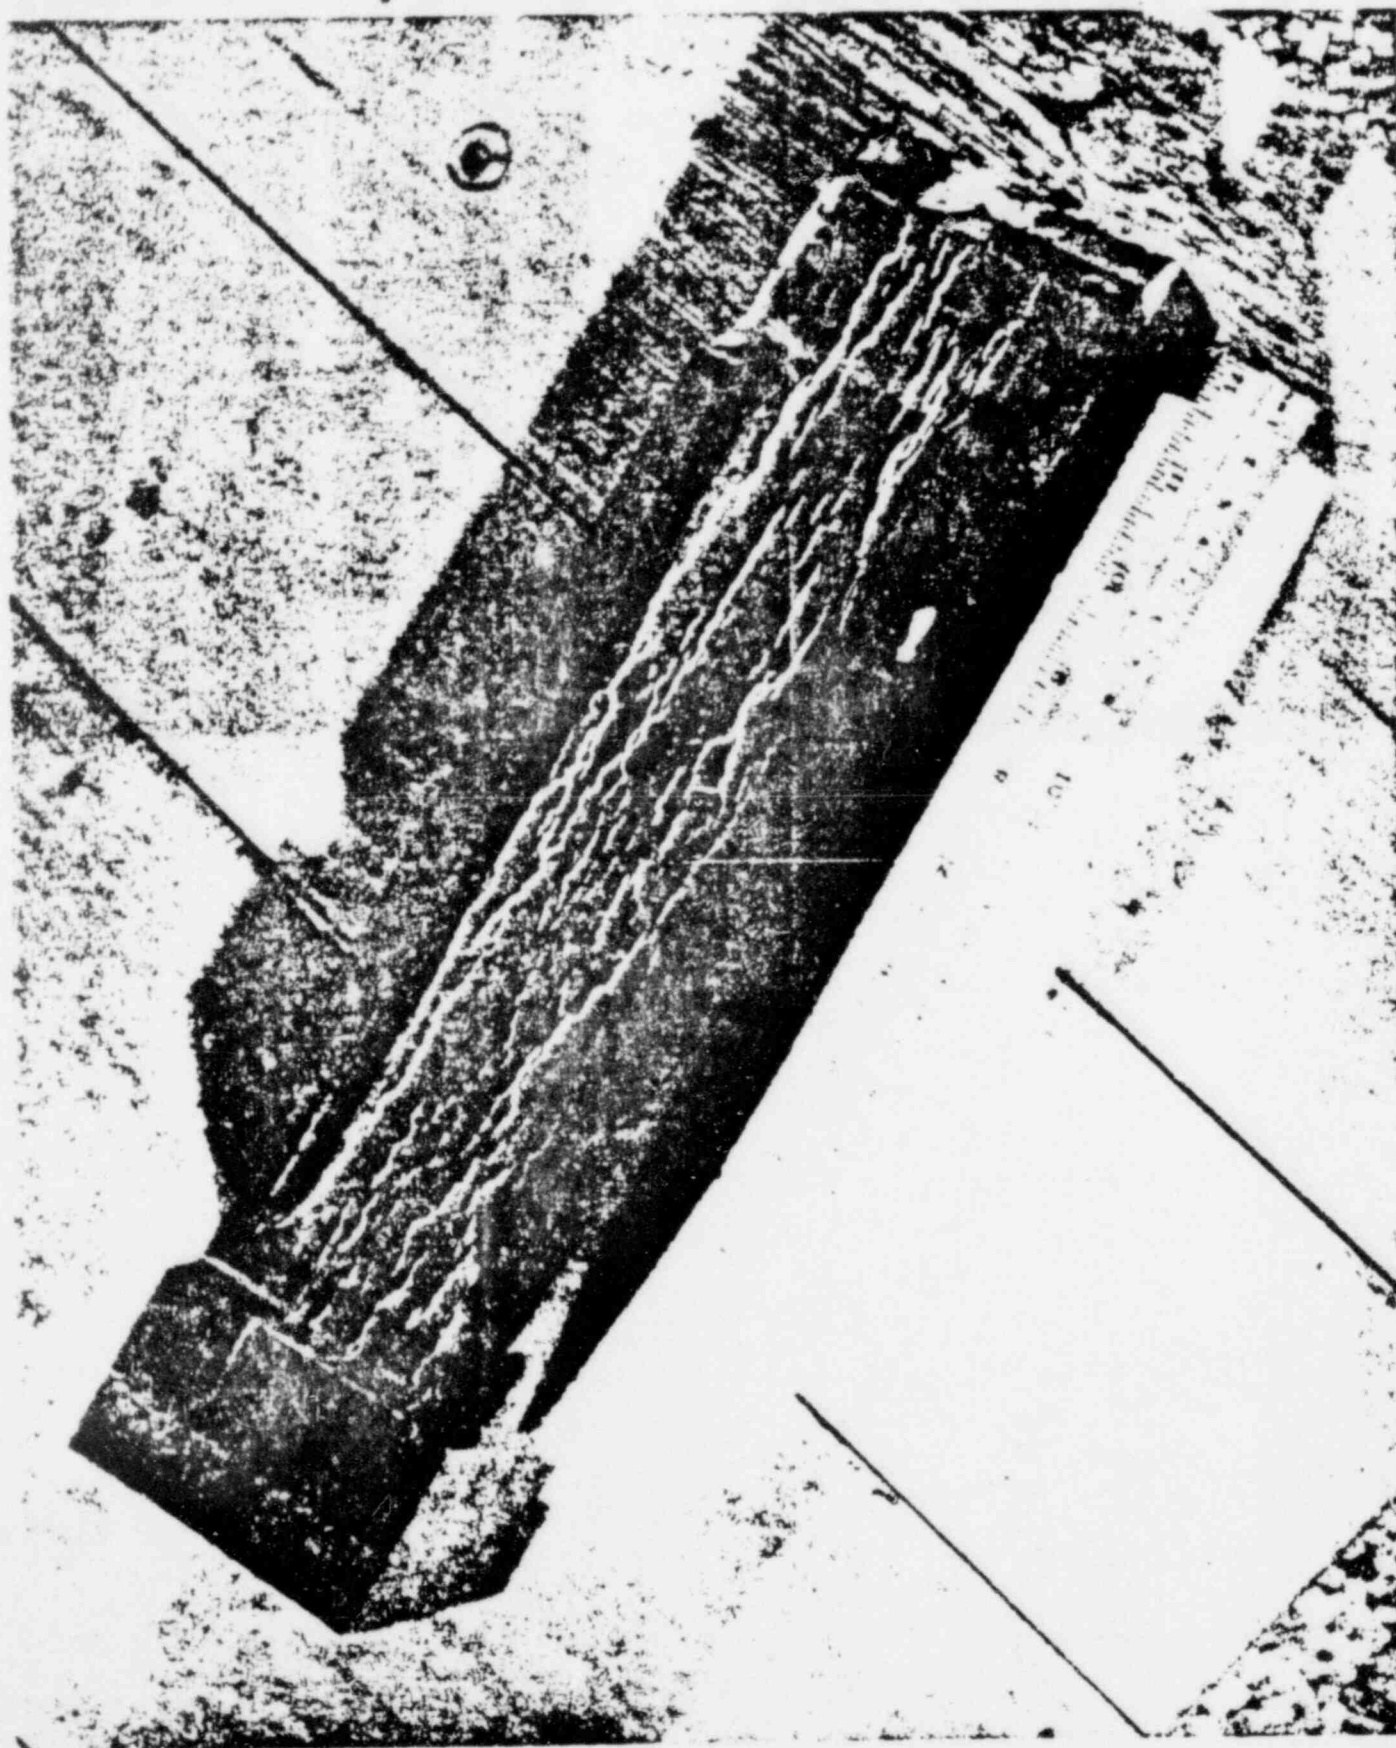
FIGURE 22

STRESS CORROSION CRACKS IN KEYWAY
