UNITED STATES  
NUCLEAR REGULATORY COMMISSION  
WASHINGTON, D. C. 20555

May 15, 1980

CRACKING IN LOW PRESSURE TURBINE DISCS

SUBJECT: MEETING WITH GENERAL ELECTRIC RELATED TO TURBINE DISC  
CRACKS

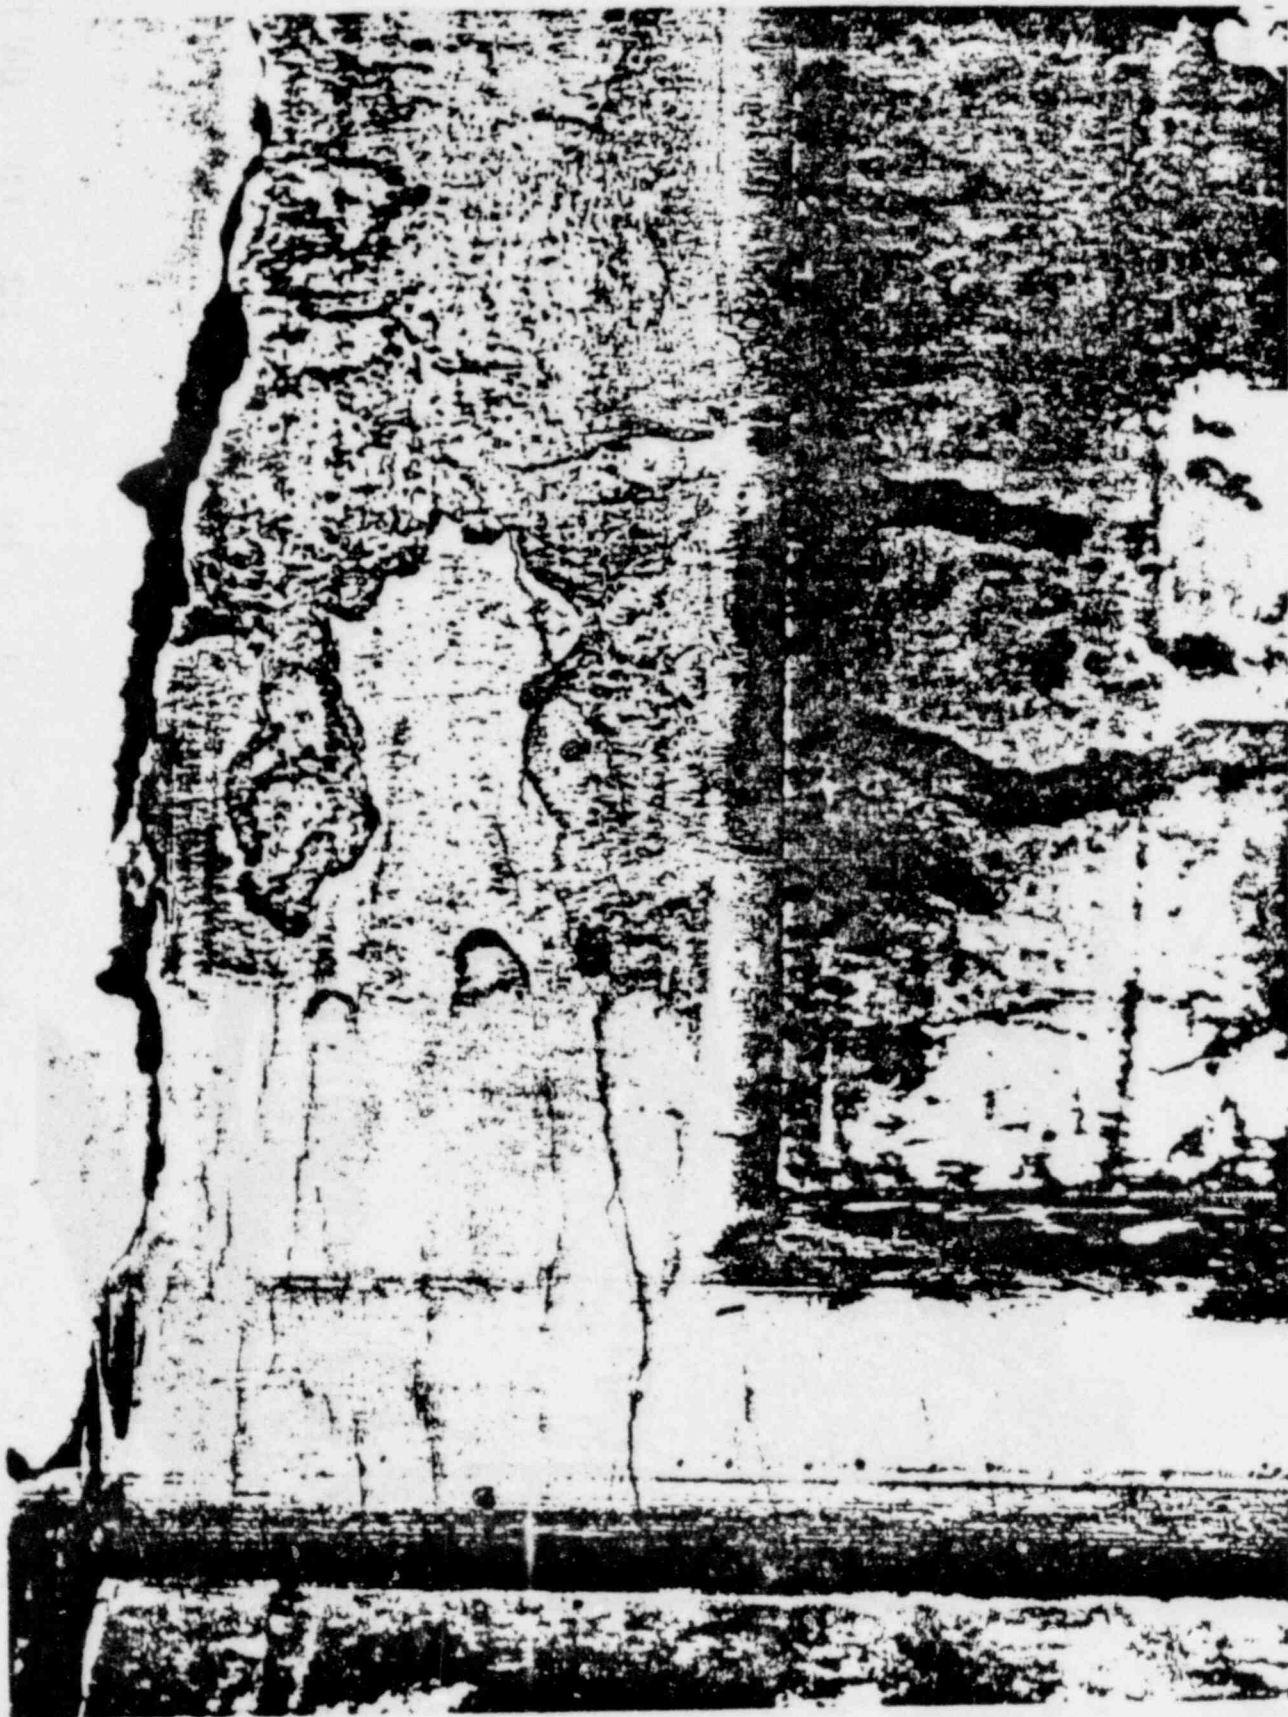
FIGURE 18

To date, a total of three wheels and two large rings have been artificially cracked. The first wheel was exposed to 40% caustic for approximately one year and later broken open (Figure 17 and 18). Ultrasonic indication amplitudes equal to that of the keyway itself were observed from these cracks as shown in Figure 19 and 20. The deepest crack in this wheel was 1 1/4 inch (32 mm). Numerous smaller cracks with approximately 1/4" (6.4 mm) depth were also present near the axial end of the keyway and were detected from the wheel hub.

STRESS CORROSION CRACK IN KEYWAY

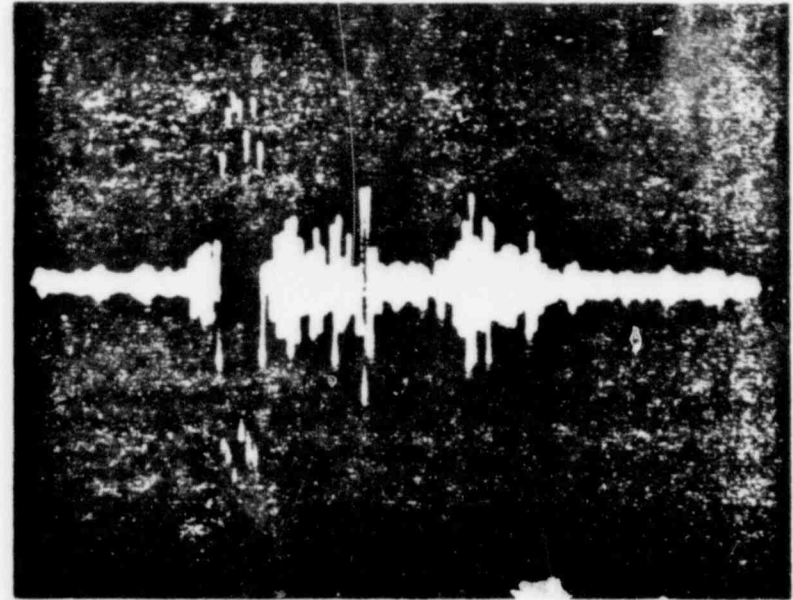
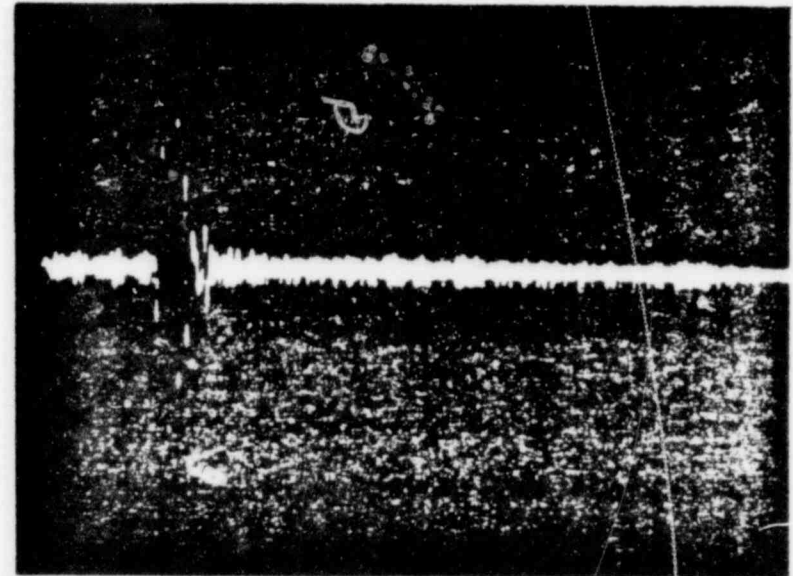
exposure, ultrasonic tests of the wheel revealed significant cracking (Figure 21). A section containing the keyway was removed and magnetic particle tested (Figure 22) revealing an extensive network of cracks.

# WHEEL SPECIMEN

10/16/78  
CONDITION

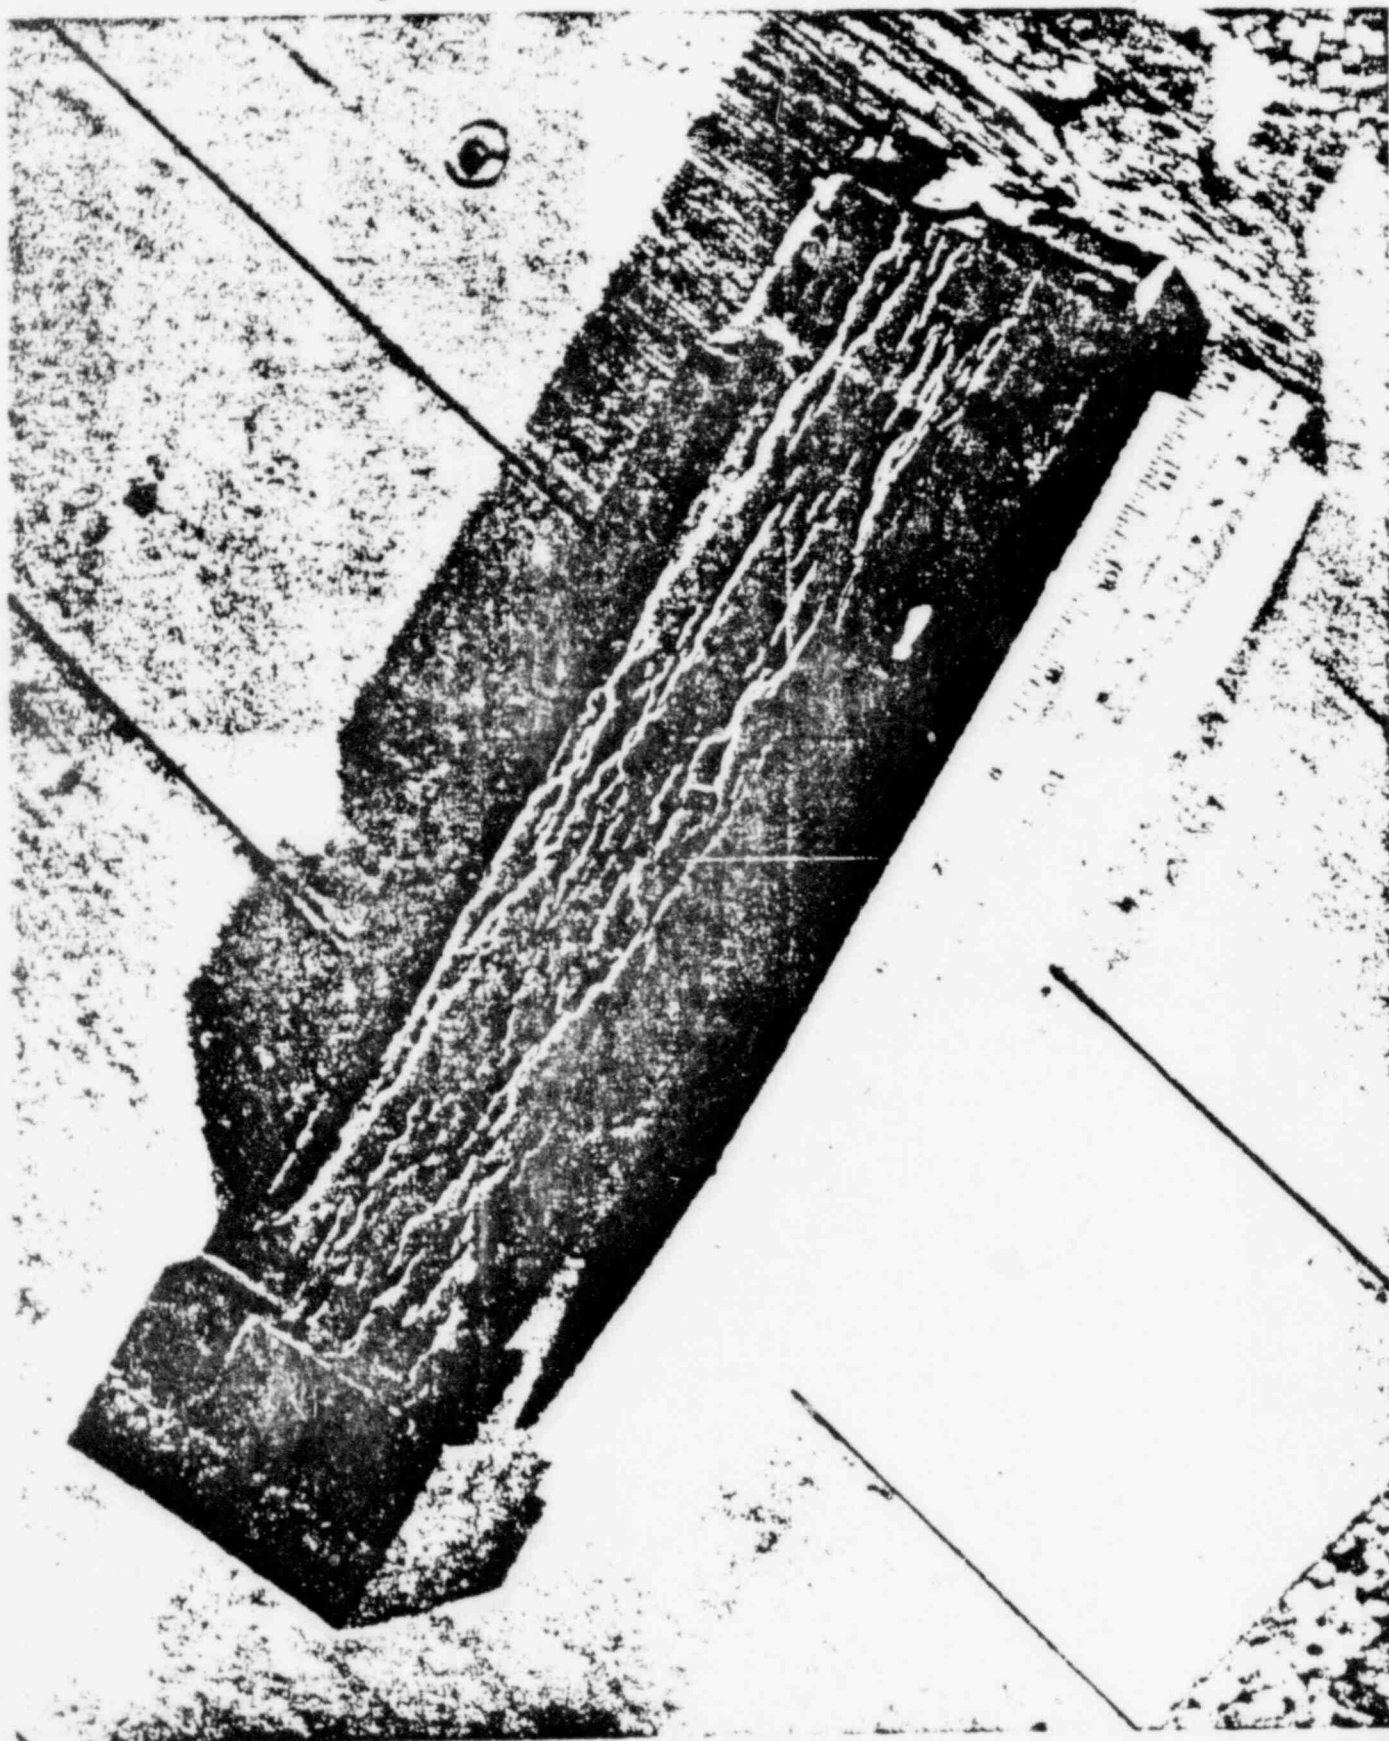
FIGURE 22

STRESS CORROSION CRACKS IN KEYWAY
