UNITED STATES
NUCLEAR REGULATORY COMMISSION
WASHINGTON, D. C. 20555

Docket No. 50-317

CRACKING IN LOW PRESSURE TURBINE DISCS

SUBJECT: MEETING WITH GENERAL ELECTRIC RELATED TO TURBINE DISC
CRACKS

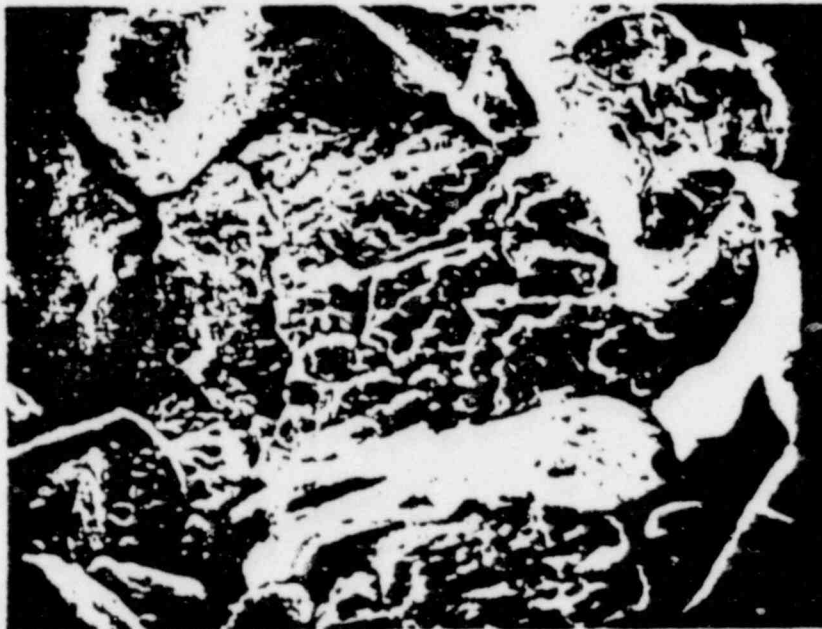
Figure 3: Scanning electron micrographs of NiCrMoV sample. Micrograph (a) shows intergranular SCC near edge. Micrograph (b) shows transgranular tear at center of micrograph (a).

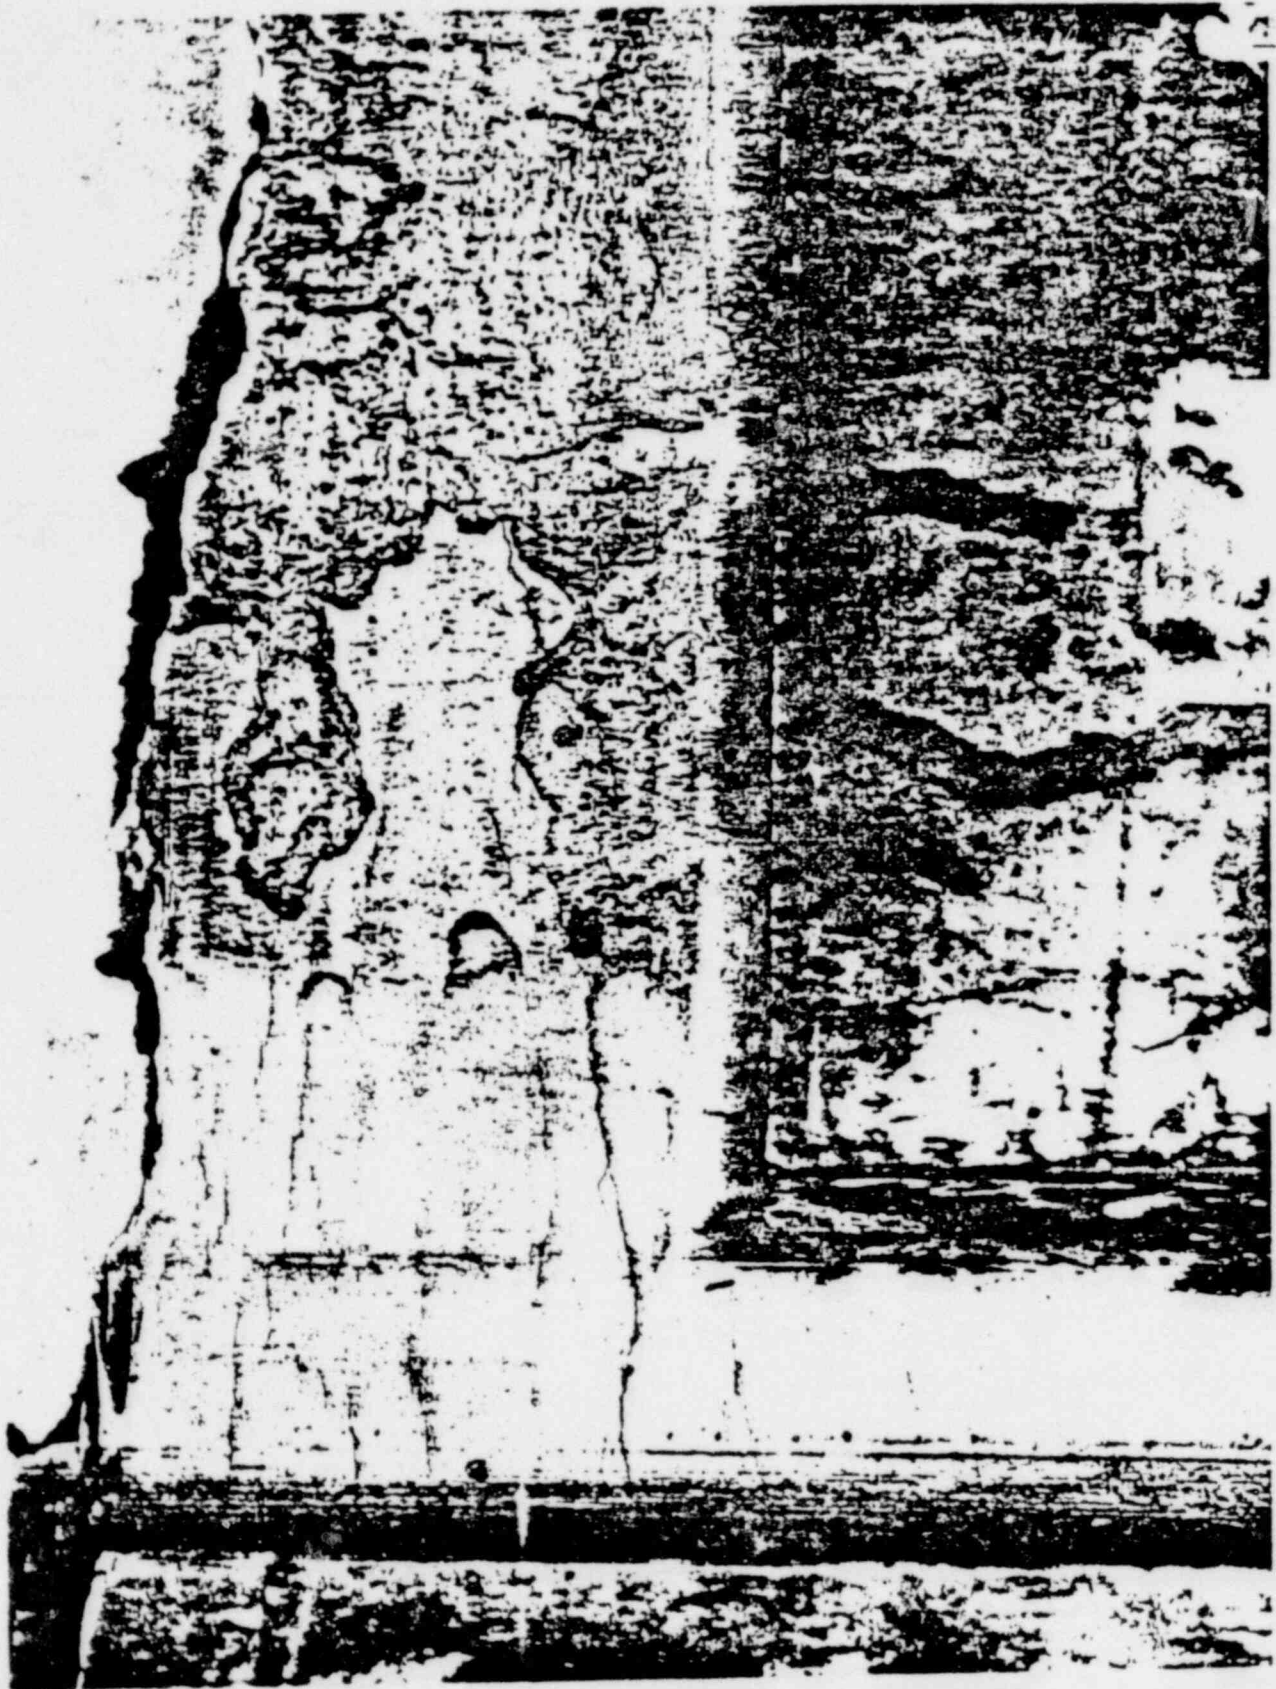
FIGURE 18

To date, a total of three wheels and two large rings have been artificially cracked. The first wheel was exposed to 40% caustic for approximately one year and later broken open (Figure 17 and 18). Ultrasonic indication amplitudes equal to that of the keyway itself were observed from these cracks as shown in Figure 19 and 20. The deepest crack in this wheel was 1 1/4 inch (32 mm). Numerous smaller cracks with approximately 1/4" (6.4 mm) depth were also present near the axial end of the keyway and were detected from the wheel hub.

STRESS CORROSION CRACK IN KEYWAY

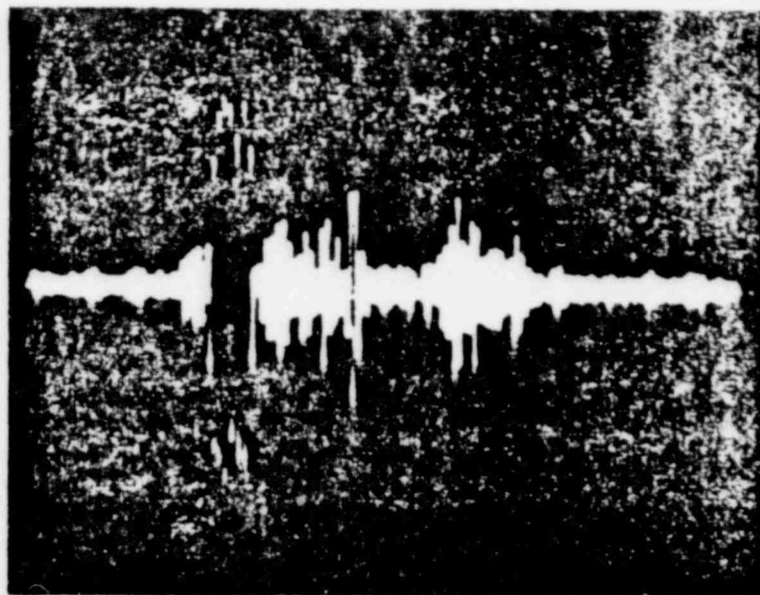
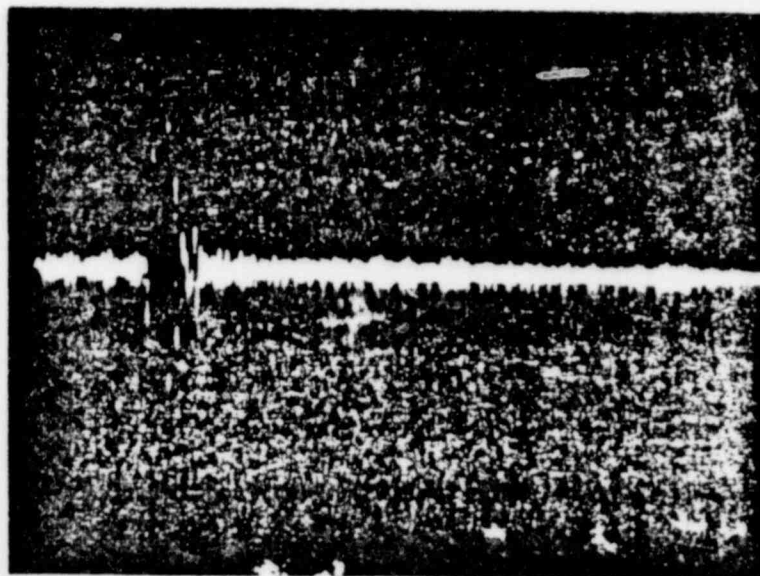
exposure, ultrasonic tests of the wheel revealed significant cracking (Figure 21). A section containing the keyway was removed and magnetic particle tested (Figure 22) revealing an extensive network of cracks.

WHEEL SPECIMEN

10/16/78
CONDITION

BASE CONDITION
2/2/78

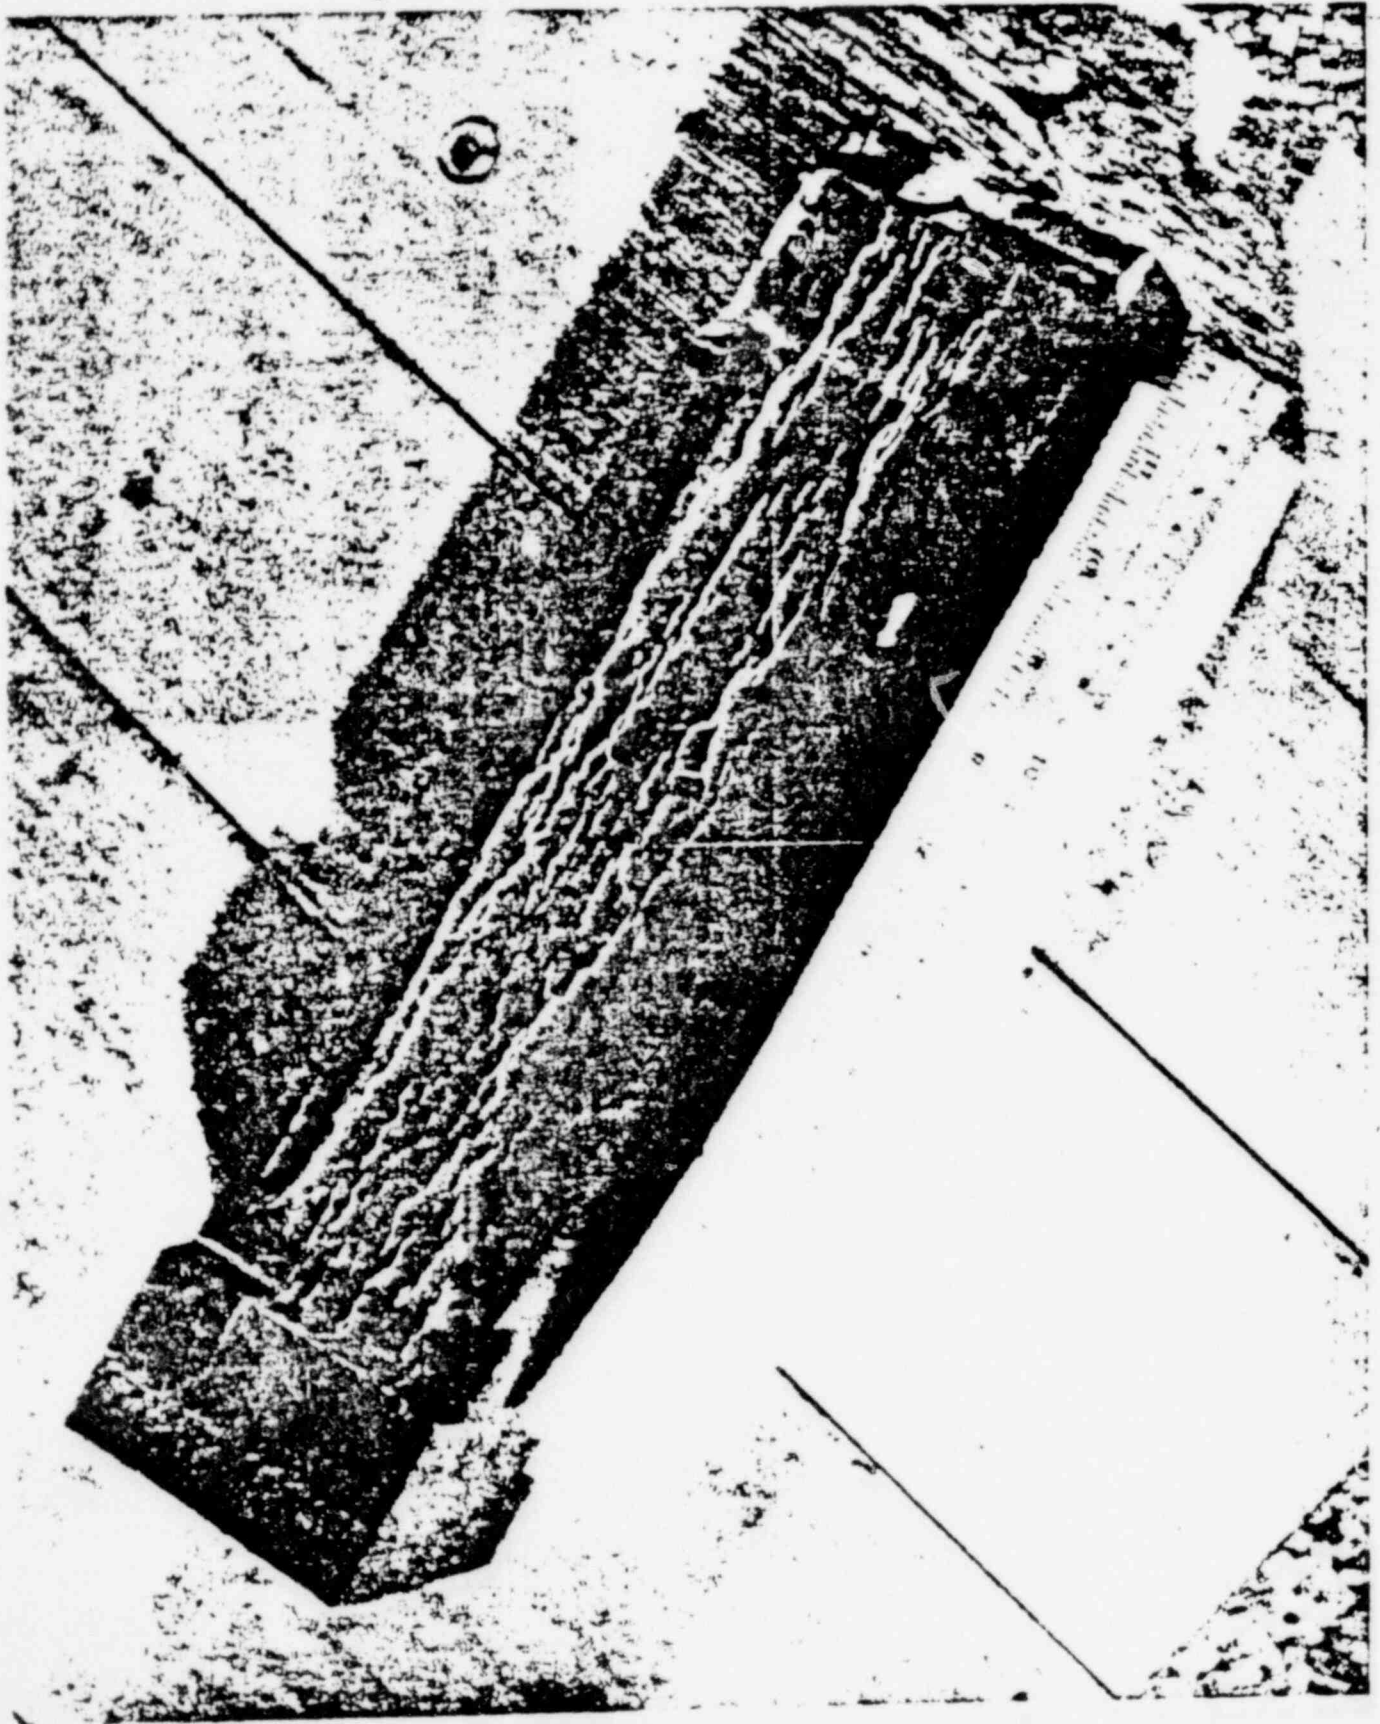
FIGURE 22

STRESS CORROSION CRACKS IN KEYWAY
