UNITED STATES  
NUCLEAR REGULATORY COMMISSION  
WASHINGTON, D. C. 20555

Docket No. 50-336

CRACKING IN LOW PRESSURE TURBINE DISCS

SUBJECT: MEETING WITH GENERAL ELECTRIC RELATED TO TURBINE DISC  
CRACKS

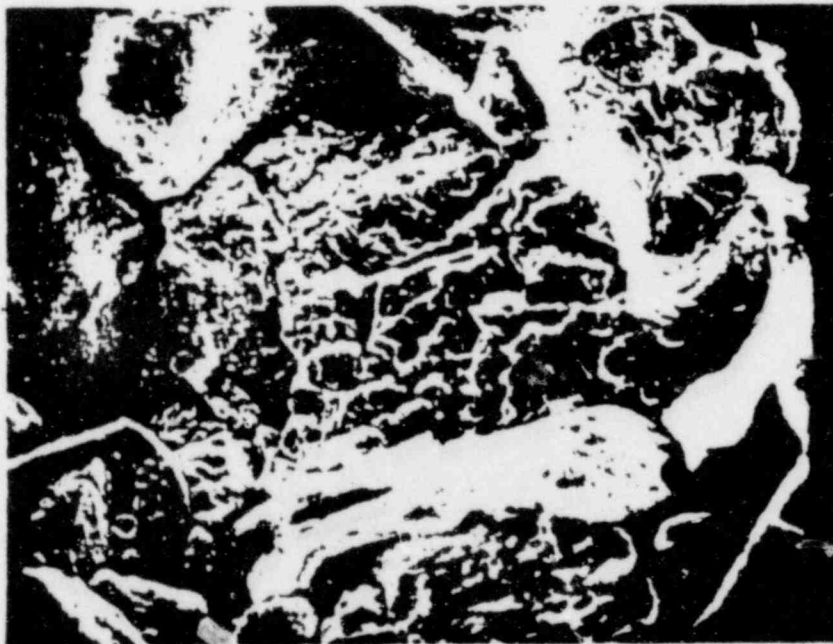
Figure 3: Scanning electron micrographs of NiCrMoV sample. Micrograph (a) shows intergranular SCC near edge. Micrograph (b) shows transgranular tear at center of micrograph (a).

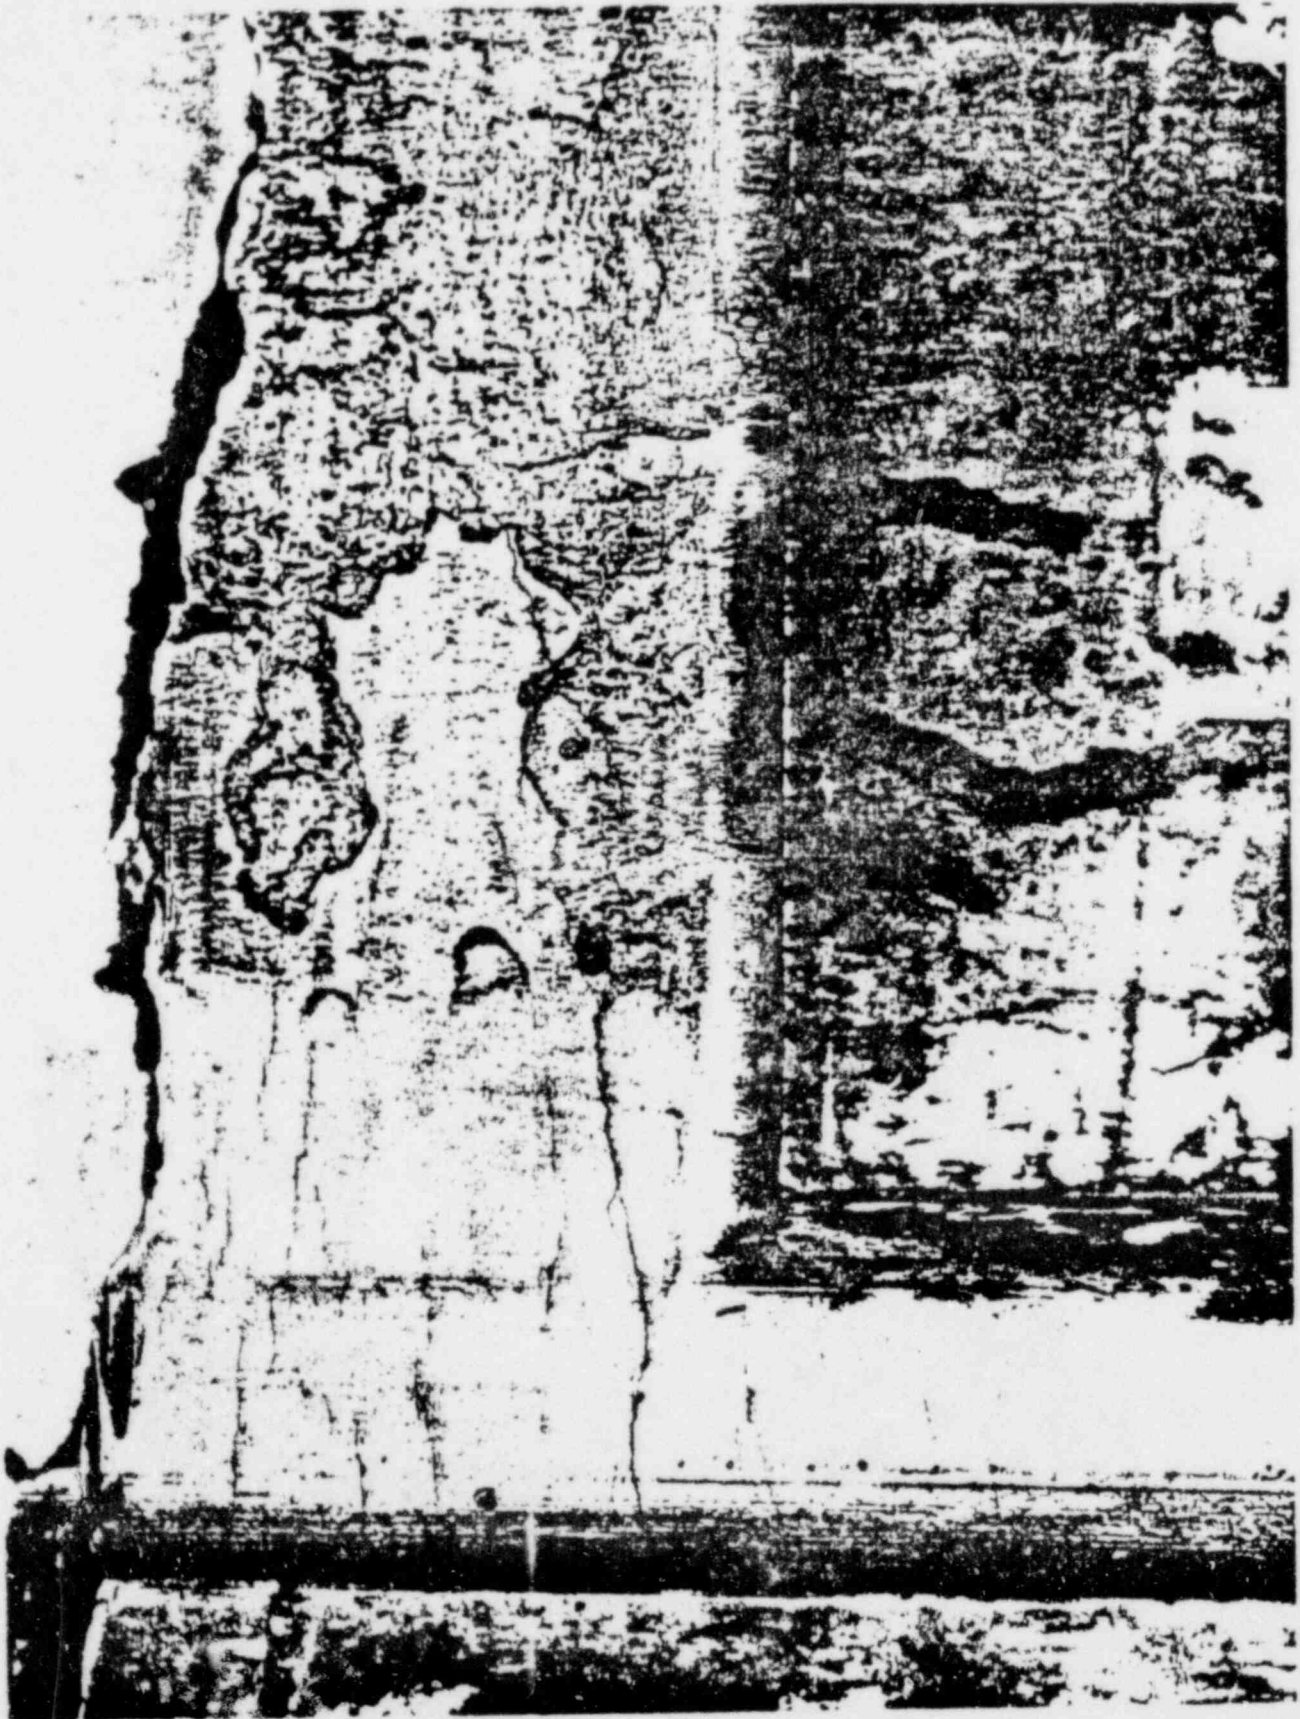
To date, a total of three wheels and two large rings have been artificially cracked. The first wheel was exposed to 40% caustic for approximately one year and later broken open (Figure 17 and 18). Ultrasonic indication amplitudes equal to that of the keyway itself were observed from these cracks as shown in Figure 19 and 20. The deepest crack in this wheel was 1 1/4 inch (32 mm). Numerous smaller cracks with approximately 1/4" (6.4 mm) depth were also present near the axial end of the keyway and were detected from the wheel hub.

STRESS CORROSION CRACK IN KEYWAY

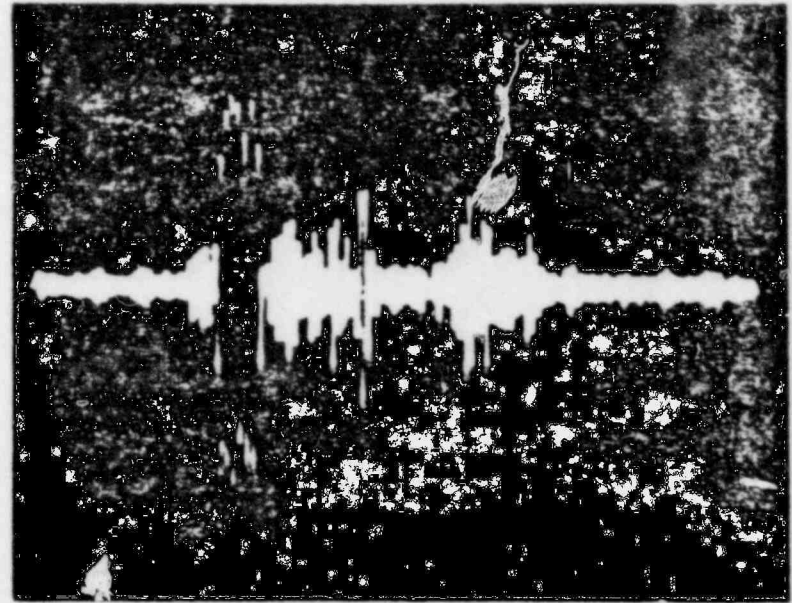
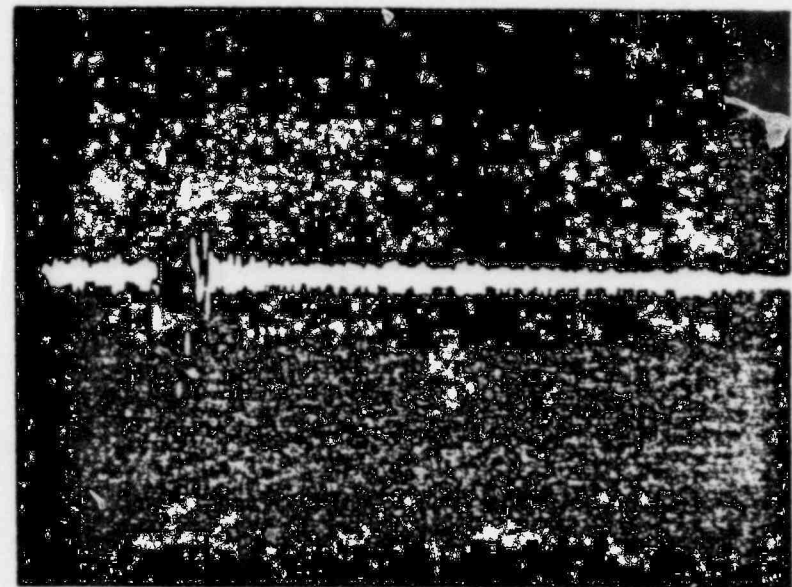
exposure, ultrasonic tests of the wheel revealed significant cracking (Figure 21). A section containing the keyway was removed and magnetic particle tested (Figure 22) revealing an extensive network of cracks.

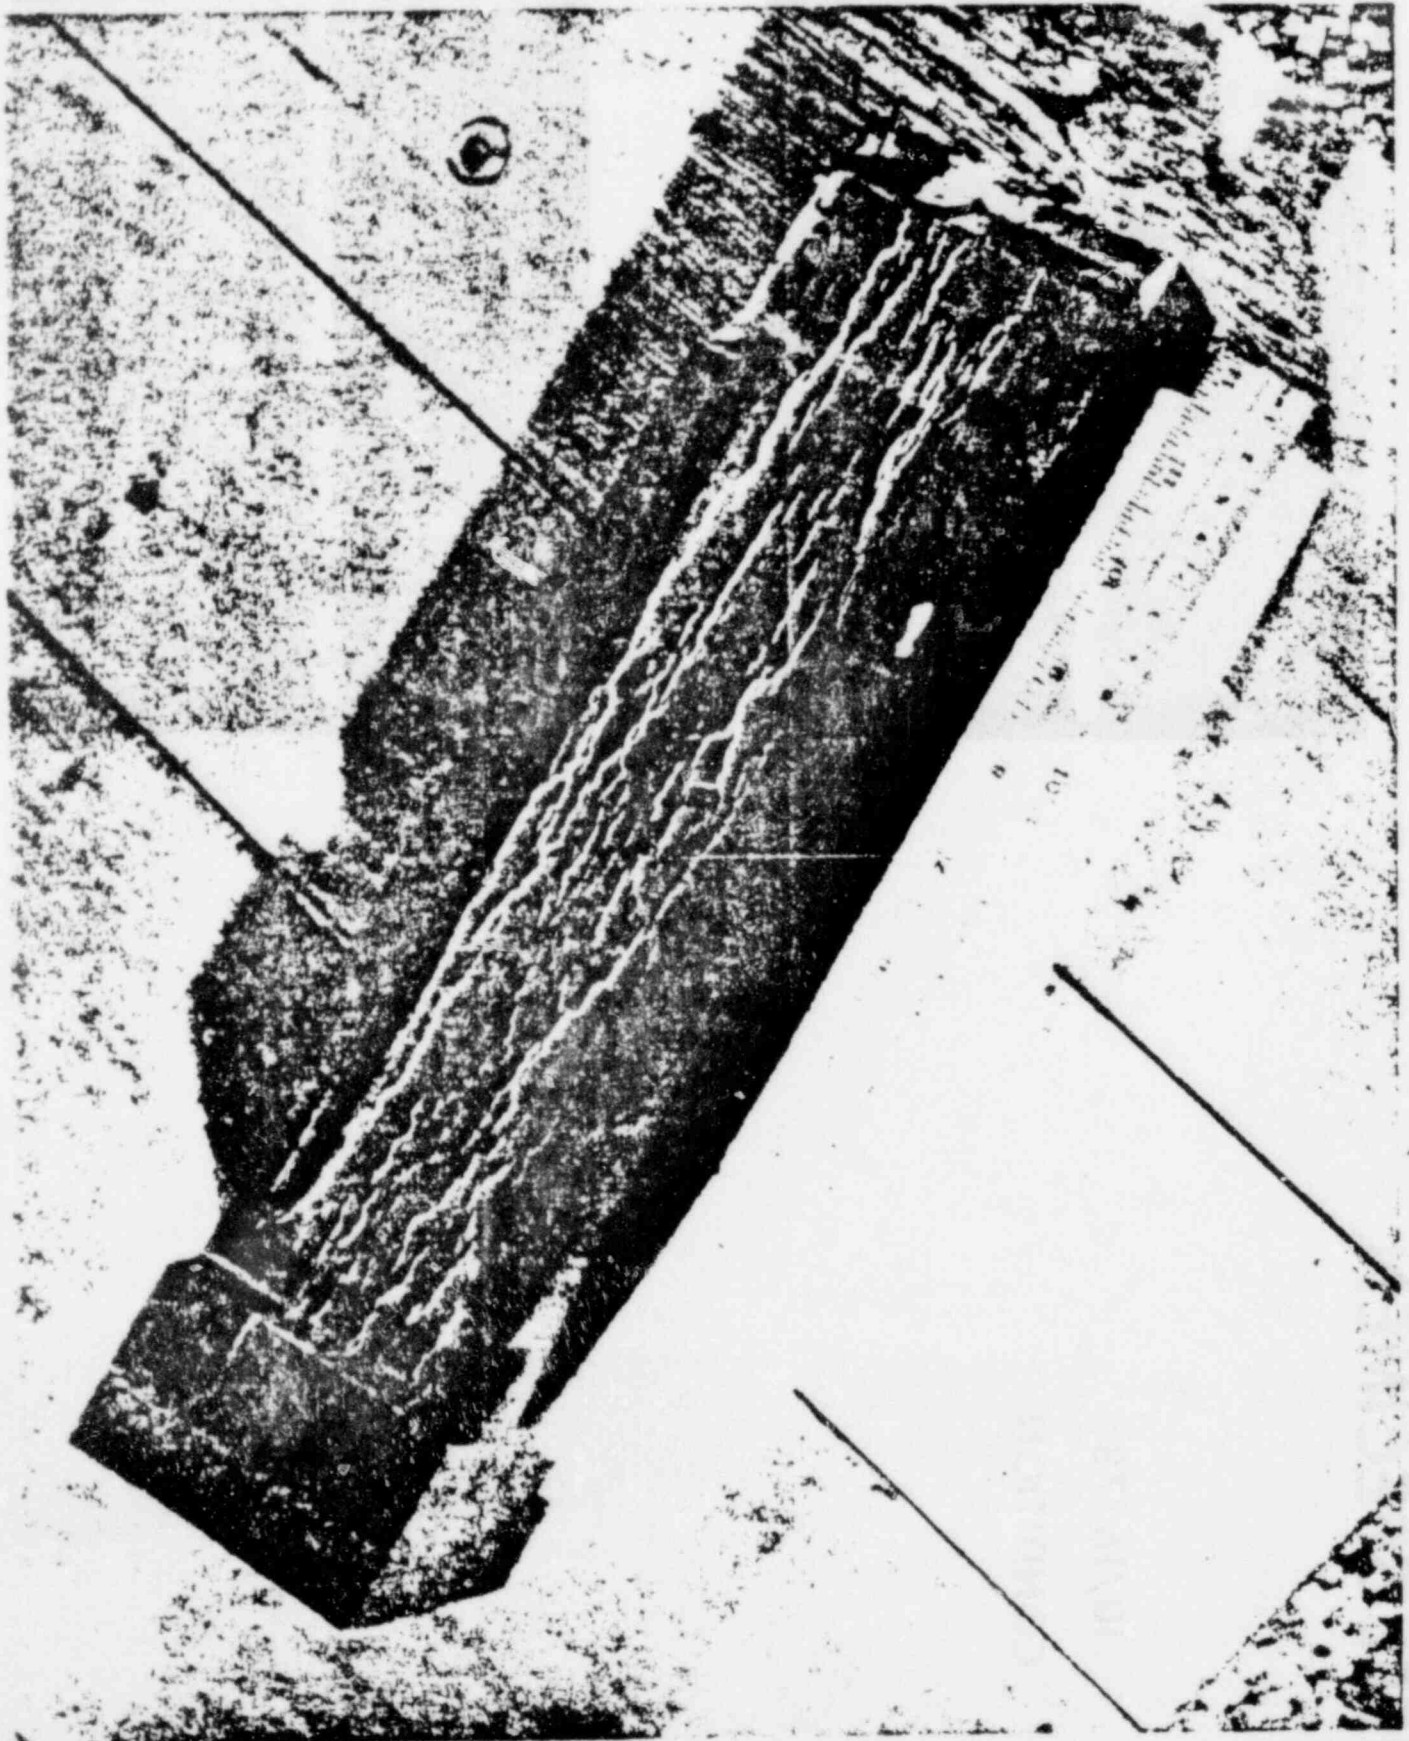
FIGURE 22

STRESS CORROSION CRACKS IN KEYWAY
