NUCLEAR REACTOR LABORATORY
MASSACHUSETTS INSTITUTE OF TECHNOLOGY

Re: Reportable Occurrence 50-20/80-2, License R-37: Binding of a Shim
Blade During Reactor Startup

1. Report No. 50-20/1980-2
2. a) Report Date: May 23, 1980
b) Date of Occurrence: May 19, 1980
3. Facility: M.I.T. Research Reactor
138 Albany Street
Cambridge, Massachusetts 02139

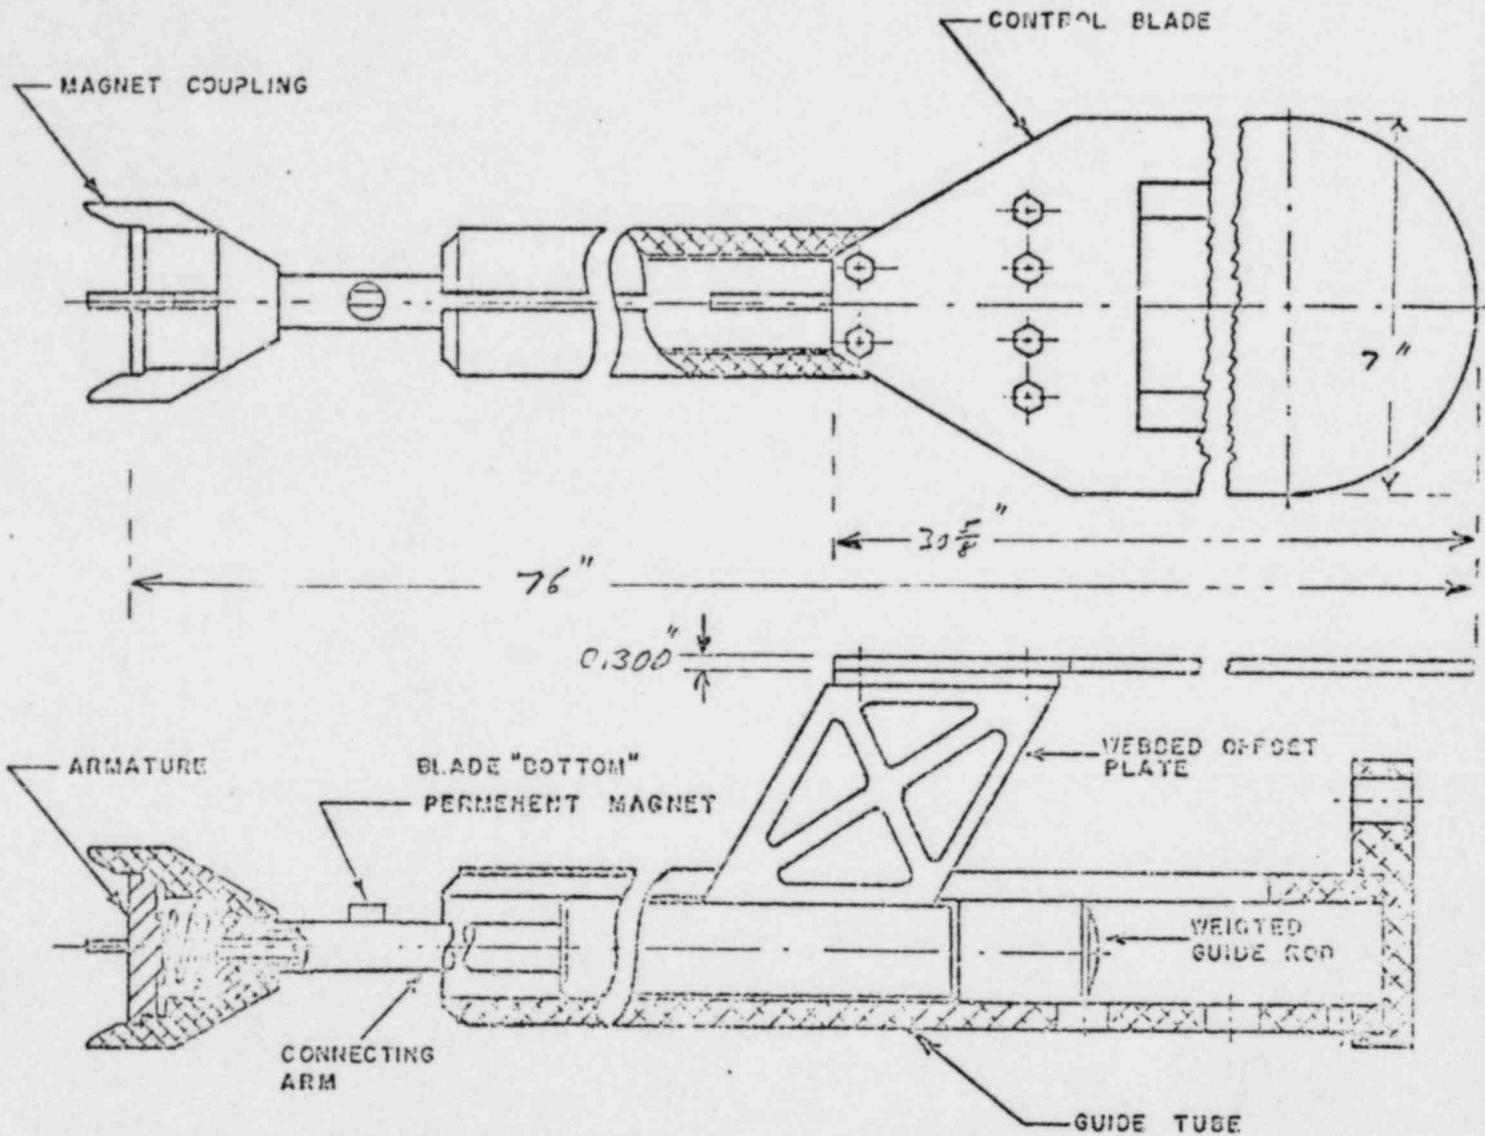
FIGURE 1
CONTROL BLADE ASSEMBLY

7. Description of Apparent Cause of Occurrence: This occurrence was apparently due to the presence of a small particle, possibly more than one, of foreign material that impeded the motion of the blade.

Each blade is attached by a webbed offset plate to a weighted guide piece that moves vertically in a tube machined to a 1/16 inch clearance (see Figure 1). The use of this weighted guide piece insures both that the blade will drop rapidly and that, should there be any misalignment with the drive, the resulting wear will not occur on the blade. An armature, with a flat upper surface, sits atop the guide piece. The blade may be raised or lowered by mating the armature to the lower surface of an electromagnet that is connected to the drive mechanism. Hence, the only support provided to the blade is in the vertical direction via an electromagnet. There is neither any lateral support nor any type of mechanical latch. This means that, in the event of any friction between the blade and its slot or between the weighted guide piece and its tube, the blade will readily separate from the drive mechanism. The reason for this design is to insure that, in the event of a scram signal, the blade will readily decouple and insert.

Subsequent to the determination that blade #1 was binding, both the blade and its associated guide piece were removed and examined in accordance with standard procedures. There was intermittent binding, either of the blade or the guide rod, throughout most of its upward travel during removal. Although the binding had been sufficient to cause decoupling, it was not enough to prevent lifting the assembly by hand. Just before the blade came completely out of its slot, the binding ceased and, thereafter, the assembly could be moved throughout its travel in both directions with no evidence of binding whatsoever. The blade was furthermore observed not to be contacting any core or experimental component.

No foreign material was found in the blade slot or guide tube that could have impaired the motion of either the blade or its guide piece. However, four pieces of foreign material were found on the horizontal surface surrounding the core. Three of these were near blade #1 and may have been the cause of the binding. The four pieces are:

9. Corrective Action: The corrective actions consisted of:
- a) Performance of blade thickness and drop time measurements on the other five shim blades. All data was within specification. No evidence of swelling was detected on any blade.
 - b) Replacement of the electromagnet that was found to be the source of the flecks of chrome plating.
 - c) Reemphasized to all personnel the importance of preventing the entry of any foreign material into the core tank.
 - d) Reemphasized the value of cleanliness on the reactor top and in all areas where experiments and samples are handled, such as benches, hot cells, glove boxes, etc.
