LICENSEE EVENT REPORT

1. Report Number: 80-07

3. Facility: Trojan Nuclear Plant, P. O. Box 439, Rainier, OR 97048

Design Description of Wall on Column Line 55

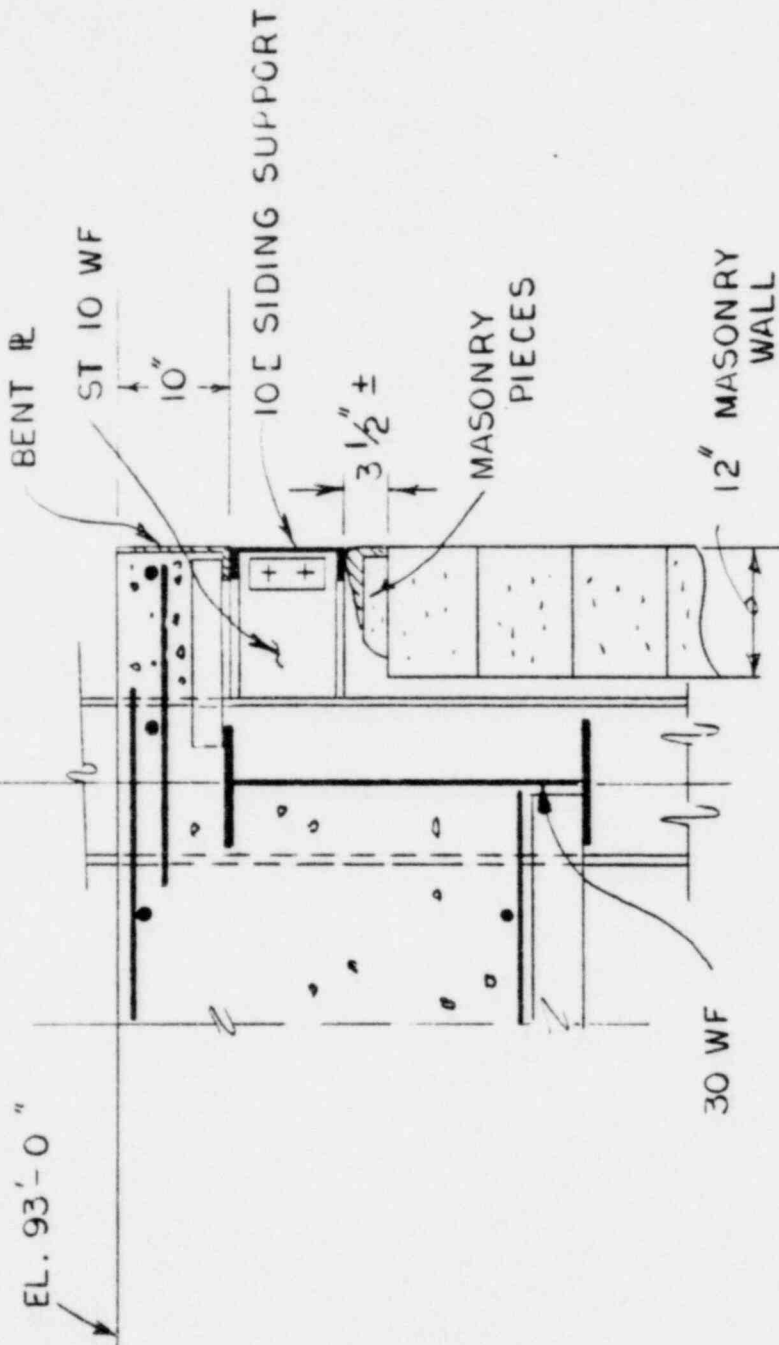
FIGURE A1

As-Built Condition of 12-in. Masonry Wall on Column Line 55,
Between F and N, at the Elevation 93 ft. Slab Interface

The as-built configuration of the 12-in. masonry wall interface with the Elevation 93 ft. reinforced concrete slab and adjacent steel elements is shown in Figure A1. The masonry wall was constructed after the structural steel framing, reinforced concrete slab, and siding support framing were completed. The interference of the 10-in. siding support channel with the continuation of the masonry wythe is apparent from Figure A1.

Detailed inspection of the interface could not be performed from either inside or outside of the Auxiliary Building without special techniques because of the difficult access. However, with use of mirrors and remote camera photographs, the as-built condition at the top of the wall was determined. For the length of the wall from about 3 ft. west of column line L to about 5 ft. west of column line F (approximately 56 ft.) it was observed that the wall masonry was terminated at the standard course dimension which is approximately 3-1/2 in. below the bottom of the siding support channel. No reinforcing steel dowels were observed projecting down from the reinforced concrete slab to match with the masonry reinforcing spacing, no masonry reinforcing projected above the top of the masonry, and no lateral ties were observed between the masonry and adjacent structural steel beam. The top-of-wall closure was finished to the underside of the siding support channel with cut sections of masonry block mortared to the top of the wall and finished on the exterior with mortar.

For the length of wall from about 3 ft. west of column line L to column line N (approximately 16 ft.), the containment airlock access slab extends over the masonry wall. In this length of wall, the existence of reinforcing steel dowels from the slab into the wall was confirmed by visual observation after removal of some of the mortar with a pneumatic chipping tool.
