UNITED STATES
NUCLEAR REGULATORY COMMISSION
WASHINGTON, D. C. 20555

May 19, 1980

Docket No. 50-289

CRACKING IN LOW PRESSURE TURBINE DISCS

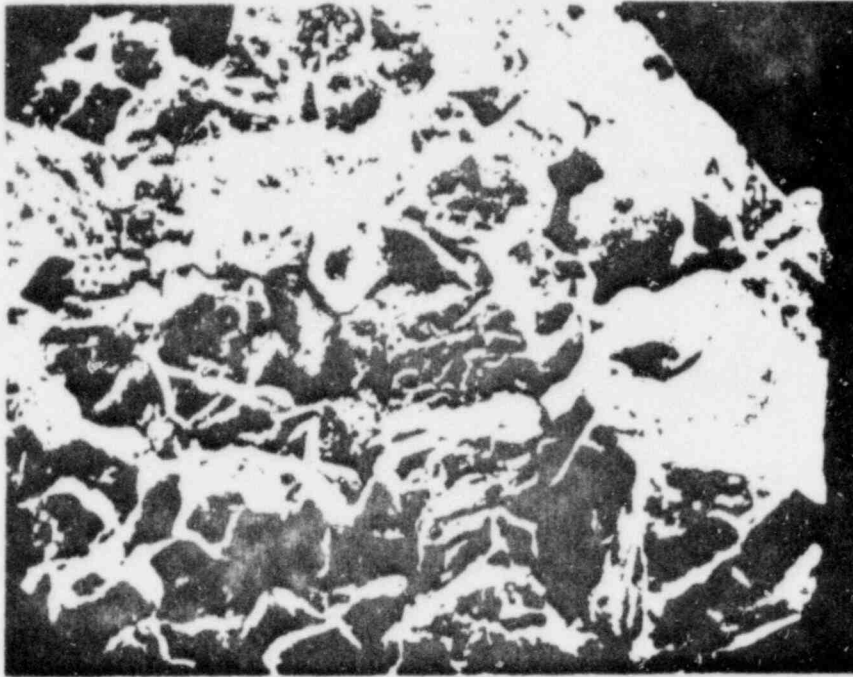
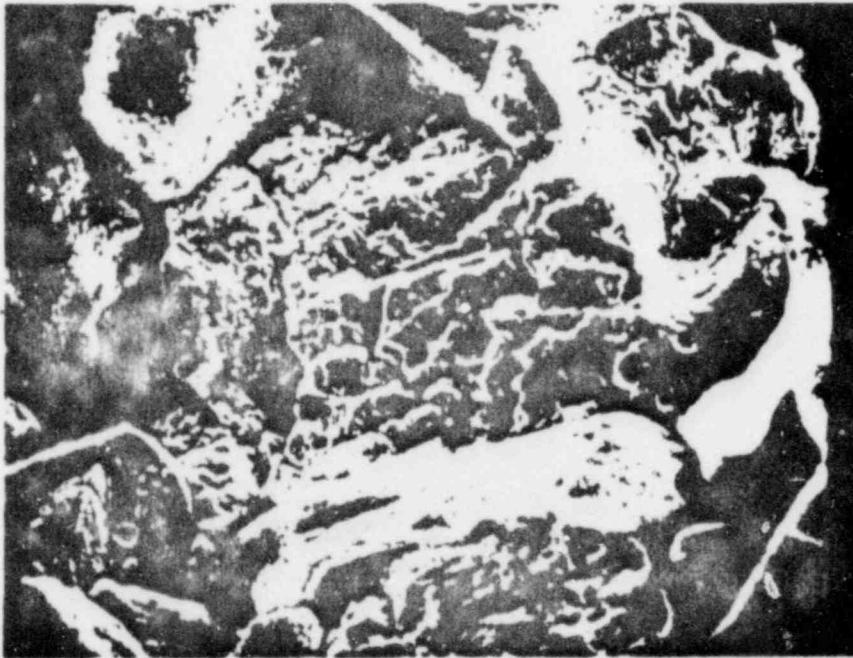
STRESS CORROSION FAILURE

Figure 3: Scanning electron micrographs of NiCrMoV sample. Micrograph (a) shows intergranular SCC near edge. Micrograph (b) shows transgranular tear at center of micrograph (a).

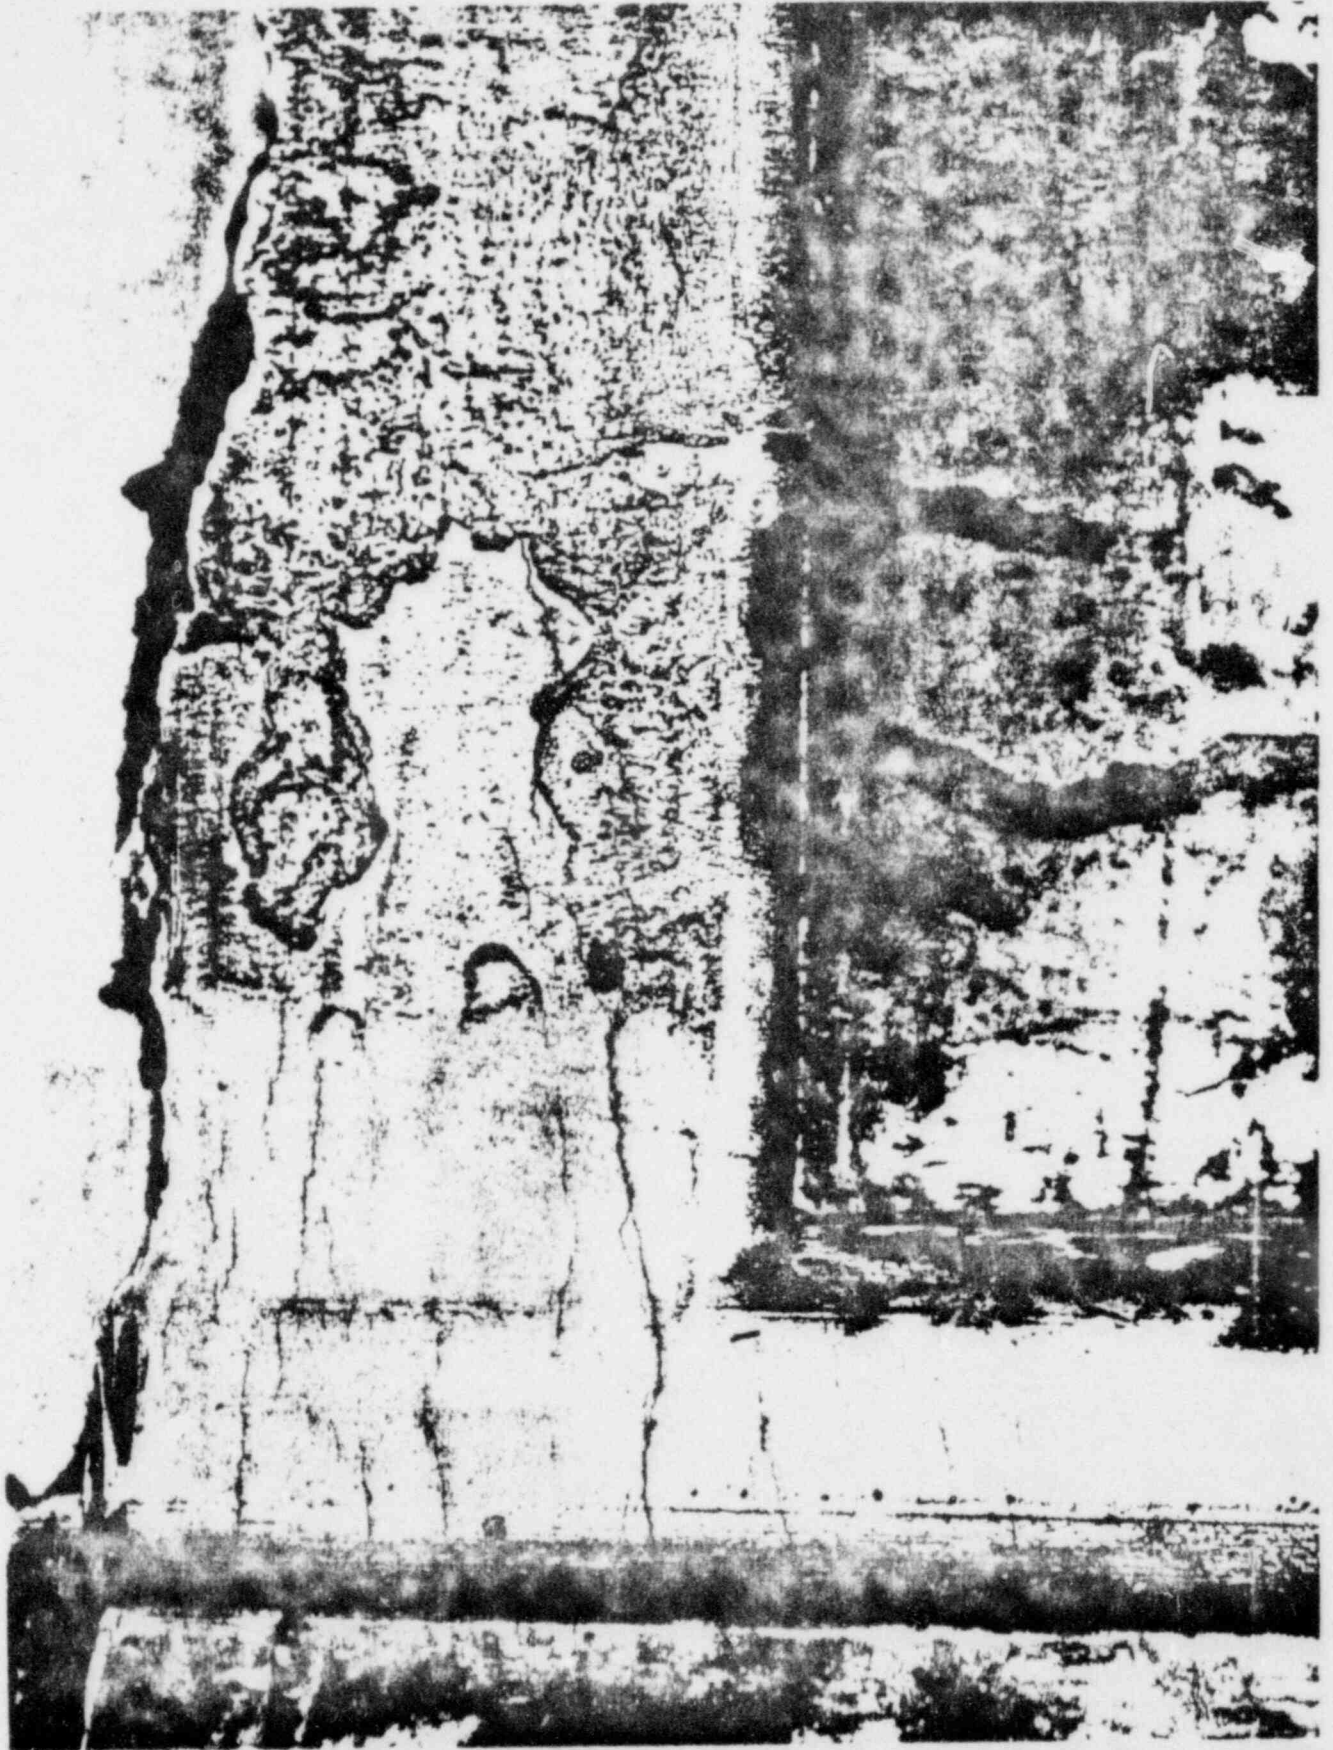
FIGURE 18

To date, a total of three wheels and two large rings have been artificially cracked. The first wheel was exposed to 40% caustic for approximately one year and later broken open (Figure 17 and 18). Ultrasonic indication amplitudes equal to that of the keyway itself were observed from these cracks as shown in Figure 19 and 20. The deepest crack in this wheel was 1 1/4 inch (32 mm). Numerous smaller cracks with approximately 1/4" (6.4 mm) depth were also present near the axial end of the keyway and were detected from the wheel hub.

STRESS CORROSION CRACK IN KEYWAY

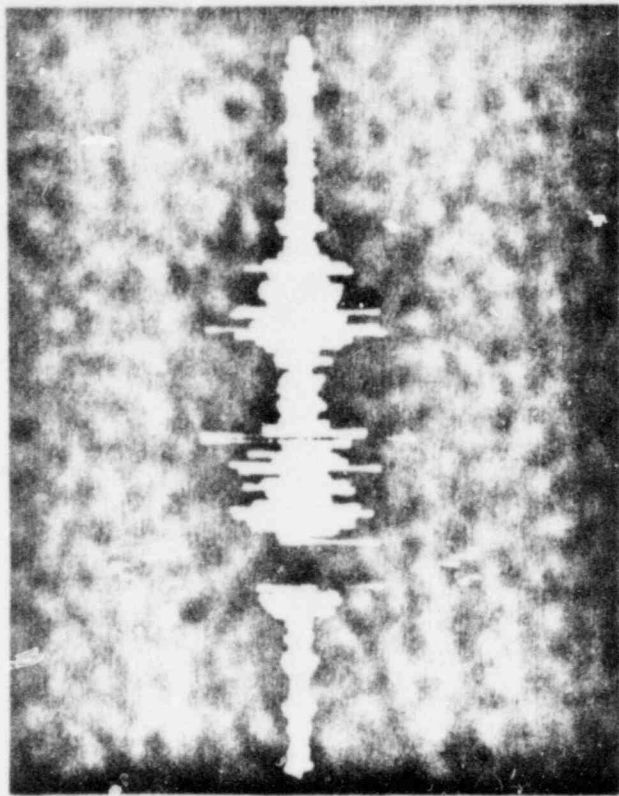
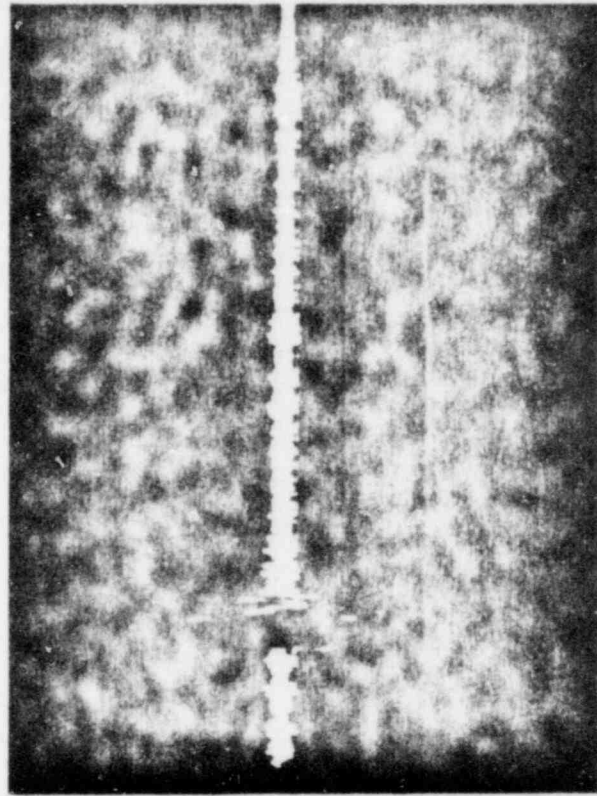
FIGURE 21

Another wheel was exposed with the objective of producing smaller cracks nearer to the detection limit of the ultrasonic test. After eight months of

exposure, ultrasonic tests of the wheel revealed significant cracking (Figure 21). A section containing the keyway was removed and magnetic particle tested (Figure 22) revealing an extensive network of cracks.

WHEEL SPECIMEN

10/16/78
CONDITION

BASE CONDITION
2/2/78

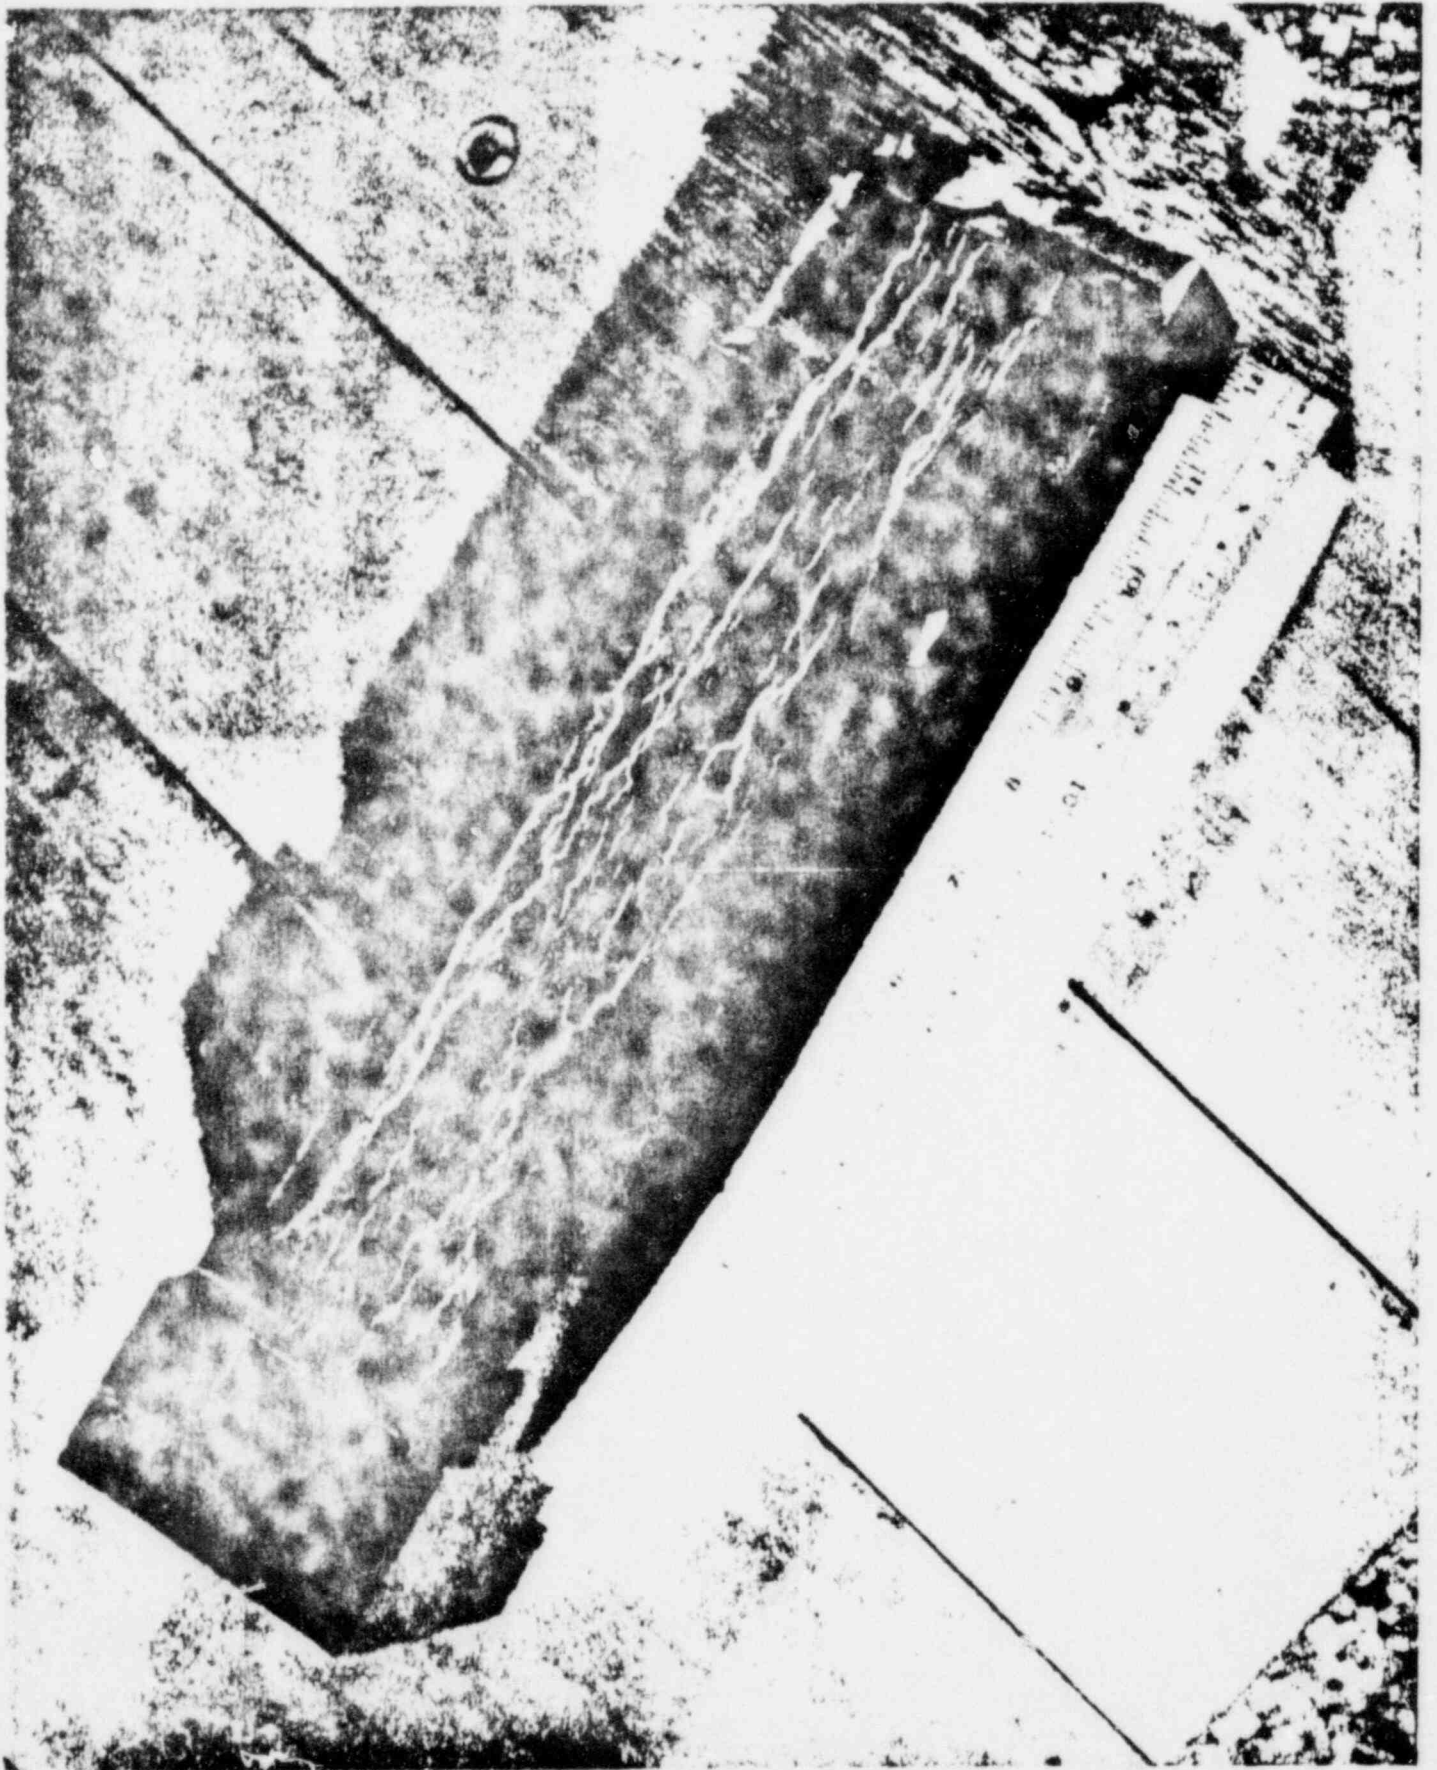
FIGURE 22

STRESS CORROSION CRACKS IN KEYWAY
