Public Service Company of Colorado

June 6, 1980
Fort St. Vrain
Unit No. 1
P-80144

REPORTABLE OCCURRENCE 80-23

REPORT NO. 50-267/80-23/03-L-0

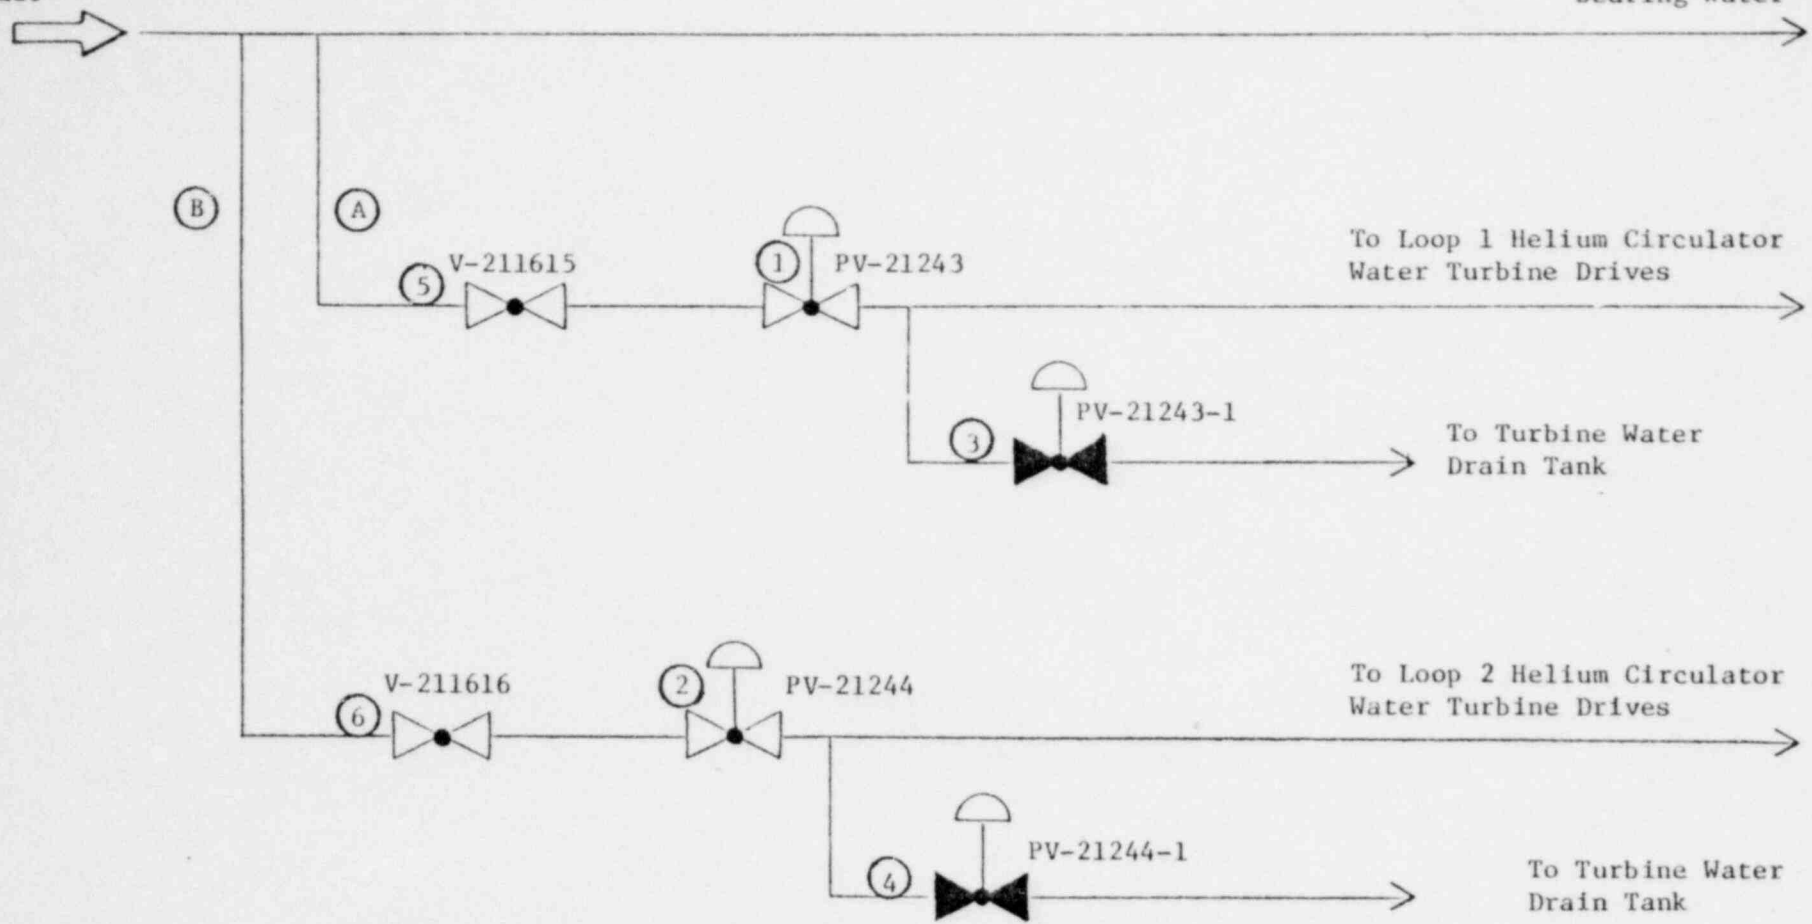
FIGURE 1

On May 7, 1980, a Plant Trouble Report was initiated, indicating that PV-21244-1 (4 of Figure 1) was leaking. At 1430 hours on May 7, with the plant operating at approximately 45% thermal power and 135 MWe, emergency feedwater header supply to Loop 2 helium circulators was isolated in order to determine the cause of leakage and repair the problem.

At 2100 hours on May 7, 1980, with plant conditions essentially unchanged, Loop 2 emergency feedwater supply was again isolated as the system was not providing proper pressure control. At this time, the line downstream of PV-21244-1 was replaced, and the system was returned to service at 2315 hours.

On May 8, 1980, with the plant operating at approximately 46% thermal power and 135 MWe, lack of pressure control was still being observed on the emergency feedwater header supply to Loop 2 circulators. At that time, it was decided that valve leakage through PV-21244 (2 of Figure 1) was contributing to the pressure control problems. In order to rectify this situation, the system was isolated at 1030 hours on May 8 to replace the trim in PV-21244. This work was completed and the valve and system returned to service at 1300 hours.

On May 16, 1980, a Plant Trouble Report was initiated to indicate that Loop 1 emergency feedwater pressure control valve PV-21243 was leaking (see 1 of Figure 1). At 0850 hours on May 16, with the plant operating at approximately 47% thermal power and 130 MWe, the Loop 1 emergency feedwater header supply was isolated in order to repair this valve. Repairs were completed and the valve and system returned to service at 0830 hours on May 17, 1980.

Isolation of the Loop 2 emergency feedwater header supply described in Events #1, #2, and #3 was a result of leakage in the line downstream of PV-21244-1, as well as valve leakage through PV-21244. This leakage contributed to the poor pressure control and system isolation to effect repairs resulted in operation under a degraded mode of LCO 4.2.2(a).

Leakage between the seat ring and valve body of PV-21243 was a result of wear on the gasket. System isolation to repair the valve resulted in LCO 4.2.2(a) degraded mode operation.

Leakage in the line downstream of PV-21244-1 was eliminated by weld repair and eventual replacement of the line.

Valve leakage through PV-21244 was rectified by replacing the 2" trim with 1 3/8" trim. The valve and system were returned to service.

Leakage through PV-21243 was eliminated by applying devcon compound to the valve gasket surface. The valve was re-assembled and the system returned to service.
