DUKE POWER

Subject: McGuire Nuclear Station Unit 2
Docket No. 50-370
Licensee Event Report 370/89-10

LICENSEE EVENT REPORT (LER)

TITLE (4)
A Leak Occurred On Containment Spray Heat Exchanger 2A After Valve Stroke Timing Because Of A Deficient Procedure And An Inappropriate Action

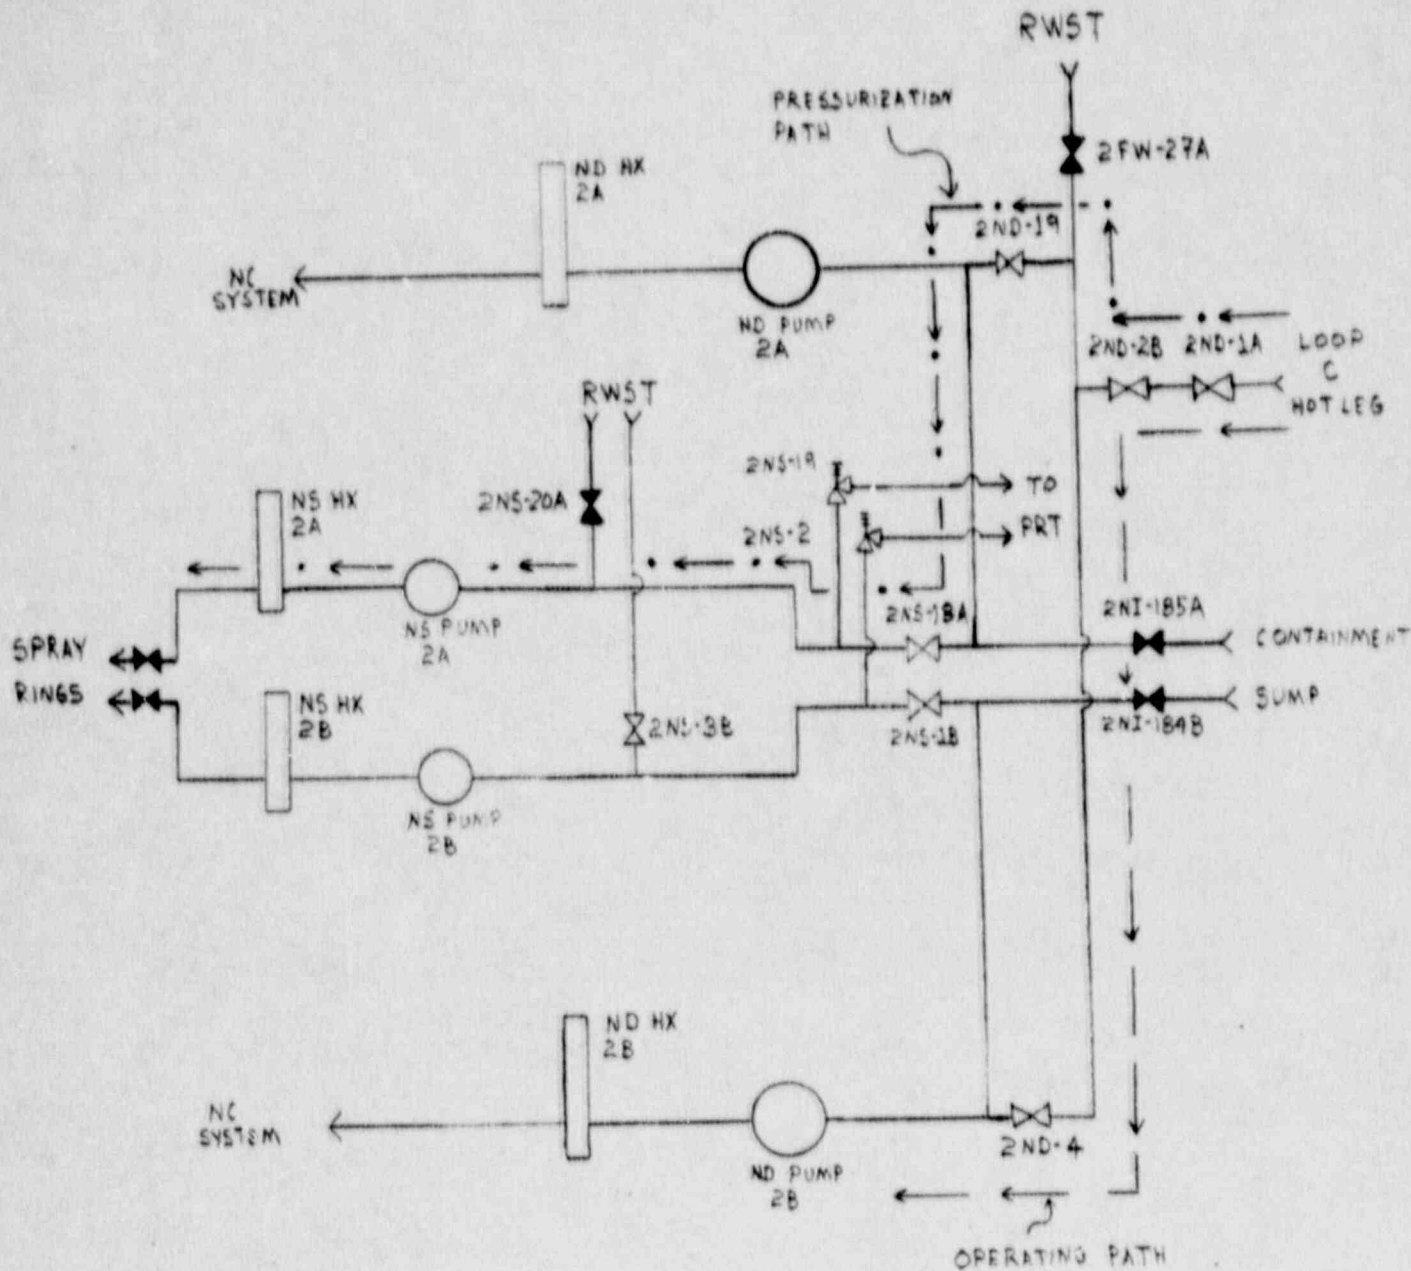
Valve Alignment At Time Of Leak

to be stroke timed before Unit 2 entered Mode 4, Hot Shutdown. Included was valve 2NS-18A, which would be stroked using procedure PT/2/A/4208/02, NS Valve Stroke Timing - Quarterly. Operator A in the Control Room [EIIS:NA] reviewed the portion of the procedure applicable to valve 2NS-18A to ensure all prerequisites were met and to evaluate system conditions before opening the valve. After his review and evaluation were completed, Operator A granted permission to cycle valve 2NS-18A. The NC system was at 305 psi and 139.5 degrees-F with ND Pump 2B in operation (reference page 10 of 12).

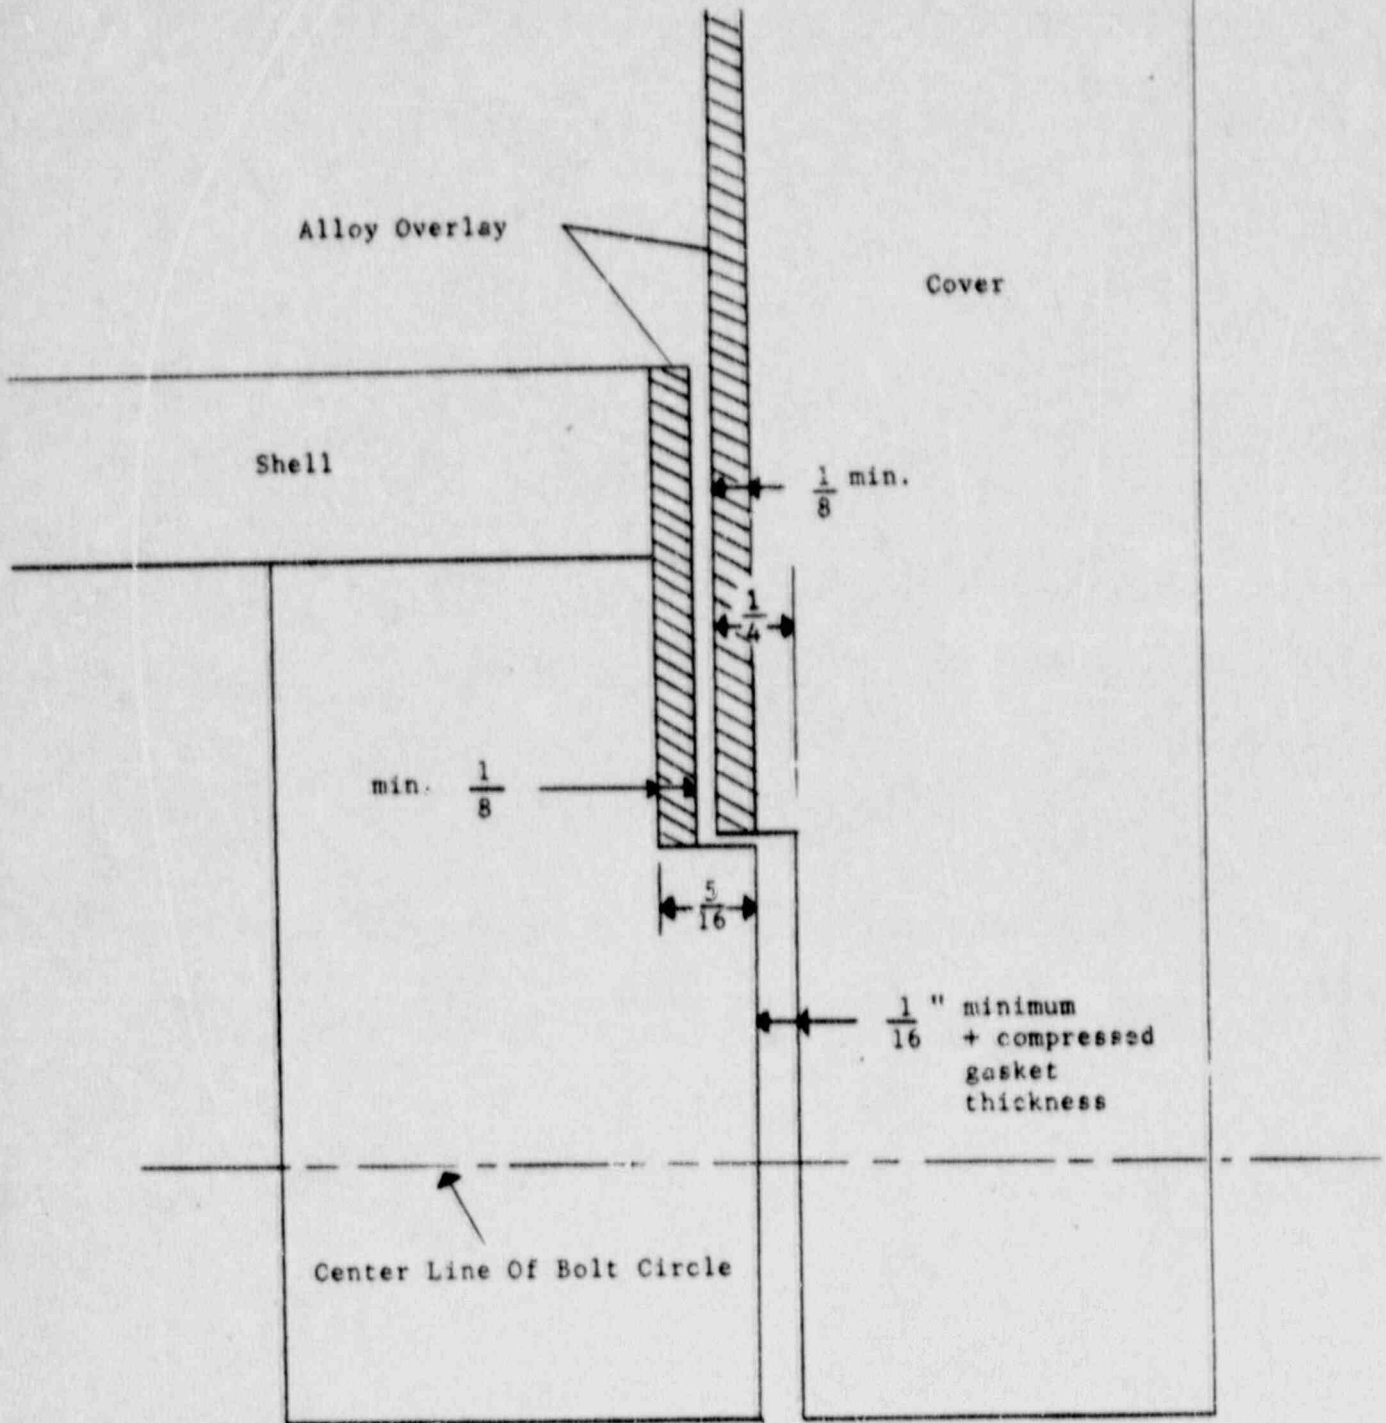
NS Heat Exchanger Cover Joint
No Scale

The head gasket for NS HX 2A had been replaced in October, 1988 as documented on WR 96042 and procedure MP/O/A/7150/069, Containment Spray Heat Exchanger Cover Plate Gasket Removal, and was torqued to 150 ft-lbs. The NS pumps were then run to ensure there were no leaks. However, after the leaking gasket was removed on September 7, 1989, MNT personnel noticed that a section of the gasket approximately 12 to 15 inches long and 1/8 to 3/16 inches wide (on the outside diameter) was not

compressed because of misalignment during the October, 1988 replacement. A gasket compression check was not documented in WR 96042 and there is no requirement to check gasket compression in the gasket removal procedure. McGuire Engineering Services (MES) personnel stated that because of the HX orientation and gasket cover configuration, it is almost impossible to check alignment (reference page 12 of 12). However, MES personnel have performed a review of the gasket removal procedure and believe that section 11.3 is adequate to ensure proper gasket alignment.

In the Operability Evaluation for the NS system dated September 8, 1989, D.E. personnel stated that a phenomenon called relaxation also contributed to the gasket leak. Relaxation occurs when a bolt loses its initial torque load as a result of conditions such as lack of proper bolt lubrication, thermal cycling, vibration, temperature gradients, pressure gradients, and loss of gasket resiliency after compression, and can be as high as 25 percent. Relaxation of initial bolt load (150 ft-lbs) resulted in a bolt load that, at best, was marginal and possibly below that required to withstand 305 psi, especially at the area of non-compression. However, DE personnel stated that even with the gasket misalignment and the relaxation phenomenon, 150 ft-lbs was sufficient torque to prevent a gasket leak at normal operating pressure. D.E. has recommended a torque value of 200 ft-lbs which will be incorporated into the appropriate procedures for an additional margin of safety.

MNT personnel replaced the HX gasket on September 7, 1989 using WR 139654. The gasket was torqued to 200 ft-lbs as recommended by Design Engineering (D.E.) personnel. The nominal torque for this gasket is 150 ft-lbs. The HX cover to shell clearance was measured at the bolt circle to ensure gasket compression was not being hampered by metal to metal contact. Values measured at 4 points were approximately 0.07 inches. D.E. personnel also performed an Operability Evaluation on September 8, 1989 which concluded that the portion of the NS system exposed to NC pressure suffered no degradation which would prevent the NS system from being returned to service. However, this portion of the NS system was hydrostatically pressurized to 242 psi, which is 110 percent of the design operating pressure (220 psi). The NRC and Station Management felt it prudent to pressure test the new gasket installation. This test also revealed no resulting degradation. Valve 2NS-19, NS Pump 2A Suction Safety Relief, was independently pressure tested. During the test, this valve began leaking by and was subsequently repaired.

- 1) MES personnel will make changes to procedure MP/0/A/7150/69, Containment Spray Heat Exchanger Cover Plate Gasket Removal, to increase the present torque value to 200 ft-lbs.
