NOTICE OF VIOLATION  
AND  
PROPOSED IMPOSITION OF CIVIL PENALTY

Uniroyal Goodrich Tire Company  
Akron, Ohio

Docket No. 030-12542  
License No. 34-09024-05  
EA 89-198

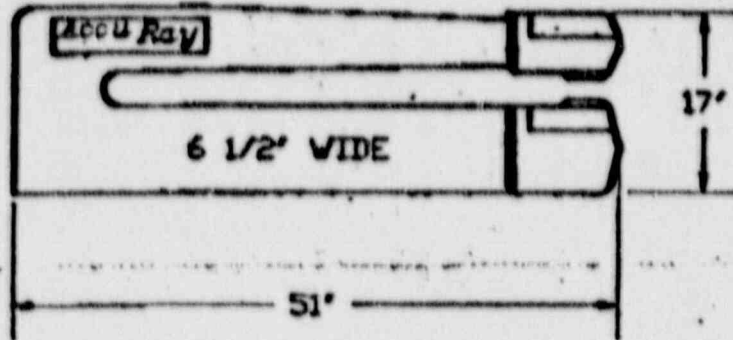
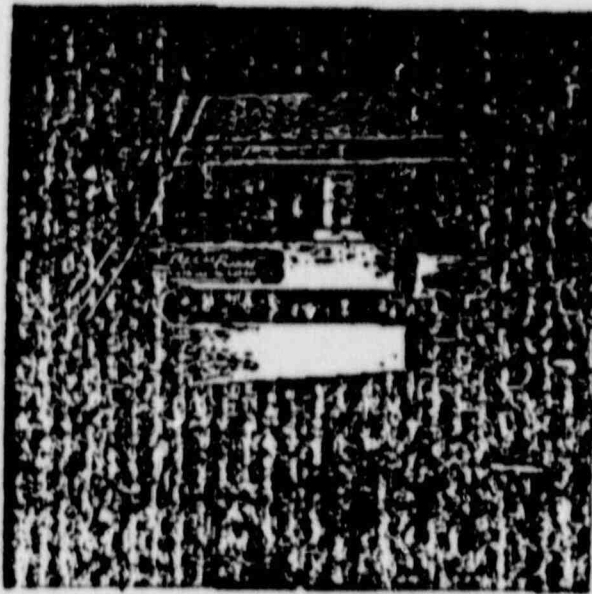
## ACCURAY U-FRAME

**THERE ARE TWO UNITS WHICH WERE MISTAKENLY SENT OUT AS SCRAP ON 9/7/89. IF THESE UNITS ARE LOCATED, PLEASE HOLD THEM BACK AND NOTIFY DAN STUART OR LON VAN AT UNIROYAL GOODRICH TIRE COMPANY. PHONE #493-8100**
