UNITED STATES NUCLEAR REGULATORY COMMISSION WASHINGTON, D. C. 20555

FACILITY: McGuire Nuclear Station, Units 1 and 2

SUBJECT: MCGUIRE SITE VISIT AND MEETING ON STEEL CONTAINMENT

CORROSION

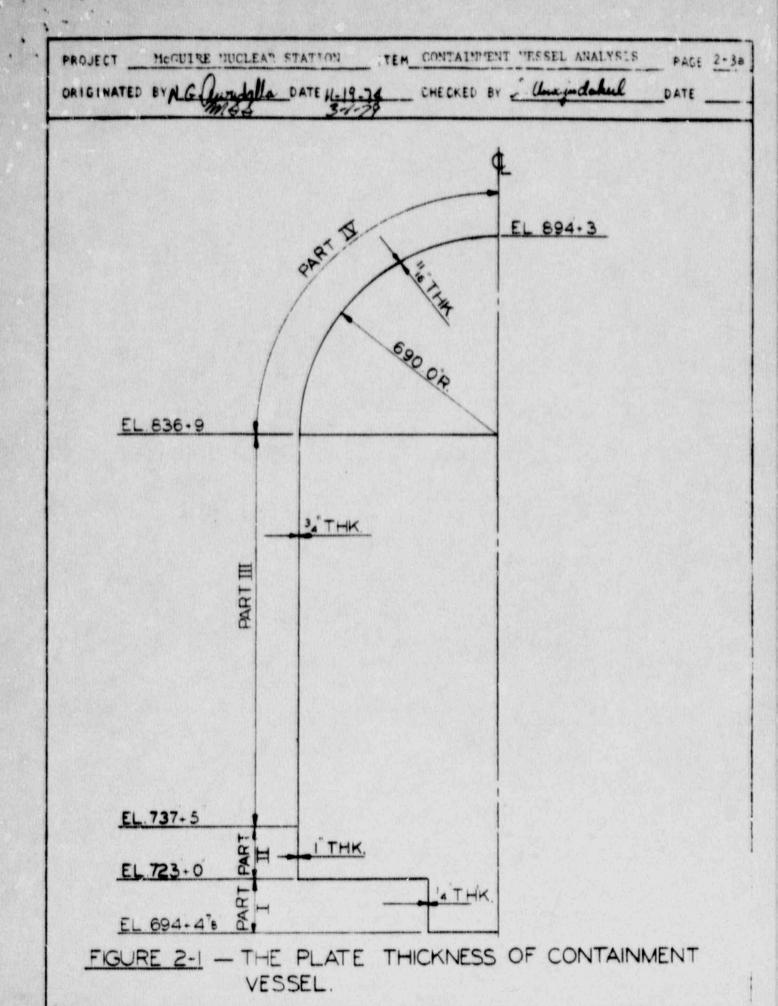
UNIT 1 PRELIMINARY INSPECTION FINDINGS

- * Similar Coating Failures as Unit 2
- * Similar Ponding of Water as Unit 2
 - 1. Azimuth 218° to 253°
- * More Extensive Boric Acid Deposits Than Unit 2
 - 1. Azimuth 121° to 198°
 - 2. Azimuth 206° to 253°
 - 3. Azimuth 284° to 330°
- * Comparable Corrosion Depths as Unit 2

Azimuth (deg)	Above E	leight (lev. 725 (hes)	Maximum Pit Depth (mils)
216	0 t	0 .5	103
21.8	0 t	0.5	60
221	0 t	0.5	55
228	0 t	0.5	73
245	0 t	0.5	82
316	0 t	0.5	125
