SUBJECT: Virgil C. Summer Nuclear Station
Docket No. 50/395
Operating License No. NPF-12
LER 89-016

LICENSEE EVENT REPORT (LER)

TITLE (4)
Shutdown Due to Inoperable MSIV

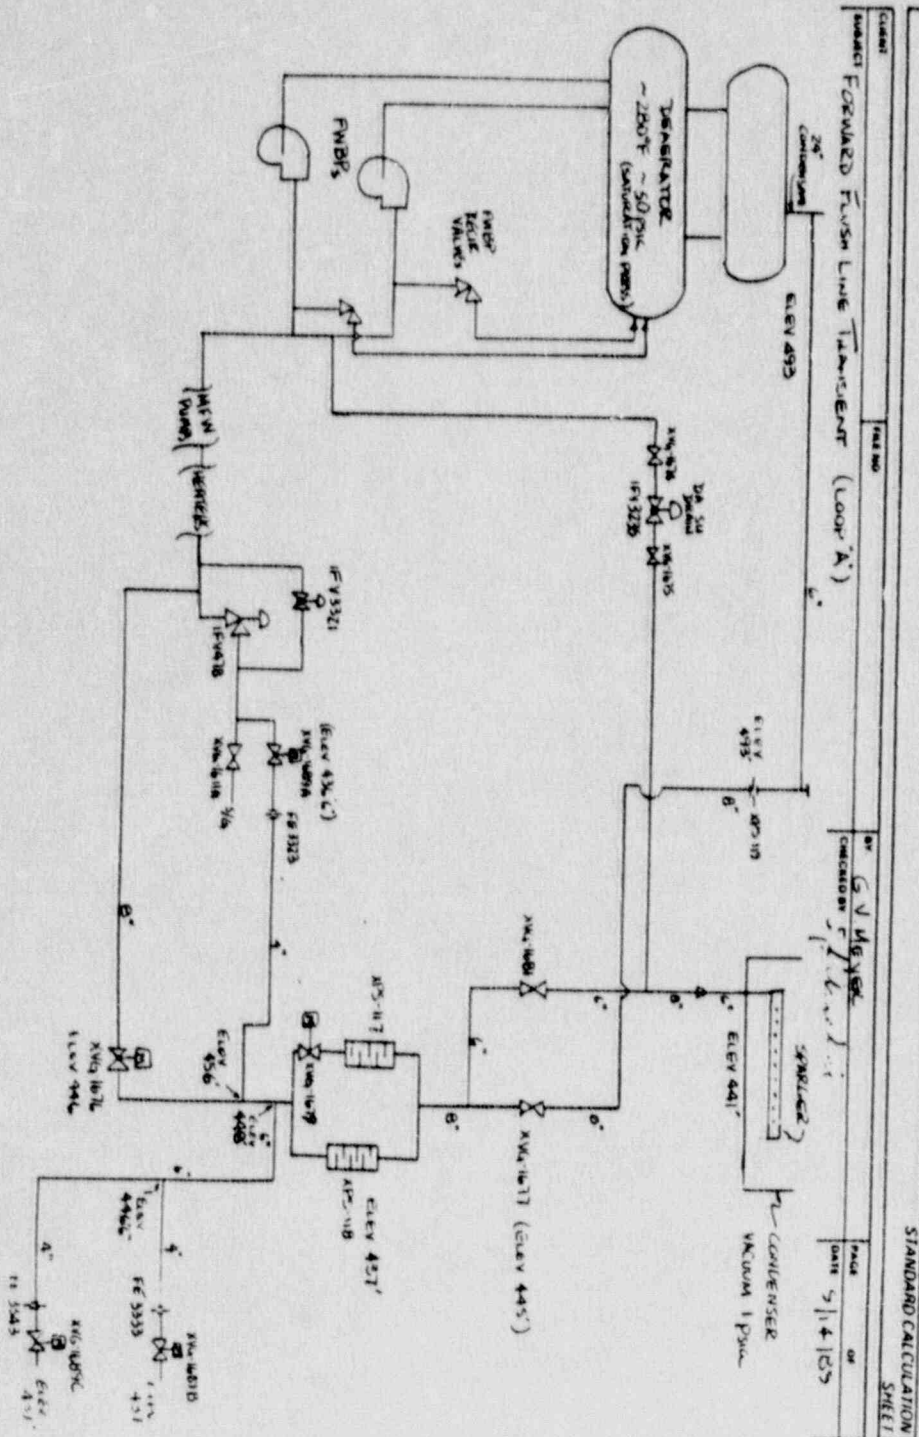
The damage to the MSIV conduit resulted from a system transient that caused the feedwater system forward flush line to move axially and hit the conduit. The following is a summary of the feedwater forward flushing line transient. A one line diagram is provided for system information and ease of following the event.

Opening valve 1677-FW allowed a column of water to flow into a closed piping volume filled with a steam/water mixture at 1 psia. The water was accelerated by the 50 psi steam/water mixture from the deaerator. As the water entered the line between valves 1677, 1689A, B and C, and 1676, it passed through 8 inch diameter piping to a breakdown orifice (XPS-118-FW) which limited the water's momentum. The water continued through the 8 inch diameter pipe until it reached the elevation (448 feet) of the 6 inch diameter pipe which leads to the B and C 4 inch diameter forward flush lines. A similar but smaller transient probably occurred in the B

The water continued filling the system to the elevation (456 feet) of the 4 inch diameter line to the A forward flush line and the 8 inch diameter clean up/recirculation line to valve 1676-FW. When the water reached closed valve 1689A-FW, the momentum of the water mass caused a pressure spike at the valve. A pressure wave then traveled back through the water in the A forward flush line. It was dampened by piping flexibility, friction, and the increased volume of the 8 inch diameter piping. The damage that occurred was limited to the 4 inch diameter A forward flush line.

The pipe was inspected for bulges due to hoop stresses caused by the momentary pressure spike and no indications of overstress were found. Eight supports were damaged and the 4 inch diameter pipe was bent in two locations at support points due to the axial forces. NDE was performed on the piping at elbows and locations where deformation (bending) occurred to assess the condition of the pressure boundary. NDE showed that no degradation occurred. The system was restored to the design condition, inspections and NDE were completed, and supports were repaired.
