Reference: Facility Operating License No. NPF-49
Docket No. 50-423
Licensee Event Report 88-026-03

LICENSEE EVENT REPORT (LER)

FACILITY NAME (1) **Millstone Nuclear Power Station Unit 3** DOCKET NUMBER (2) **0 5 1 0 0 0 4 2 3** PAGE (3) **1 OF 0 5**

TITLE (4) **Potential Damage to Safety Related Equipment Due to Design Inadequacy**

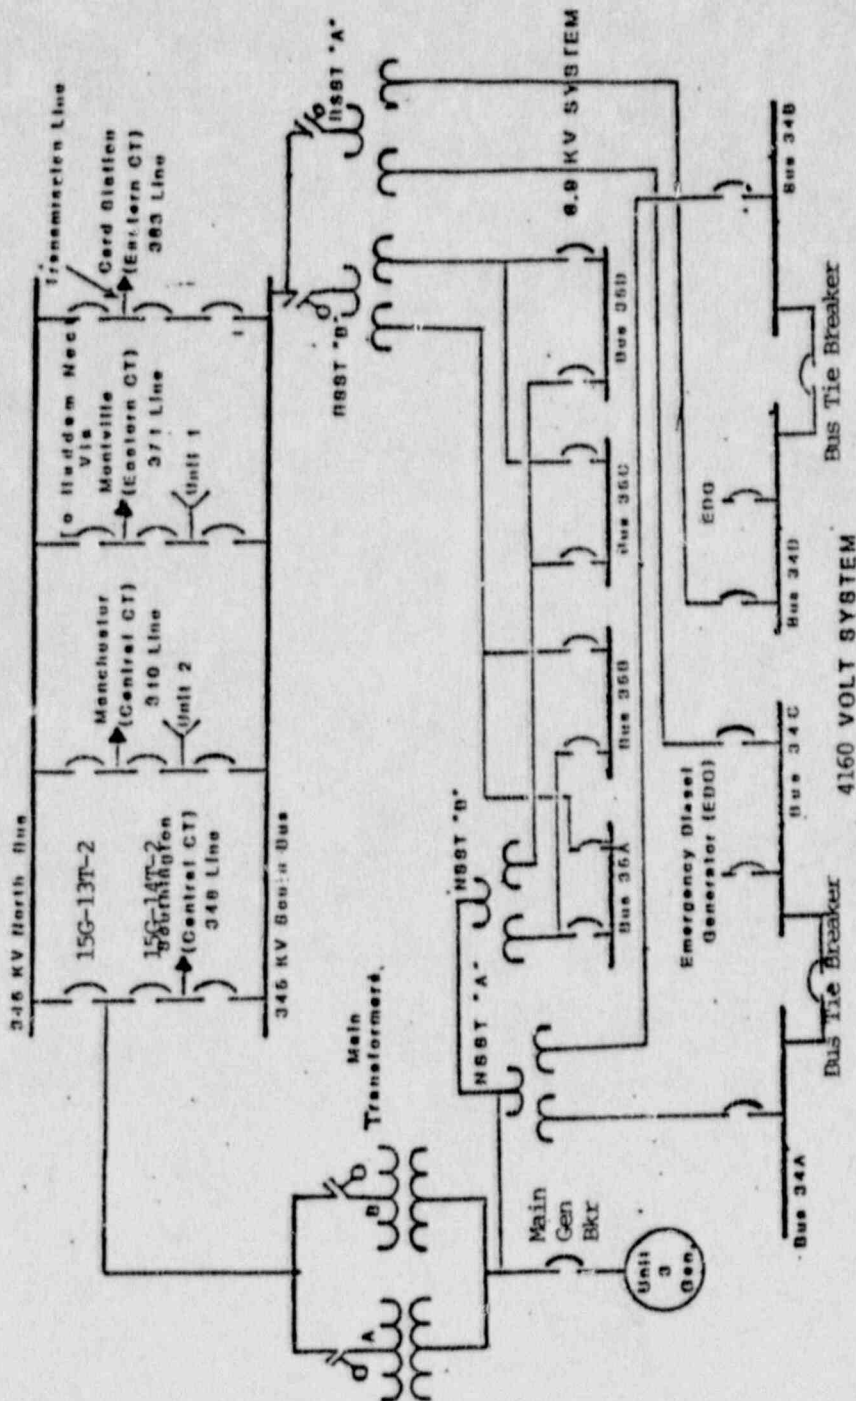
ELECTRICAL DISTRIBUTION SYSTEM
FIGURE 1

The following is a description of the events sequence that could lead to a loss of redundant safety related equipment (refer to Figure 1 for the one-line configuration of offsite and onsite power for Millstone Unit 3).

1. Switchyard breaker 15G-14T-2 is open or out of service for repairs and breaker 15G-13T-2 opens automatically to isolate a fault on the switchyard north bus.
2. Switchyard breaker 15G-13T-2 is open or out of service for repairs and breaker 15G-14T-2 opens automatically to isolate a fault on the Millstone-Southington 348 transmission line.

Both situation 1 and 2 result in the isolation of the main generator from the Millstone Station Switchyard. Under these circumstances, the main generator breaker would remain closed. The turbine subsequently trips due to a power mismatch or turbine overspeed. A turbine-generator coastdown would follow. Since the main generator breaker receives no signal to open and excitation is still present, the main generator continues to provide power via the Normal Station Service Transformers (NSST's) to the Unit 3 6900V and 4160V electrical distribution systems.

Based on a computer model of the generator coastdown, voltage on the 4160V busses would decay to 3220V at approximately 76 seconds after the turbine trip. At this time the model predicts that the main generator frequency would be approximately 40HZ. At 3220 volts, the undervoltage relays on non-vital busses 34A and 34B actuate. After a 2 second time delay, all motor loads off of 34A and 34B trip and also the supply breakers from NSST-A to bus 34A and 34B trip. The tripping of the normal supply breaker initiates a "fast transfer" to the Reserve Station Service Transformer "A" (RSST-A). During this fast transfer, the RSST-A supply breakers to the vital busses 34C and 34D close approximately 6 cycles after the NSST-A supply breakers open. Due to the fact that motor loads remain connected to vital busses 34C and 34D during this 6 cycle interval, voltage/frequency on the busses is not expected to change significantly. Therefore, the RSST supply at 4160V/60Hz will not match the vital bus conditions of 3220V/40Hz. Vital bus connected loads will remain connected unless the fast transfer is not successful. Thus, the transient could damage the connected vital loads before the protective relays open RSST to 34C and 34D bus breakers.

The root cause of these events is design inadequacy. The turbine generator coastdown/out-of-phase transfer scenario is an event which was not considered in the original design basis of the plant. Therefore, design of systems and circuitry to prevent such an event is not in compliance with applicable Regulatory Guides or 10CFR design criteria.

On January 12, 1989, a temporary circuit modification was made which prevents the out-of-phase transfer from occurring. The modification removed the undervoltage trip of the NSST supply breakers to the non-vital busses, effectively preventing a "fast transfer" on undervoltage. All other aspects of the fast transfer were unaffected by the modification. The postulated scenario (or any loss of voltage at the NSST) will now result in a "slow transfer", where the vital busses isolate from the non-vital busses and become connected to the RSST (if RSST voltage is greater than 90%) or Emergency Diesel Generators. This interim modification permitted the plant to return to the normal electrical configuration with the NSST supplying all 4160V loads.

On June 22, 1989, a permanent modification was completed to eliminate the fast transfer on an undervoltage condition. This change employed a contact from the relay that receives the signal from the non-vital undervoltage relays to block the high speed closure of the supply breaker from the RSST. All other aspects of the fast transfer scheme remain unchanged. The fast transfer will still function as designed whenever the NSST supply breaker opens automatically for reasons other than undervoltage (i.e., overcurrent, current differential, etc.). An undervoltage condition on the non-vital busses will result in a slow transfer, where the vital to non-vital bus tie breaker opens and the supply breaker from the RSST closes. In addition to the above, a modification was made to ensure that whenever switchyard breakers 15G-13T-2 and 15G-14T-2 are both open, the main generator output breaker and NSST supply breakers (both 4160V and 6900V) will trip. This will result in a 4160V and 6900V bus supply fast transfer to the RSST.
