U.S. NUCLEAR REGULATORY COMMISSION  
REGION I

Report No. 50-336/89-13

Facility Name: Millstone Unit No. 2

Inspection Conducted: July 10-21, 1989

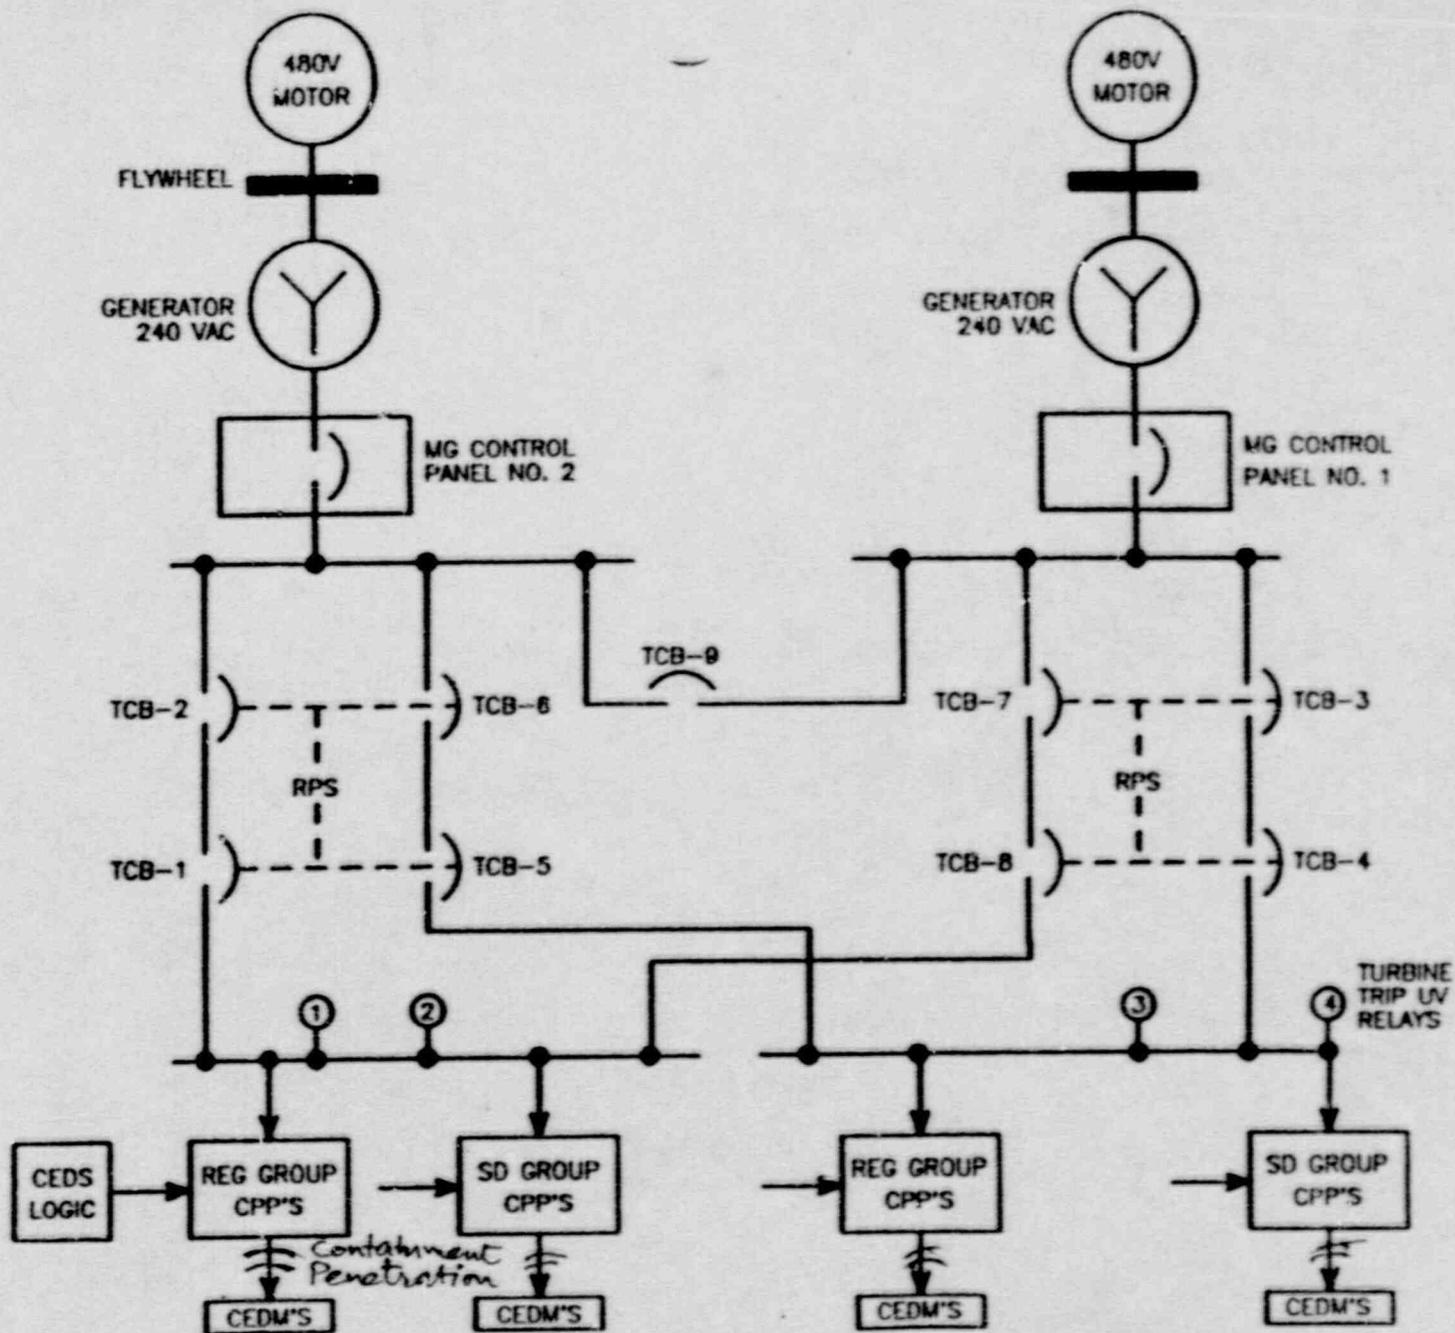
Figure C.3.41

The allegation that the reactor trip circuit breaker remote reset feature does not work is substantiated. The allegation that the reactor trip circuit breakers may not open when needed because of the inability to close them remotely is unsubstantiated.
