U. S. NUCLEAR REGULATORY COMMISSION

Report No. 030-12542/89001(DRSS)

Licensee: Uniroyal Goodrich Tire Company (Uniroyal)
500 South Main Street
Akron, OH 44318

Inspection Summary

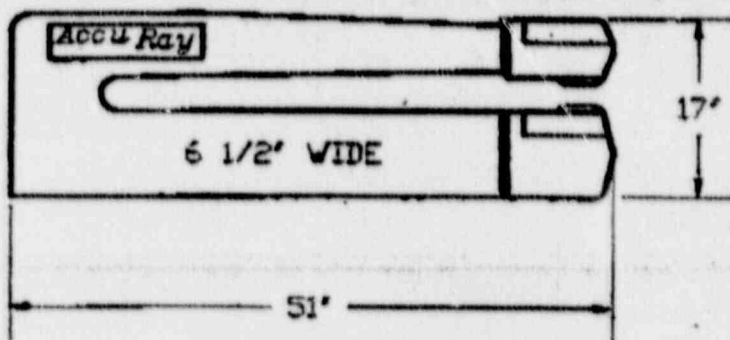
ACCURAY U-FRAME

THERE ARE TWO UNITS WHICH WERE MISTAKENLY SENT OUT AS SCRAP ON 9/7/89. IF THESE UNITS ARE LOCATED, PLEASE HOLD THEM BACK AND NOTIFY DAN STUART OR LON VAN AT UNIROYAL GOODRICH TIRE COMPANY. PHONE 493-8100
