**BOSTON EDISON**

The enclosed Licensee Event Report (LER) 89-029-00, " Locked High Radiation Area Door to the Condenser Bay Found Unsecured", is submitted in accordance with 10 CFR Part 50.73.

LICENSEE EVENT REPORT (LER)

TITLE (4)
Locked High Radiation Area Door to the Condenser Bay Found Unsecured

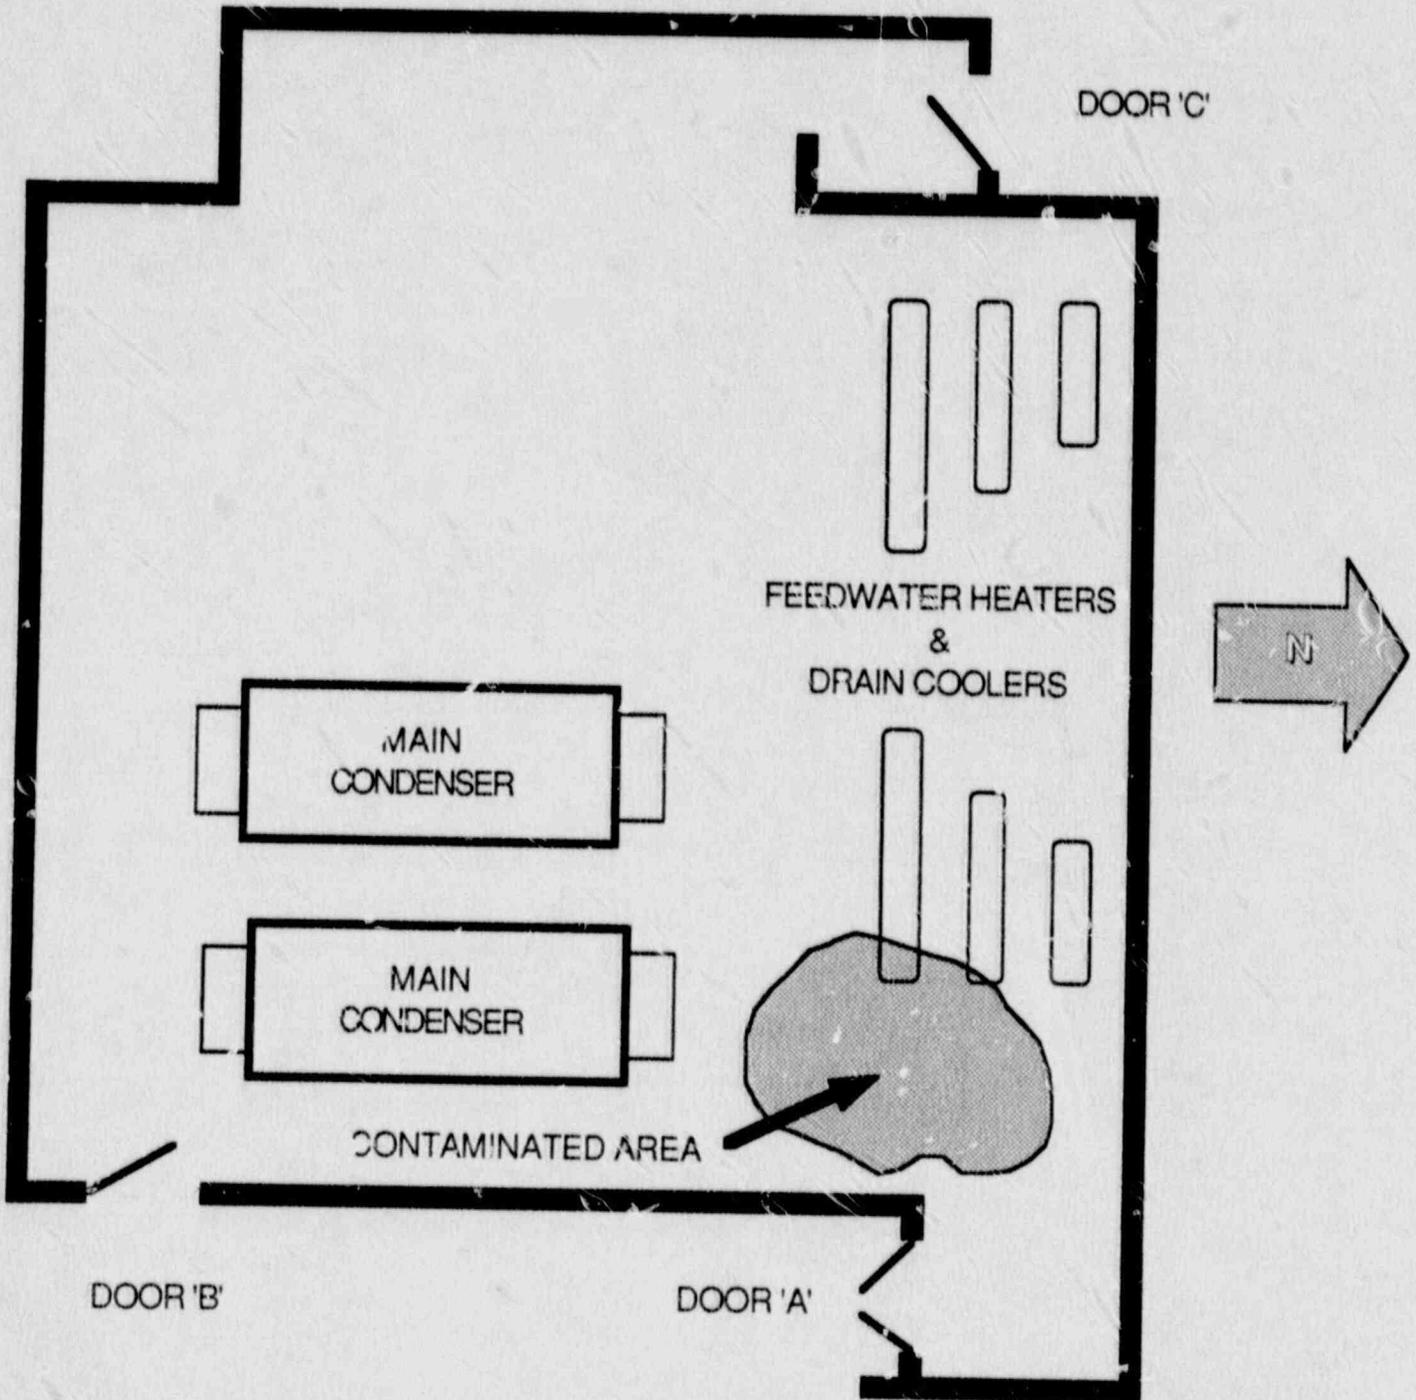
FIGURE 1

On 9/14/89, a locked high radiation area (LHRA) access door was found to have been unsecured from about 1120 hours to 1235 hours. The door latching mechanism was locked, but the latch did not extend into the doorjamb. The unsecured door provides one of three access points to the Condenser Bay (see Figure I, Pg. 7). While unsecured, the door was accessed by two individuals who had not been authorized entry. The dose received was below allowable limits. Pocket dosimeter readings for the unauthorized entries were logged at 15 milli-rem and 5 milli-rem. The highest whole body dose rate measured in the Condenser Bay was 1600 milli-rem/hour.

On September 14, 1989, multiple Condenser Bay (CB) entries occurred for instrument and Control (I&C) work and to define and post a contaminated area. Access to the CB was being controlled through door 'A' (see Figure I, Pg. 7). When the I&C work was completed at approximately 1120 hours, the I&C Technicians were directed by the Radiological Protection Technician (RPT) #1 to exit via door 'B' to prevent crossing a contaminated area. A contaminated area was created when a floor drain backed up after the I&C Technicians had entered the CB. Upon exiting door 'B', the I&C Technicians failed to check that the door was locked and secured. After the I&C Technicians left, RPT #1 checked the door by pulling the door from inside the CB. The door did not open. It was later determined that although the door latching mechanism was locked, the latch did not extend into the doorjamb.

At 1235 hours, the two NPAs who were to provide outside support went to door 'B' expecting to meet the RPT #2 and the third NPA. When the two NPAs arrived at door 'B', the RPT #2 was not present. They assumed the RPT was already in the CB and they should enter. One NPA then pushed on door 'B' with his shoulder and it opened. The two NPAs then entered the CB looking for RPT #2.

- RPT #2 questioned the two NPAs and determined that they had accessed door 'B' to the CB.
- The NPAs were directed to leave the CB.
- RPT #2 checked door 'B' and determined that it was locked but not latched and then secured door 'B'. RPT #2 also toured the CB and determined that no other personnel were in the CB.

The functioning of the door also contributed to the event. The door was sticking against the doorjamb and would not self close. The door could be opened/closed without using excessive force, but did require greater than normal force (a strong push/pull). RPT #1 has a small thin build, making it plausible that the door would have appeared secured when pulled. However, because LHRA doors are designed to open from inside an area, it would not be possible to determine if a door was locked from inside the area.

CONDENSER BAY ACCESS DOOR LOCATIONS

- CET was revised on September 22, 1989 to present and emphasize the requirements for entry to HRAs.
- Maintenance Request No. 89-33-236 has been initiated to repair door 'B' to the CB.
