# ABB Atom Inc.

# Report

Ref. BX-89-20	
From	Date
Customers, NRC	6/19/89
Author	Issued by
B. Scholin/W. Harris	WR Harris
Examined by	Approved by
<i>[Signature]</i>	<i>[Signature]</i>

Oskarshamn 2 Fuel Failures

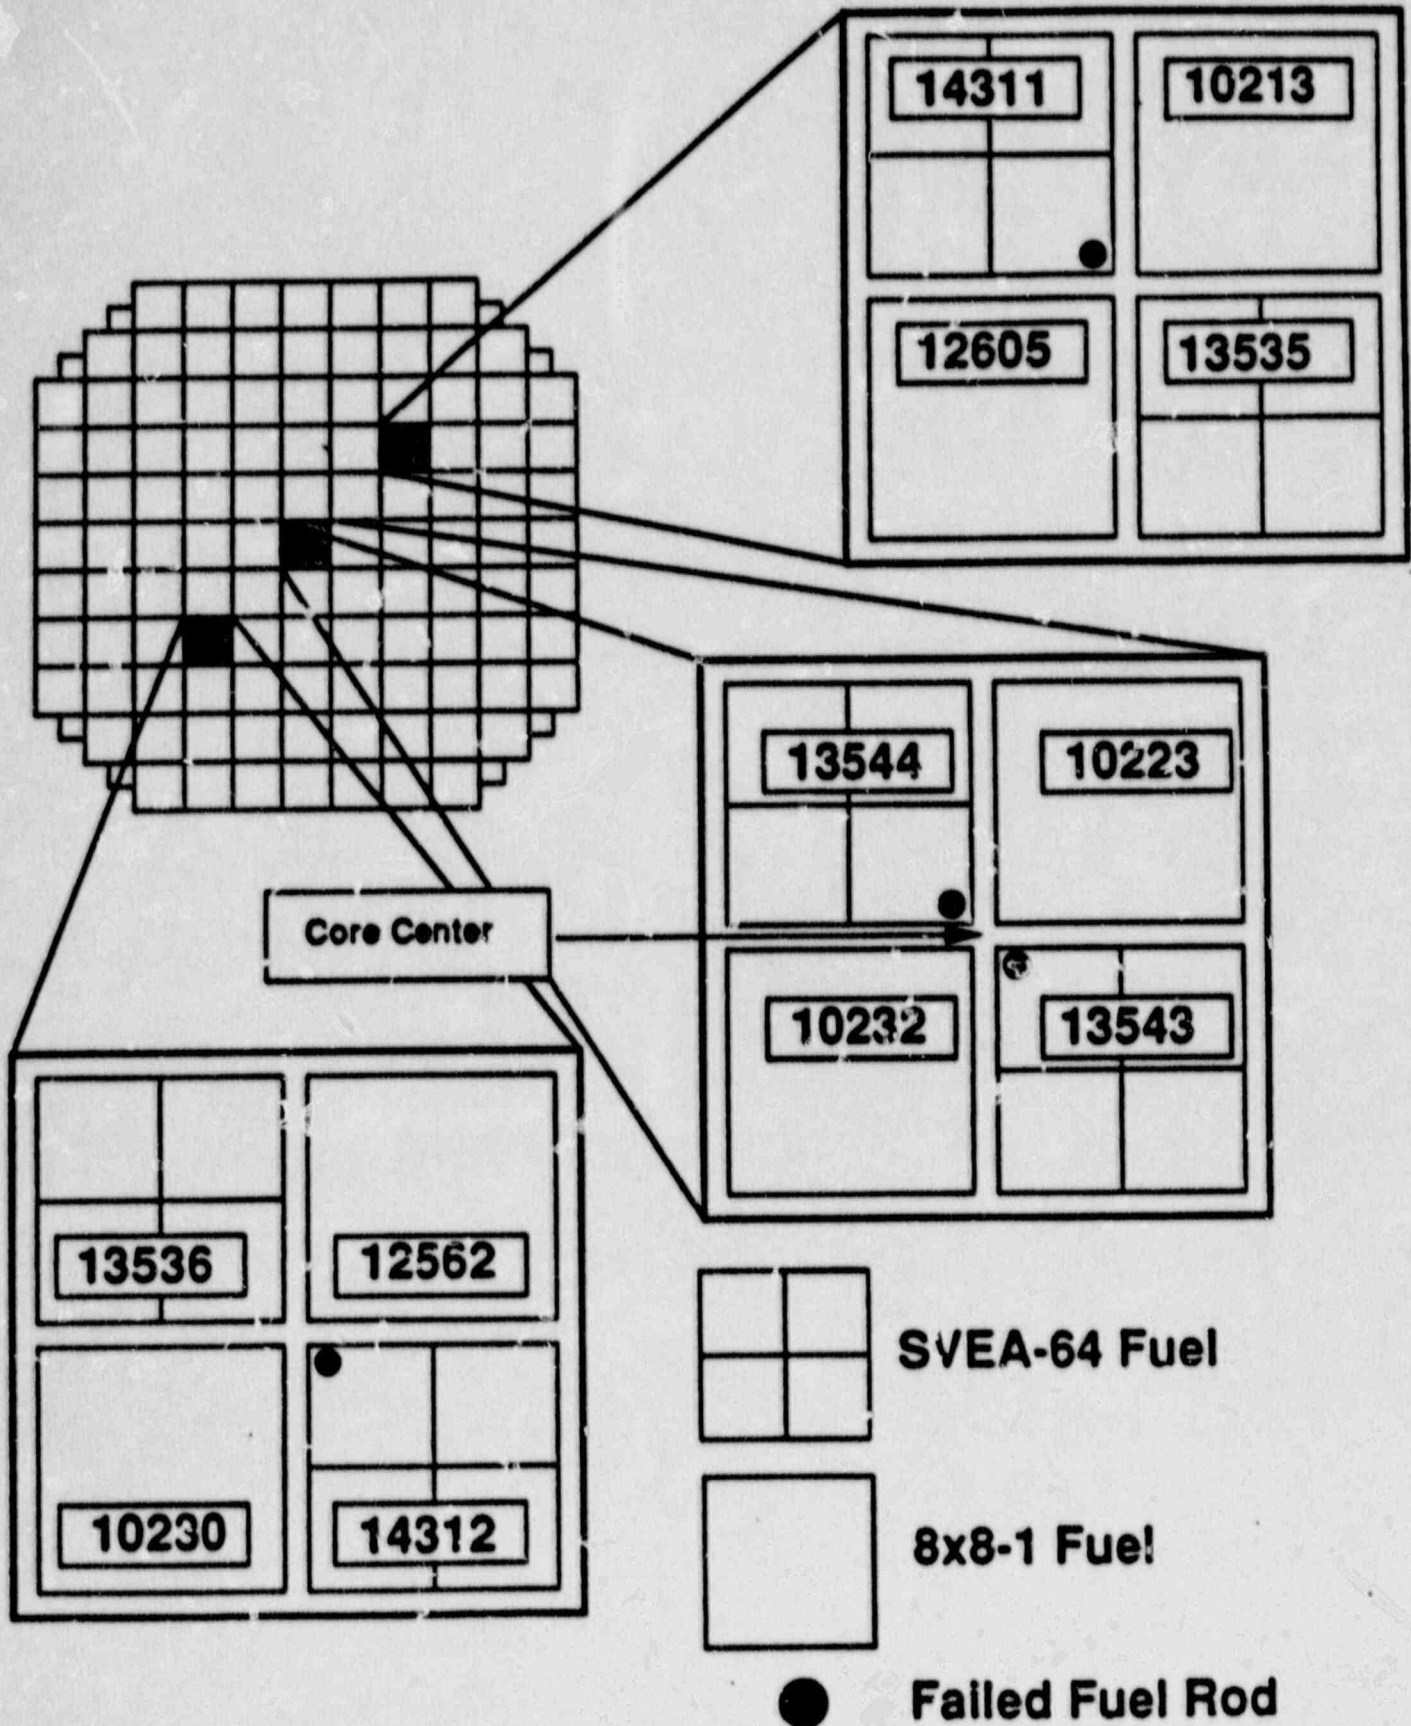
FIGURE 1

Sipping was performed to determine the location of the leaking fuel. Leaking fuel was identified in assemblies 14311, 13544, 13543, and 14312 shown in Figure 1. While initial sipping results indicated the possibility of a failure in assembly 13535, subsequent examination of the fuel showed that all rods in that assembly were intact. The minibundles in each of the SVEA-64 assemblies shown in Figure 1 were visually inspected, and the four failed fuel rods were identified as shown in Figure 1.

Oskarshamn 2: Failed Fuel Core Locations

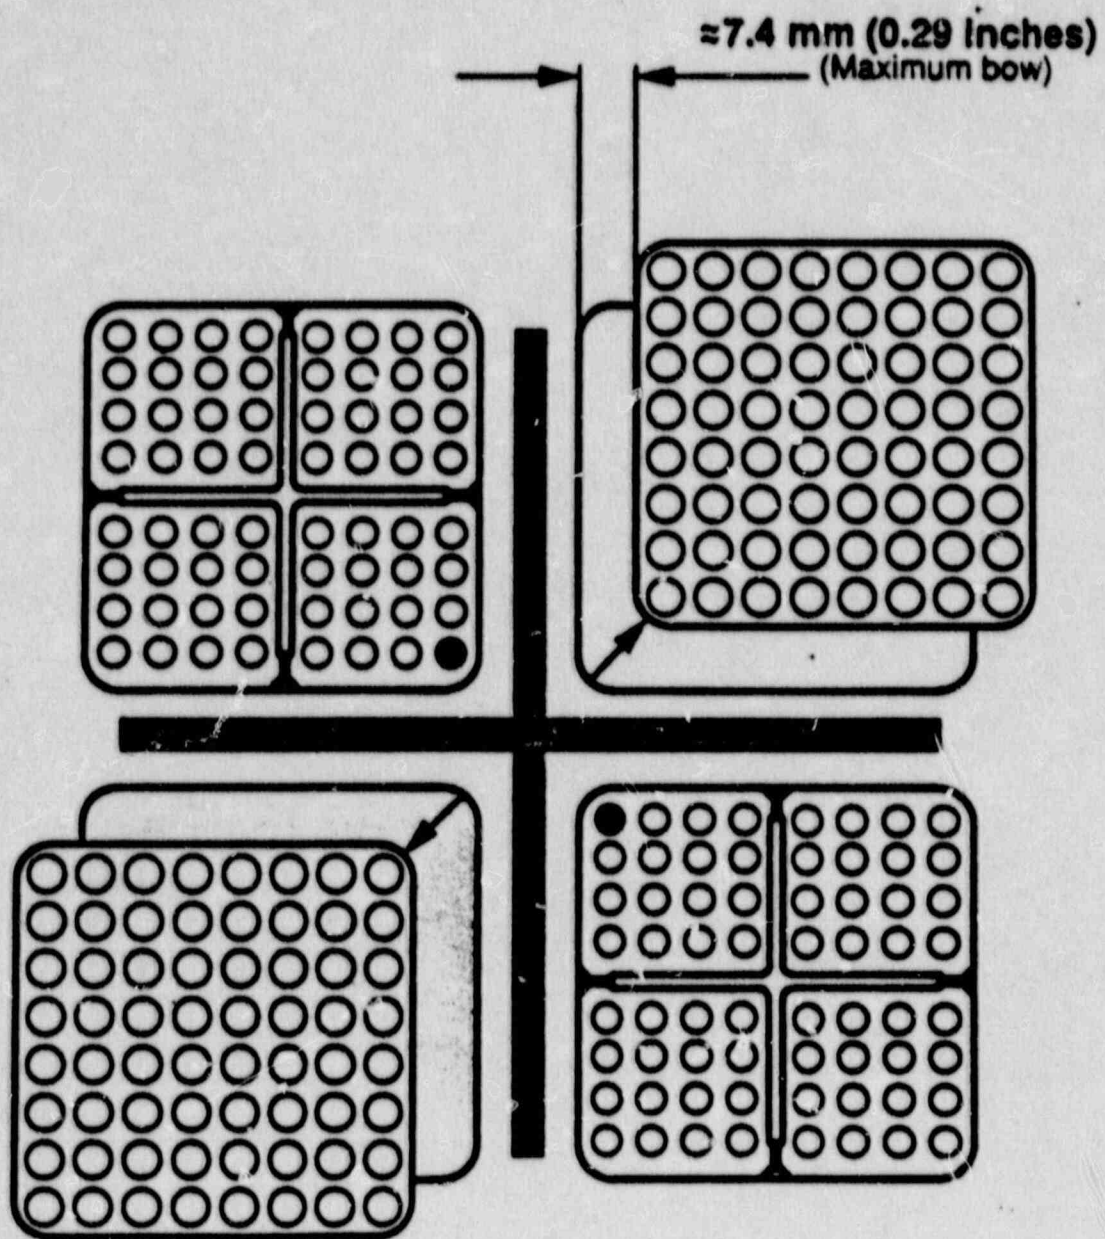
Figure 3

Channel Bow in Oskarshamn 2 Central "Supercell!"

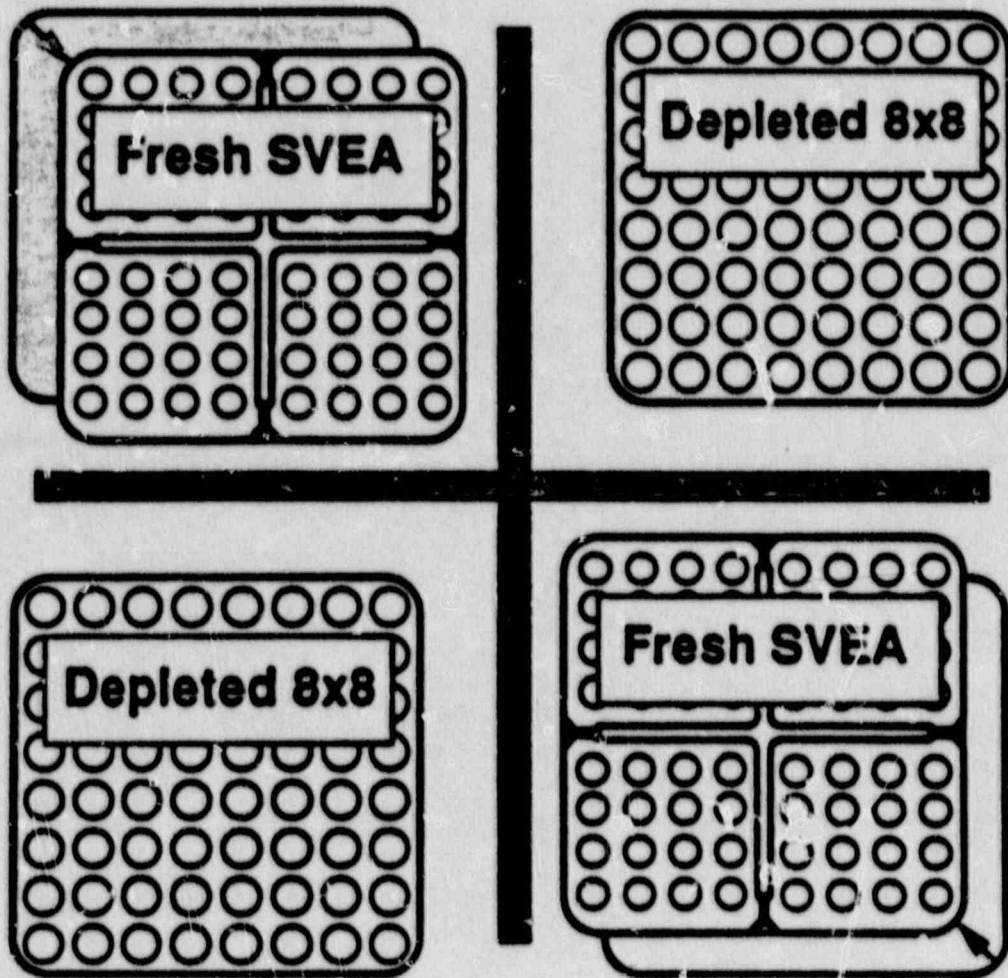
Figure 5

Quadruple With No Channel Bow - The CPR calculations were repeated for cross section and local power distribution data calculated with the geometry shown in Figure 5. This case provides the correct representation for the supercells containing the failed fuel in the absence of channel bow.

Sketch Showing the Displacement of Fresh Assemblies Toward the Control Rod Gap

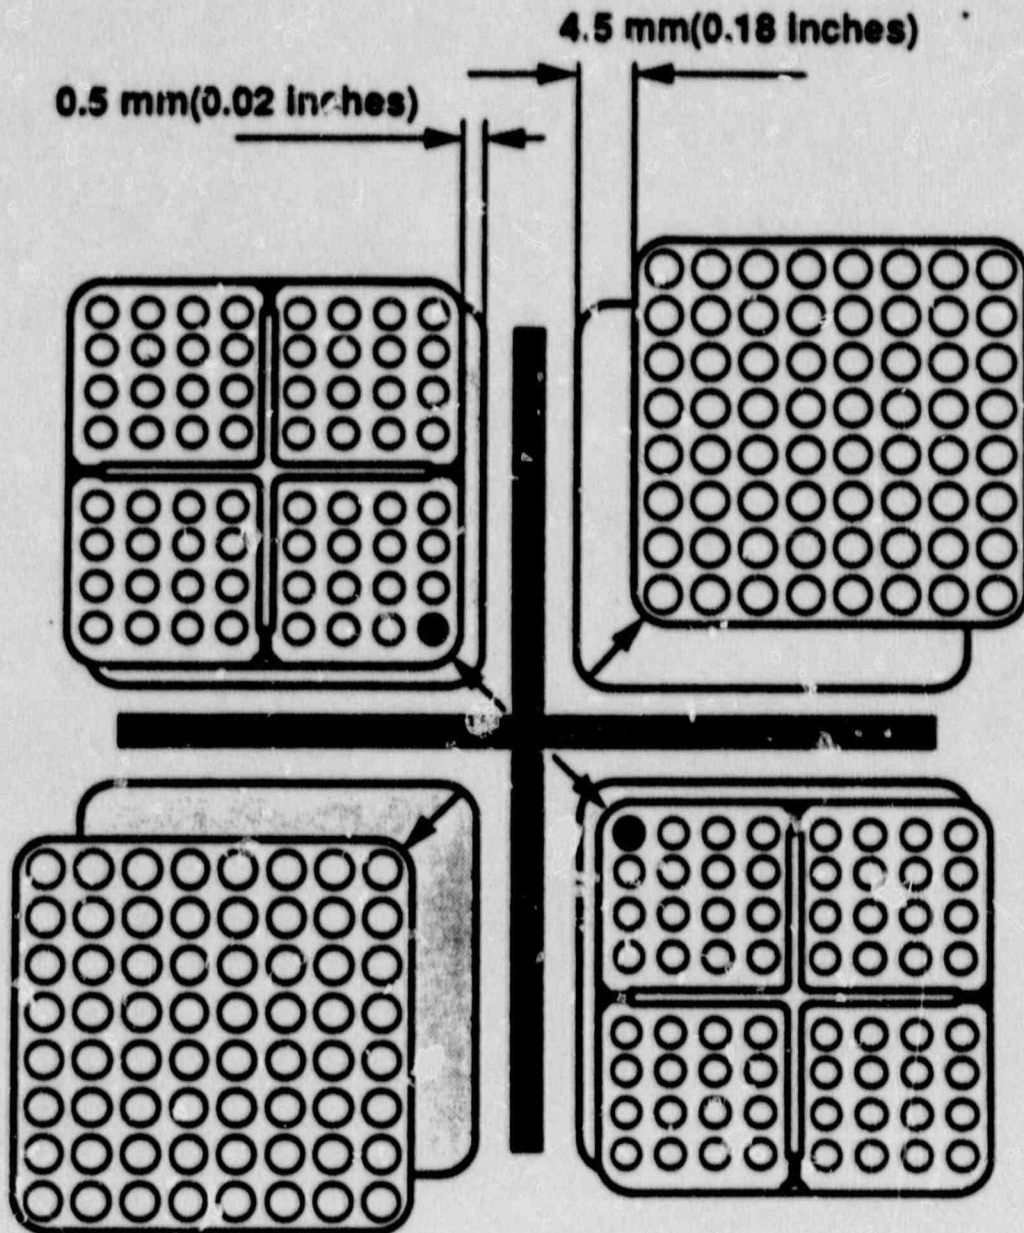
Quadruple With Channel Bow - The CPR calculations were repeated for cross section and local power distribution data for the geometry shown in Figure 6. The actual channel bow magnitudes vary axially and will be somewhat different for each of the 8XB assemblies. The geometry shown in Figure 6 represents a typical case intended to reflect the effect of the observed channel bows on CPR. The 0.5 mm (0.02 inch) channel bow applied to the SVEA bundle reflects the practice of installing assemblies with any manufacturing-related channel bow oriented away from the control rod.

Geometry Used to Evaluate the Effect of Channel Bow
