UNITED STATES
NUCLEAR REGULATORY COMMISSION

SUBJECT: PHOTOGRAPHS FROM SEPTEMBER 20, 1989 SITE VISIT
TO THE L-BAR MILL

On September 20, 1989, the authors visited the L-Bar Mill site to conduct a review of construction records and to observe the completed reclamation construction activities. Results of the inspection are contained in inspection report No. 40-8904/89-003 dated October 16, 1989.

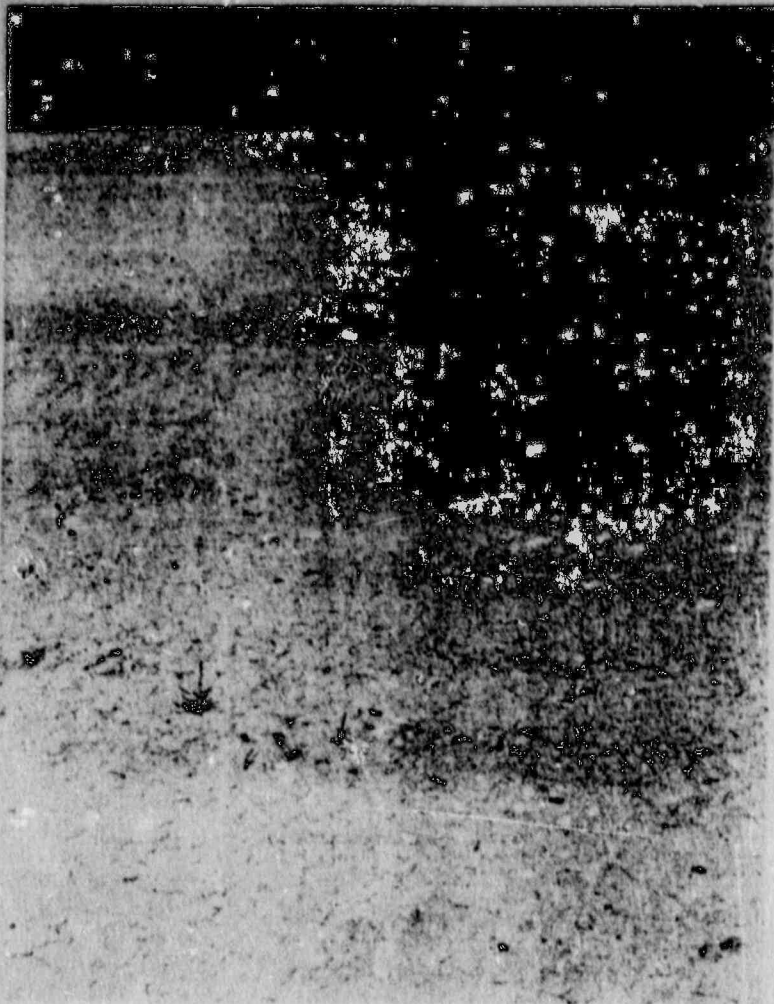
Photo 5 - South Diversion
Channel

Side Slope Adjacent to Tailings
in Hardpan Area - Note two
small erosion rills at the top
of the slope.

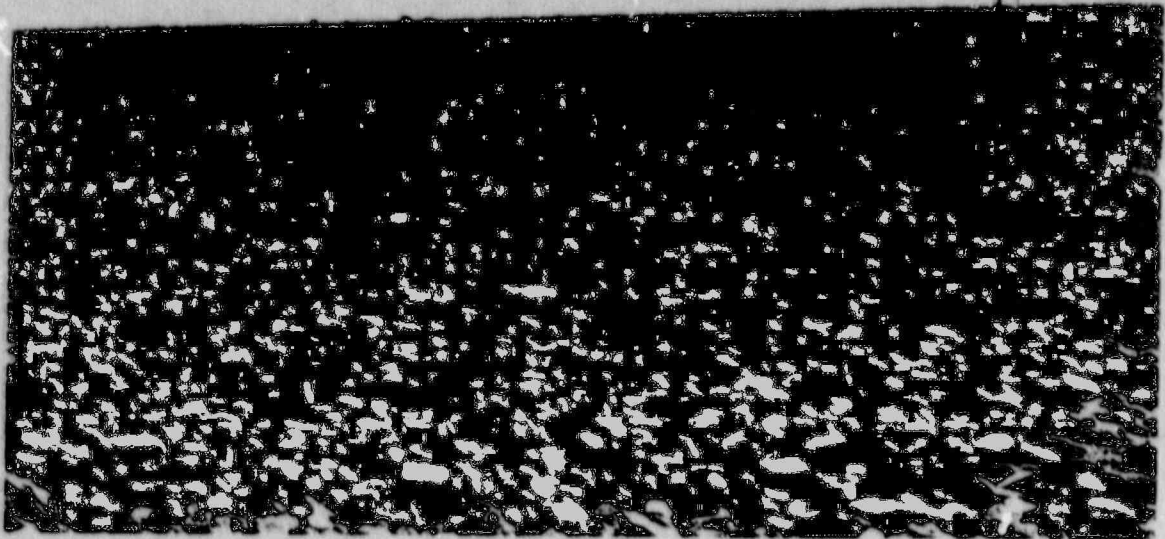
Photo 8 - Downstream Slope of Embankment - Note areas with vegetative growth indicating poor or no erosion protection.

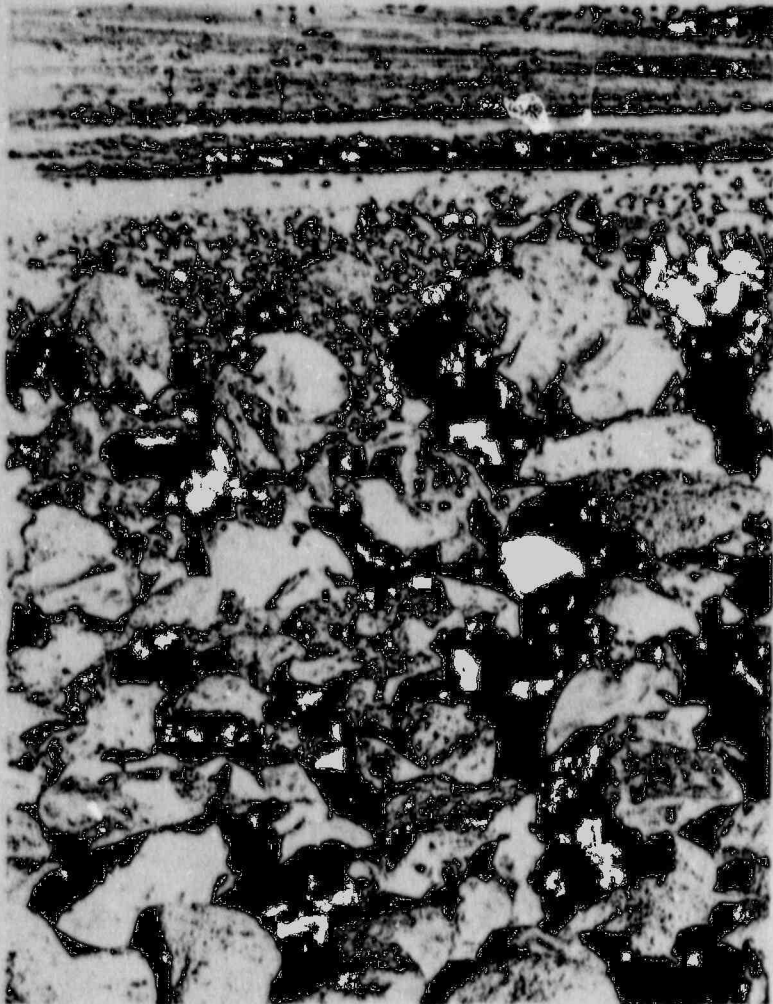
Photo 10 - Large Riprap in Swale

Note pockets of small bedding and bare spots.

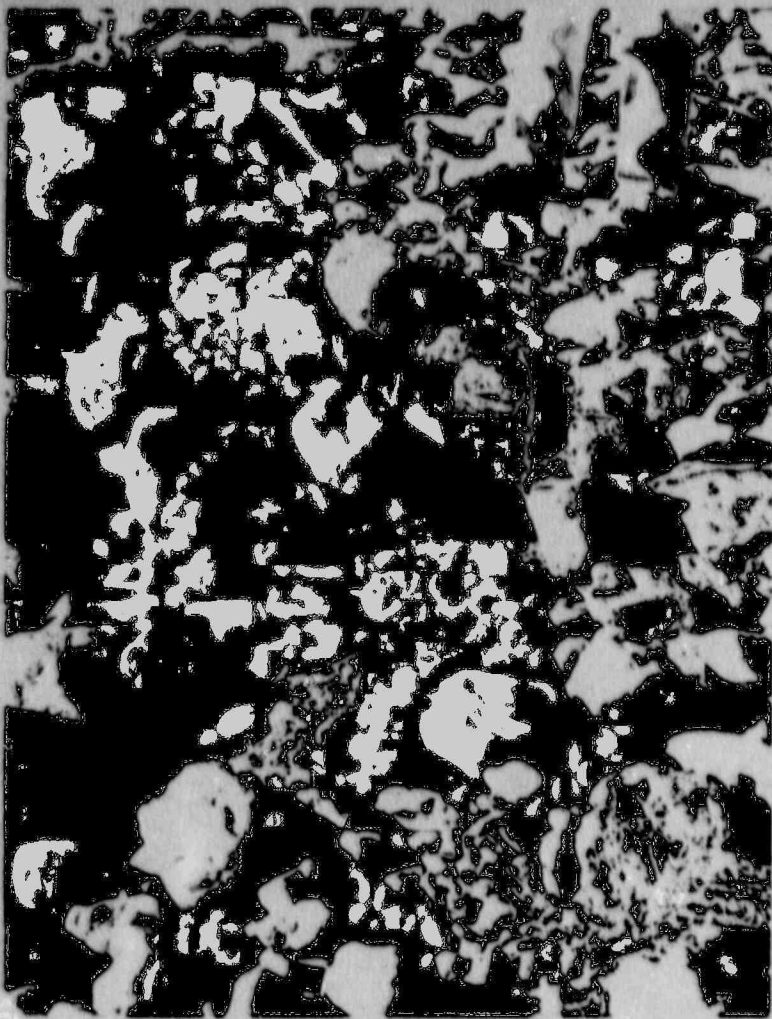
Photo 11 - Downstream Slope
of Embankment

Typical area of poor erosion
protection.

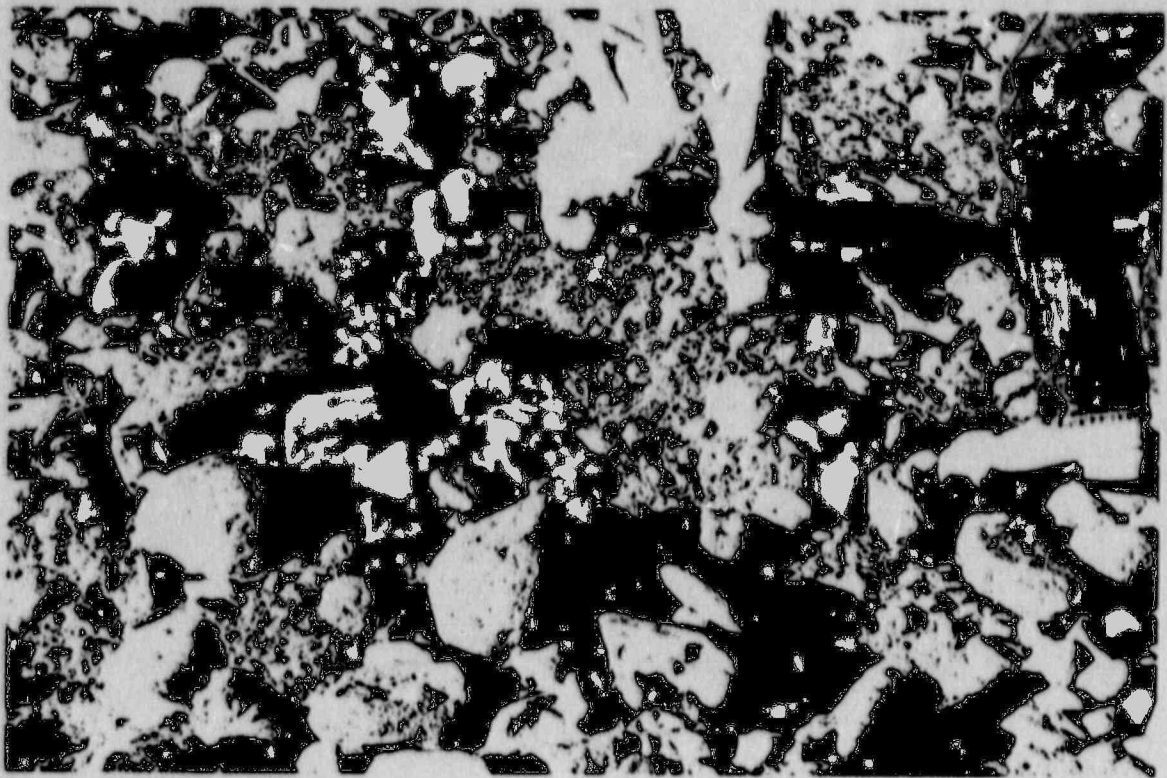
Photo 12 - Downstream Slope of Embankment - Typical area of
poor erosion protection.
