MAINE YANKEE ATOMIC POWER COMPANY
ENGINEERING OFFICE

Subject: Response to I&E Bulletin No. 79-15

Attachment A

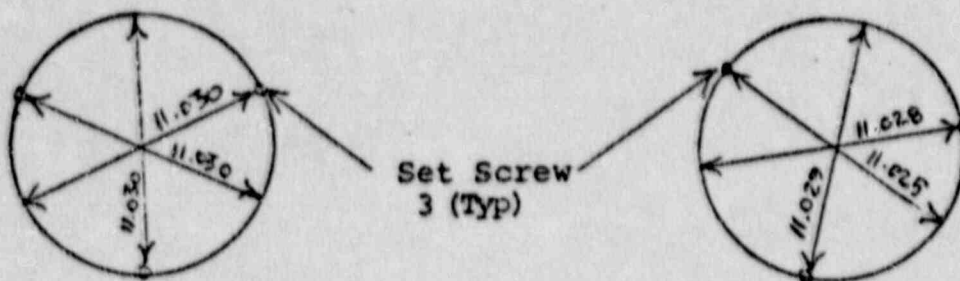
Part of the nut from the outlet check valve was found by a diver under the pump inlet in the circ. water pump bay after having dropped through the pump. When the nut went by the stationary wear rings, it caused the stationary wear rings to rotate approximately one inch causing the ring to roll over its three set screws.

This then caused a bulge in the area of the set screws. The old set screws were drilled out to relieve this problem and three holes were drilled and taped for new set screws. Upon completion, the following stationary wear rings were recorded.
