Portland General Electric Company  
Trojan Nuclear Plant  
71760 Columbia River Hwy  
Rainier, Oregon 97048  
(503) 556-3713

Licensee Event Report No. 89-16, Revision 1, is attached. This report discusses an event in which the containment recirculation sump was found not to be in accordance with design requirements.

LICENSEE EVENT REPORT (LER)

TITLE (4) Inadequate Management Oversight, Procedure Deficiencies and Personnel Errors Result in Power Operation With An Inoperable Recirculation Sump

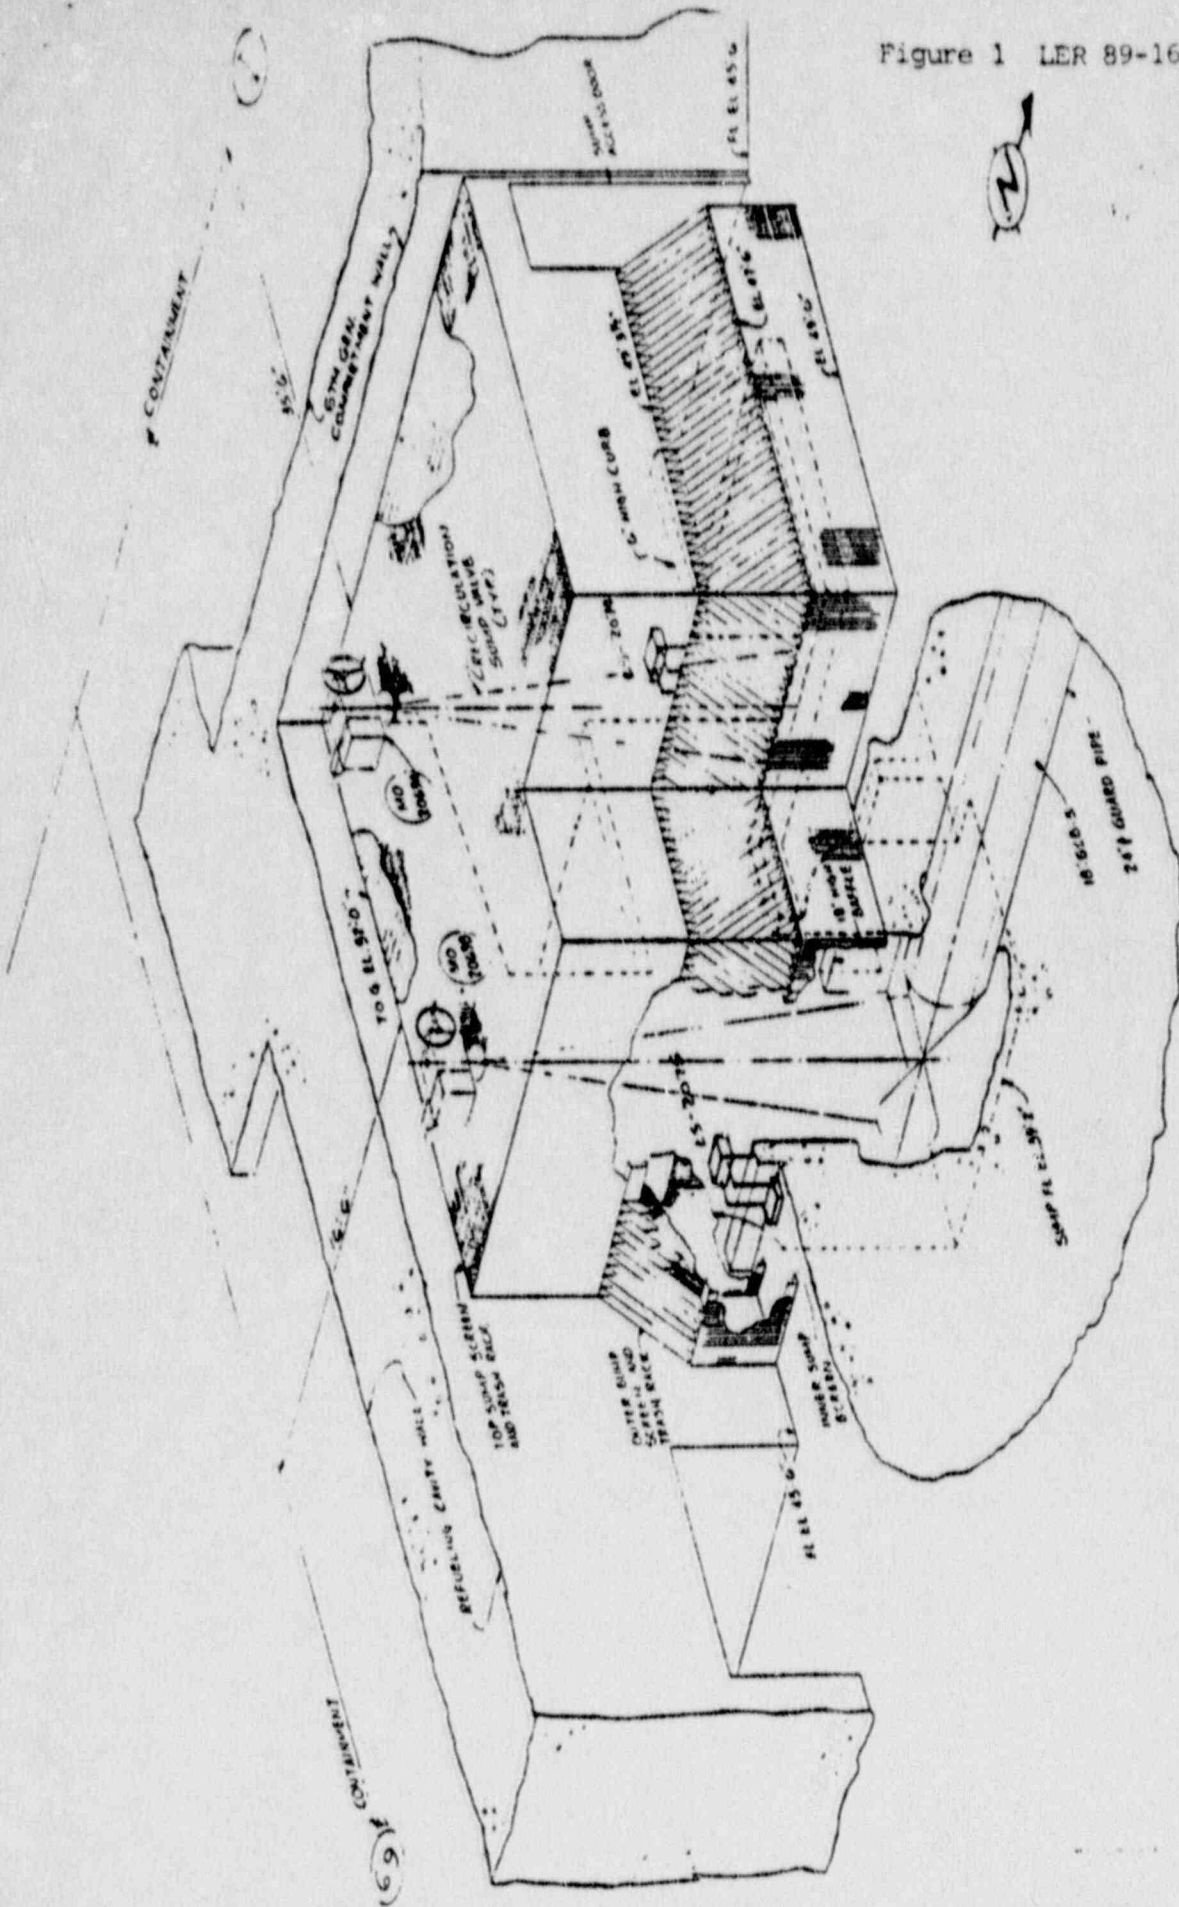
Figure 1 LER 89-16 - Rev. 1

Figure 1 / Containment Recirculation Sump

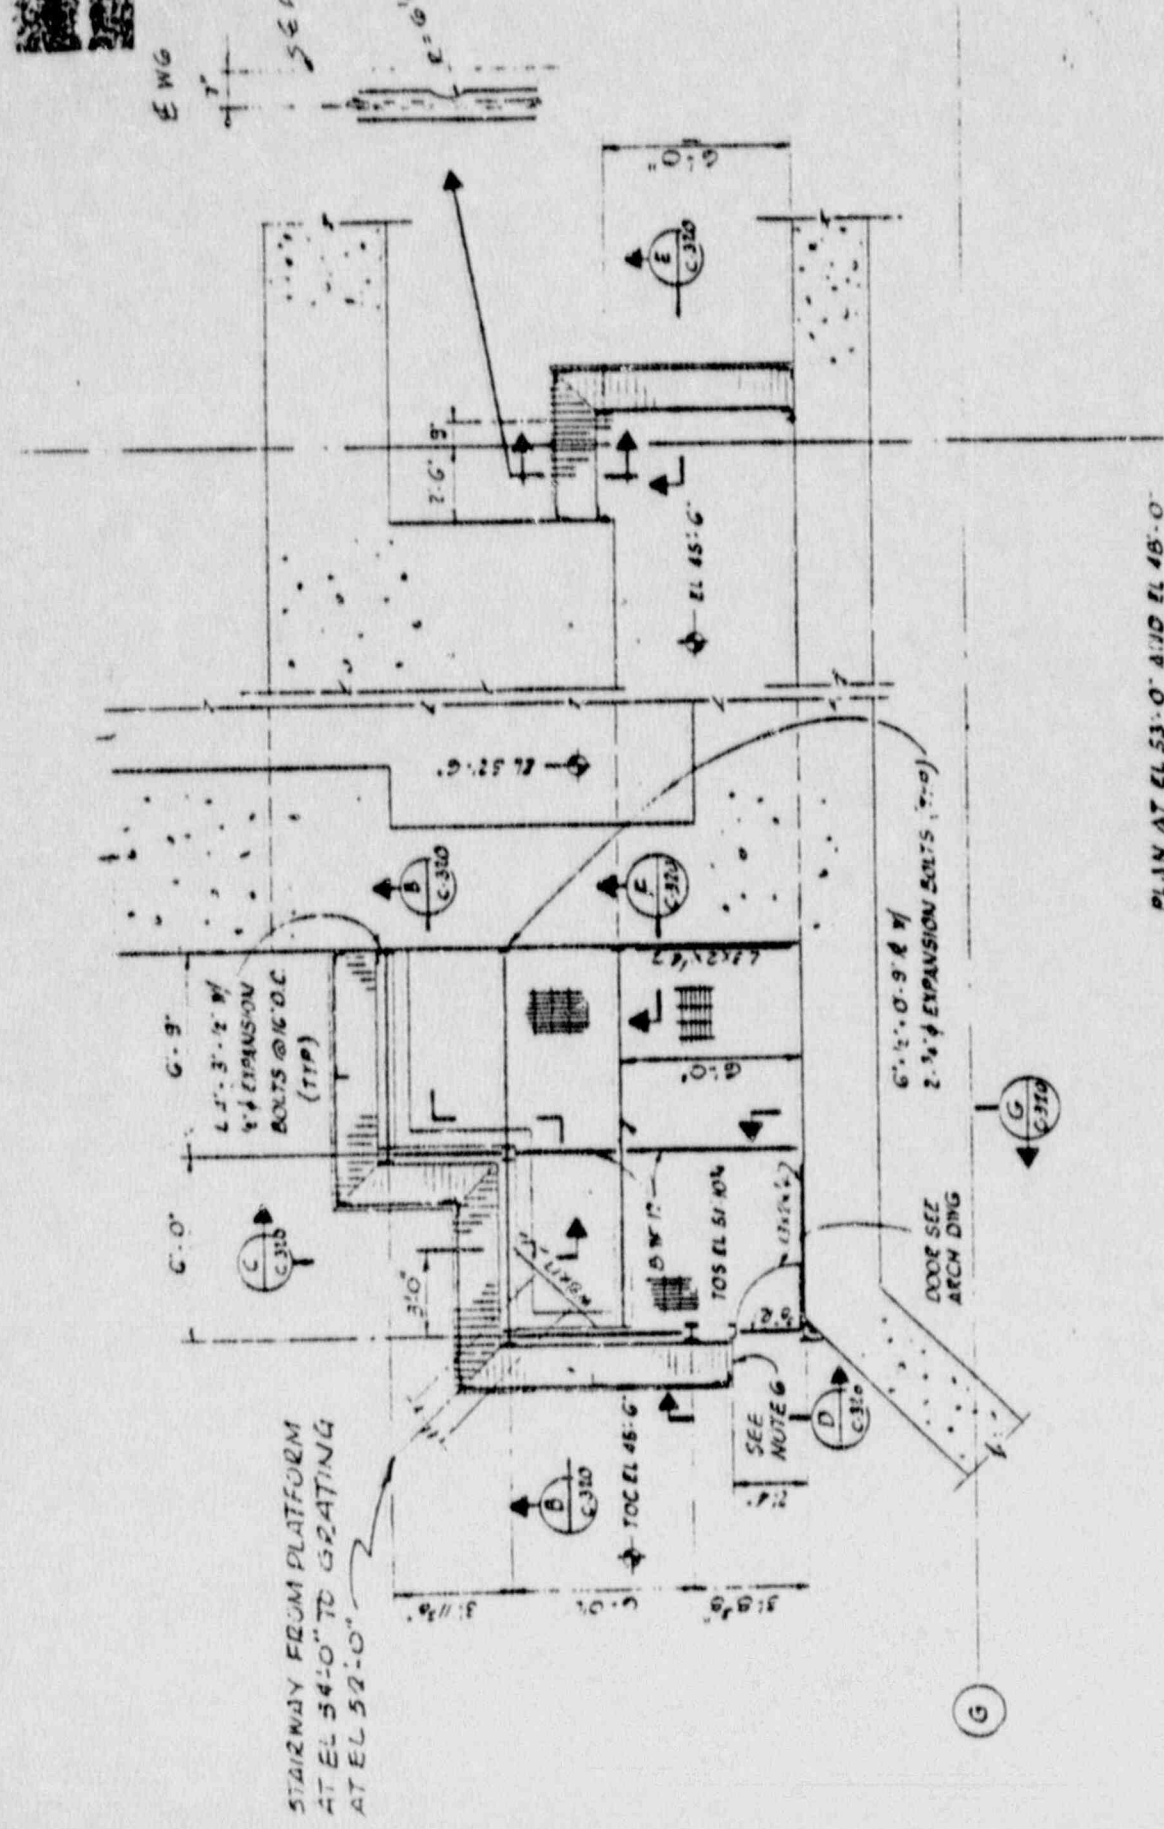
Figure 2 LER 89-16 - Rev. 1

SCREEN FRAMING AROUND THE RECIRCULATION SUMP
