November 8, 1989

Samuel Fry, Engineer in Charge  
Engine Starting Systems  
Ingersoll Rand Corporation  
7500 Shadwell Drive  
Roanoke, VA 24019

NRC INFORMATION NOTICE NO. 89-XX: FAILURE OF INGERSOLL RAND AIR START MOTORS  
AS A RESULT OF PINION GEAR ASSEMBLY  
FITTING PROBLEMS

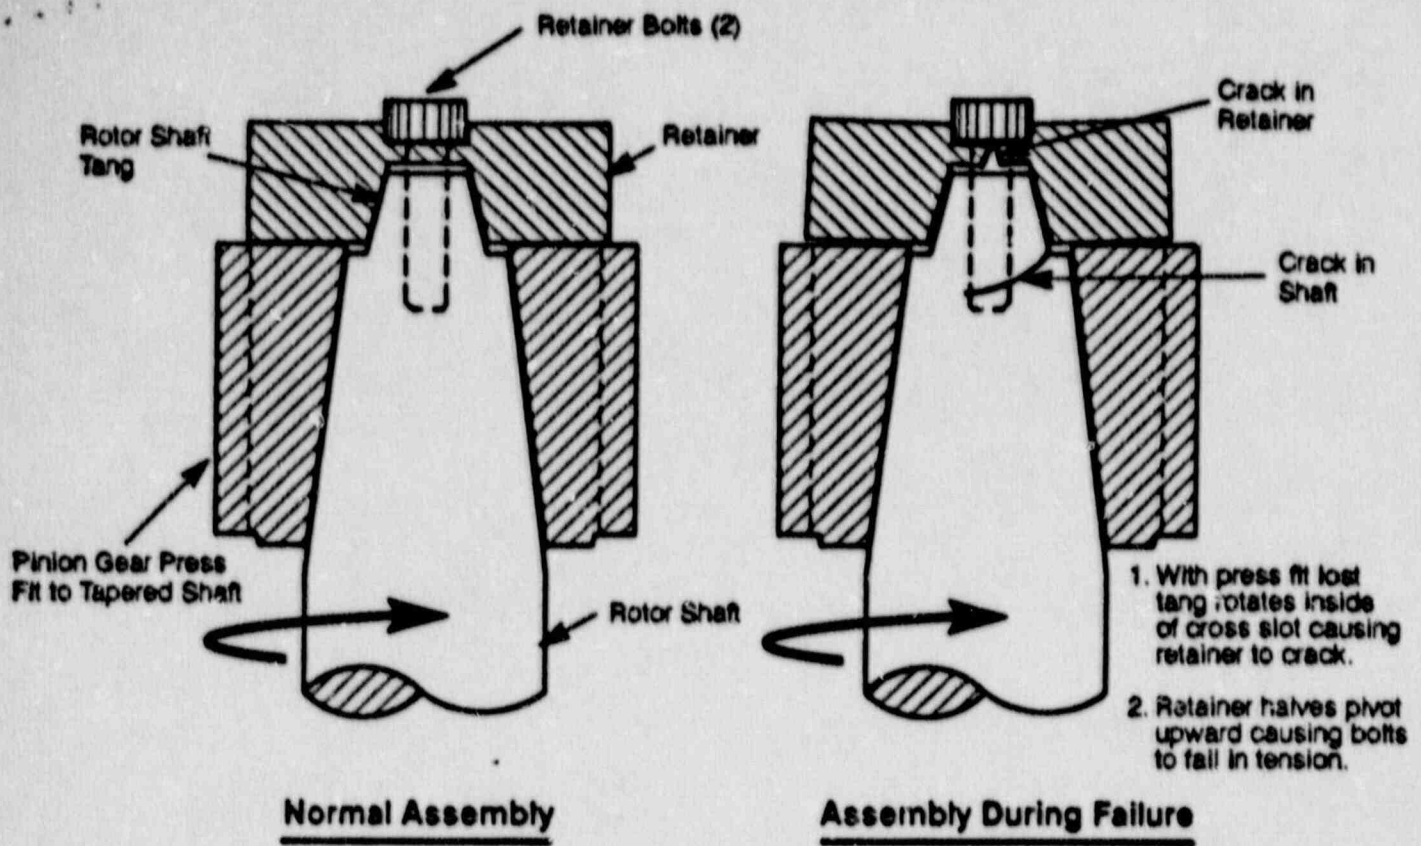
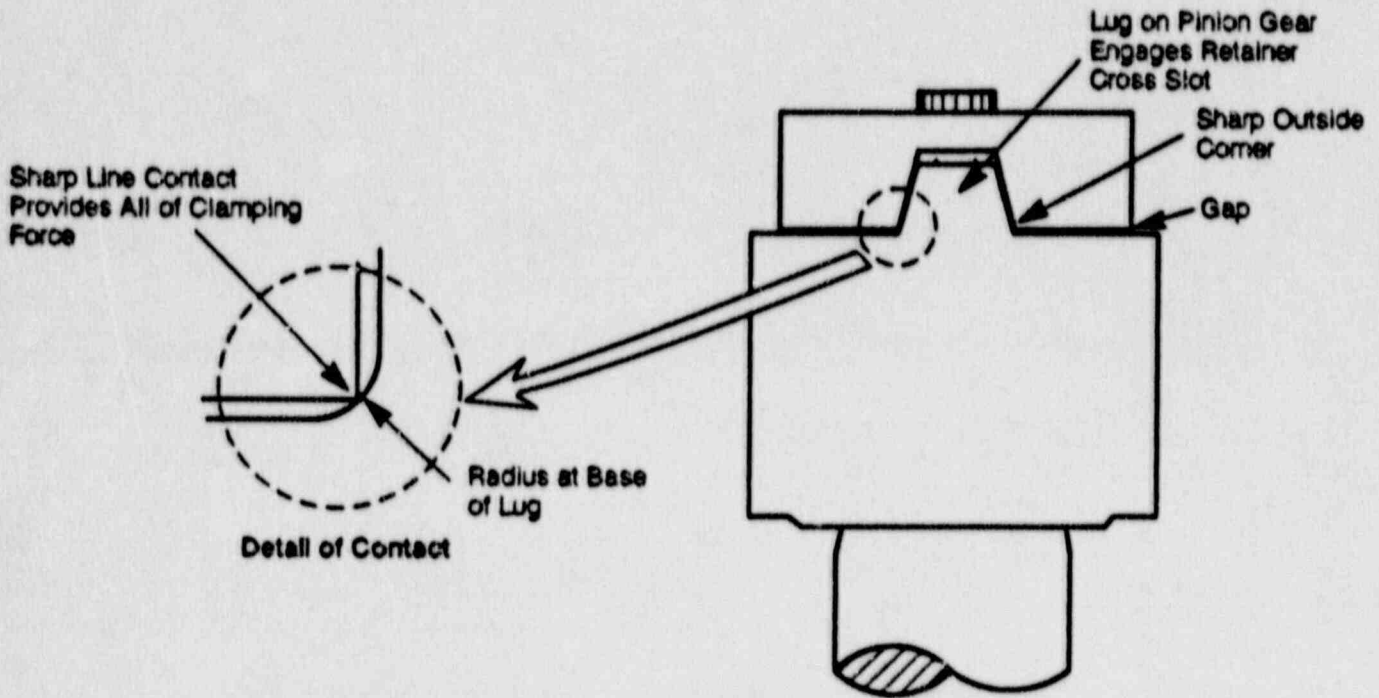
**Figure 1 Rotor Shaft and Pinion Gear Assembly**

On February 1, 1989, during the performance of a surveillance test at Diablo Canyon Unit 1, the number one emergency diesel generator failed to start. Each diesel generator at this plant is started by four Ingersoll-Rand air start motors, two of which are controlled by the primary dc power source and the other two by the backup dc power source. In accordance with the normal test procedure, the backup dc power source was disabled during the test. After repeated tests showed that the diesel generator could not be started with the primary dc power source but could be started with the backup dc power source, the two primary start motors were disassembled for inspection. Both motors were found to have broken pinion gear retainers that allowed the start motor rotor shaft to turn without driving the pinion gear (see Figure 1). In addition, both motors had broken and bent retainer bolts and cracks in the rotor shafts.

inspected, and a total of 10 were found to have cracks in their rotor shafts. Many motors had pinion gears or pinion gear retainers and retainer bolting that were loose. All of the motors with cracked shafts had well-developed wear patterns on the retainers and on the tangs at the ends of the rotor shafts that engage slots in the retainers, indicating that the pinion gears had been loose for a long time. In two cases, the retainer bolts had backed out until the retainer was on the point of becoming disengaged from the rotor shaft tang.

The basic cause of the air start motor problems at Diablo Canyon was loss of the pinion gear to shaft press fit as a result of an inadequate fitting of the shaft, pinion gear, retainer, and bolting. This loss allowed the pinion gear to slip on the shaft, forcing the retainer to transmit the full torque of the motor. This situation caused abnormal wear of the retainer and of the tang on the end of the shaft, cracking and deformation of the tang, and the loosening and backing out of the retainer bolts. Eventually two retainers for the start motors on diesel generator 1-1 failed completely, preventing the diesel generator from starting.

The loss of contact was attributed to a number of subsidiary problems, including poor fit between the pinion gear and the shaft surfaces, dirt on the surfaces, lack of "setting" pressure on the pinion gear during assembly onto the shaft, and incorrect torquing of the retainer bolts. However, the main problem appears to have been improper fit between the retainer and the pinion gear. As shown in the detail on the lower half of Figure 1, there is a sharp angle at the transition between the retainer inner surface and its slot wall. On the mating surface of the pinion gear, however, there is a radius between the side of the lug and the outer flat surface of the gear. As a consequence, the sharp edge of the retainer slot presses on the curvature of the radius at the base of the pinion gear lug. This small contact area eventually degenerates as a result of shock loading, relieving the pinion retainer clamping force. This problem was identified on 13 of the air start motors at Diablo Canyon.

**Assembly Showing Poor Fit Between Retainer and Gear**

The corrective actions for this problem included the replacement of all of the damaged parts, using revised reassembly procedures. The reassembly procedures included lapping and blueing checks to ensure the correct fit. The procedures also specified the correct retainer bolt torque and the use of lock washers and lock wiring to maintain the correct retainer force on the pinion gears. In addition, measures were taken to ensure that the start motor air header pressures would be maintained below 160 psi.
