PRELIMINARY NOTIFICATION OF EVENT OR UNUSUAL OCCURRENCE -- PN-

Facility: Florida Power Corporation  
Crystal River 3 (DN 50-302)

Subject: Spalling of Containment Dome

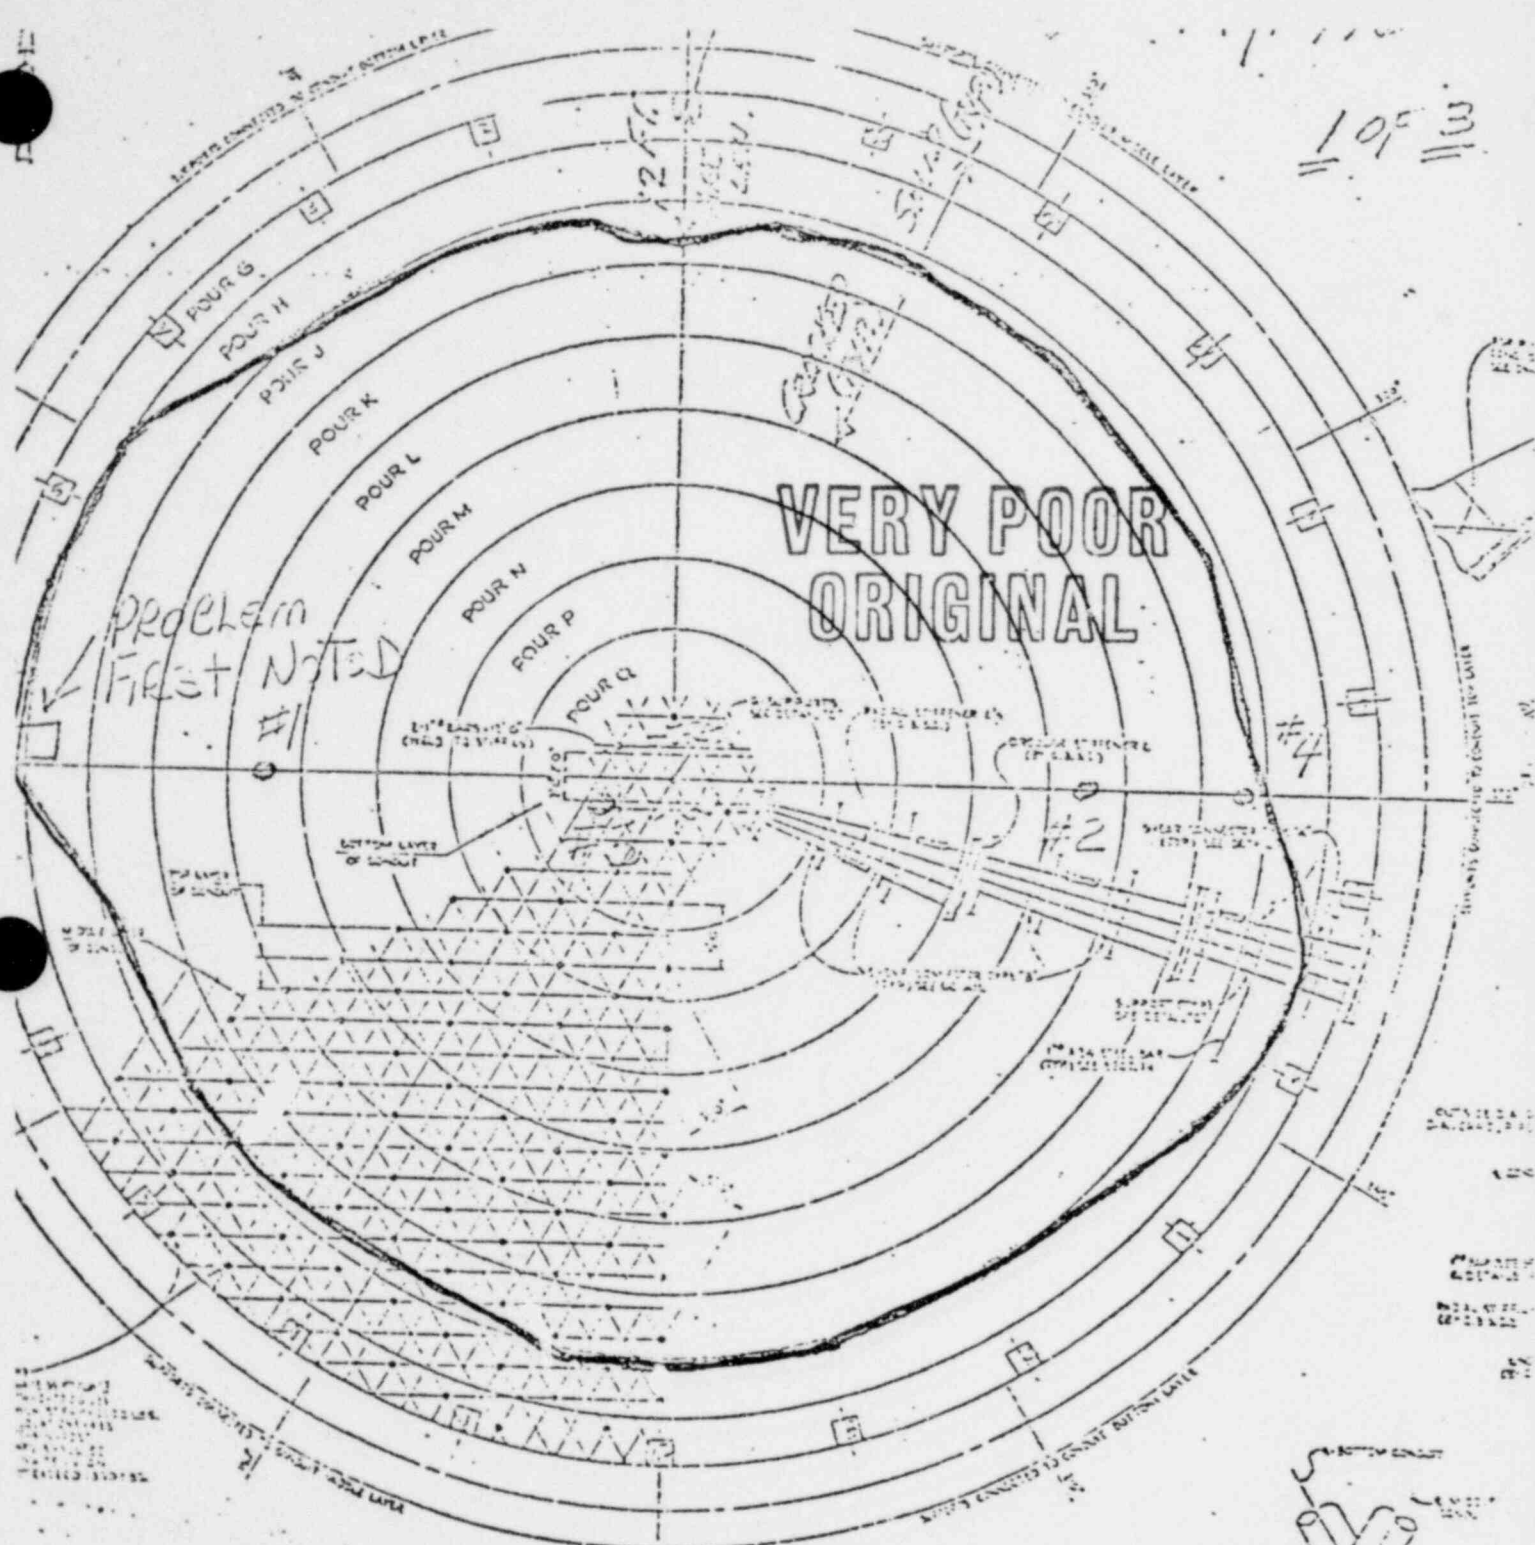
PLAN VIEW

Problem First Noted #1

Problem #2

LINE BETWEEN GOOD & CRACKED  
PORTION OF RAISED RING DOME

BASED ON SECTIONING AND TEST RESULTS
