1. Abnormal Occurrence Report No. 50-313/74-11A
2. Report Date: January 22, 1975 3. Occurrence Date: November 7, 1974
4. Facility: Arkansas Nuclear One-Unit 1
Russellville, Arkansas

ATTACHMENT TO AOR 50-313/74-11A

On November 7, 1974, a leak was discovered in a Reactor Building Spray System pipe of Arkansas Nuclear One-Unit 1. The plant was being shut down following hot functional test of the primary coolant drain line, and was going into decay heat mode at the time the leak was detected. The leak was located adjacent to a weld in line HCB-6-1. A segment of the system, including the leak, was replaced and the plant returned to operation. On November 13 a second leak was detected adjacent to a new weld which was made in the original pipe as part of the original repair. Subsequent leaks were also discovered in the spray pumps suction crossover line between valves BW7A and BW7B. These leaks (labeled #3, #4 and #5 in this report) were not considered to be abnormal occurrences since that section of the pipe is isolated under normal modes required for spray system operation. Leak #4 was found in the weld made for the repair of leak #3. Figure 1 is a simplified isometric showing the loc

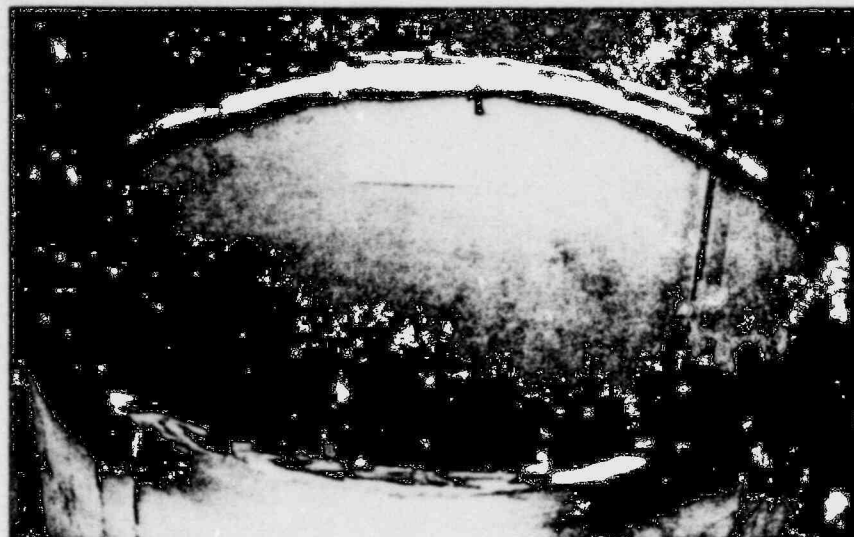
Fig. 1-1 (a) The failed end of sample No. 1 with cracks marked by the arrow.
(b) The inside surface of the crack area.
(c) The outside surface of the crack area.

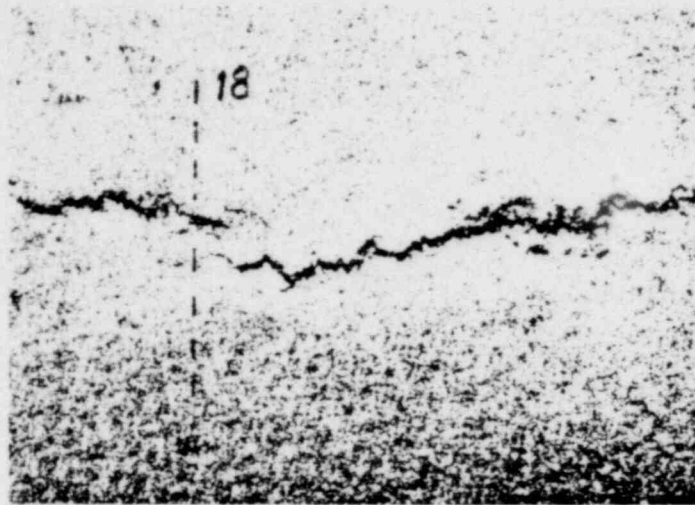
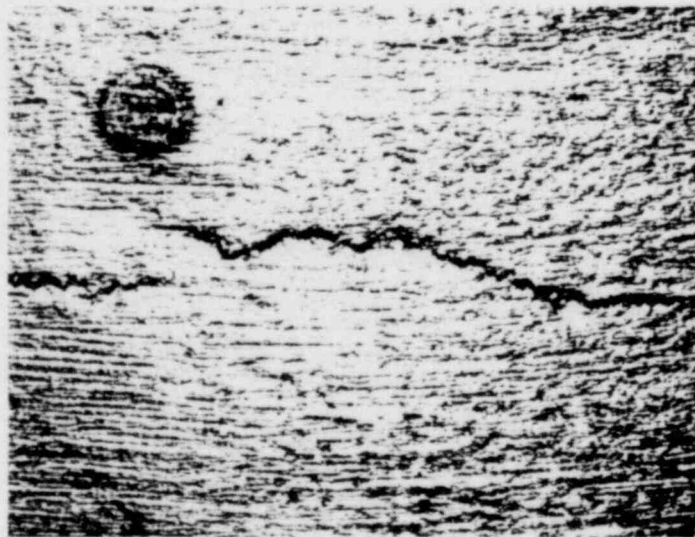
Fig. 1-2 Closeup views of the inside and outside surfaces showing the crack marked by the arrows in Fig. 1-1 (b) and (c).

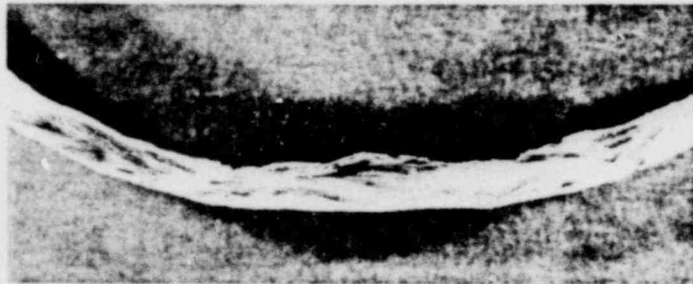
- Fig. 1-3
- (a) The crack on the outside surface.
 - (b) The top view of the cracked region showing flattened circumference.
 - (c) A semi-circular mark on the outside surface about 170° away from the crack. This area was also flattened to about the same extent as in (b).

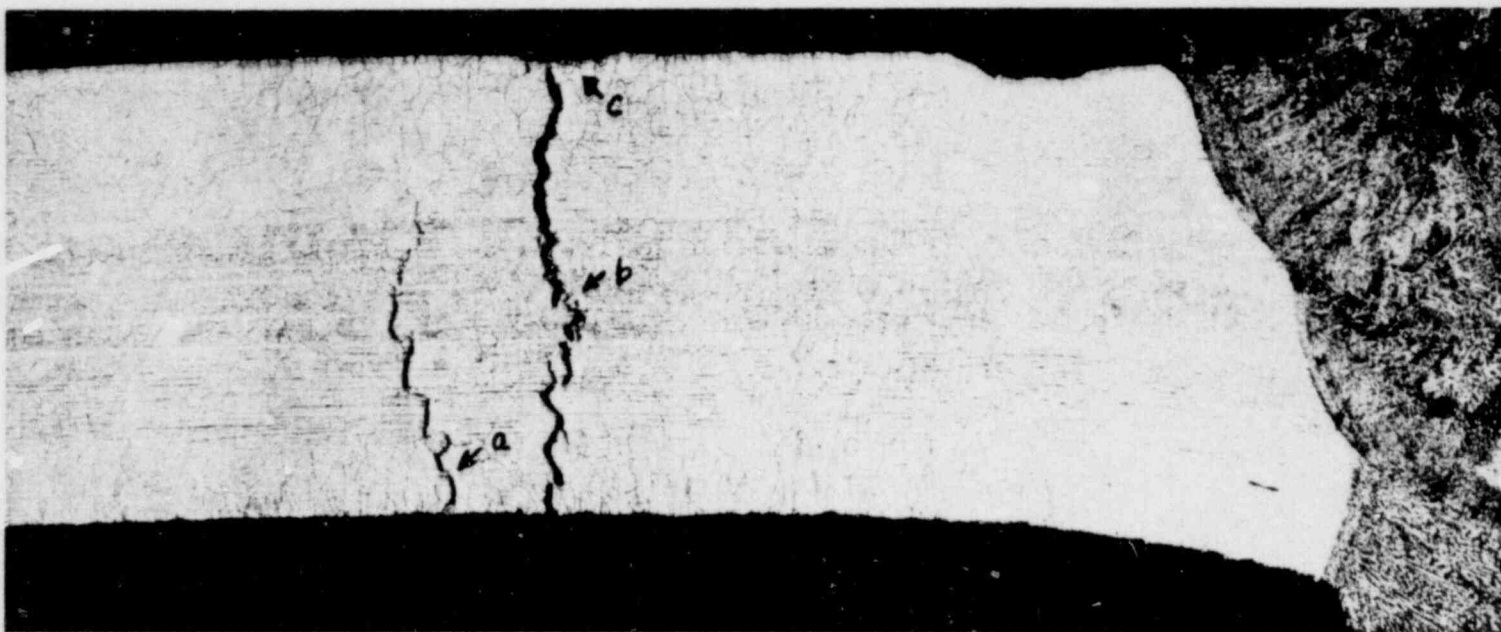
Fig. 1-5 Macrograph of specimen No. 18 showing a section through the crack as marked by the line in Fig. 1-2 (a) and a dotted line in Fig. 1-4. Note relationship of cracking with the weld HAZ.

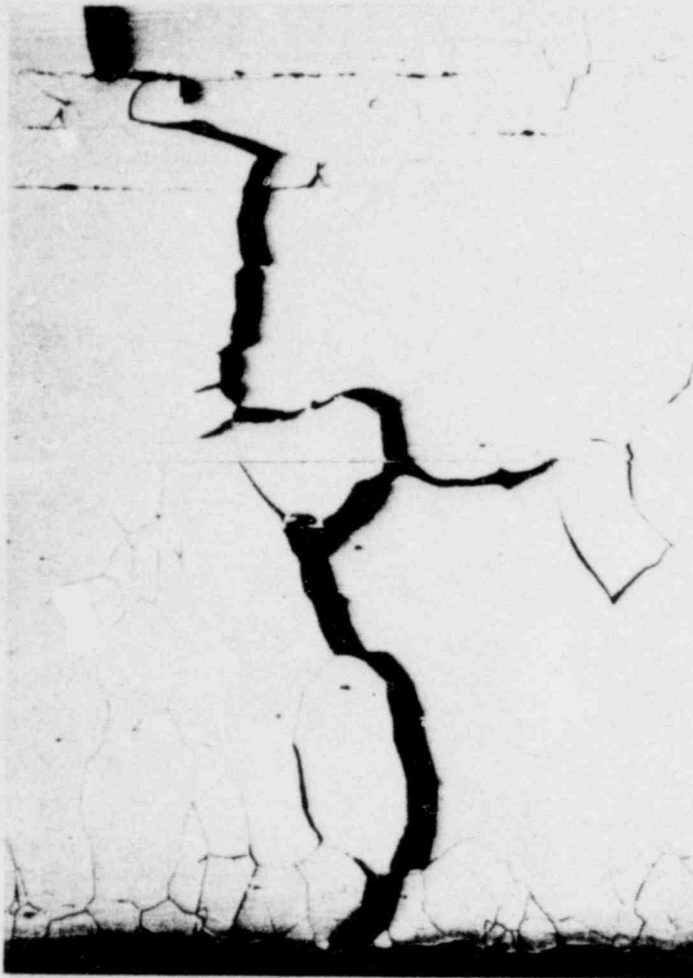
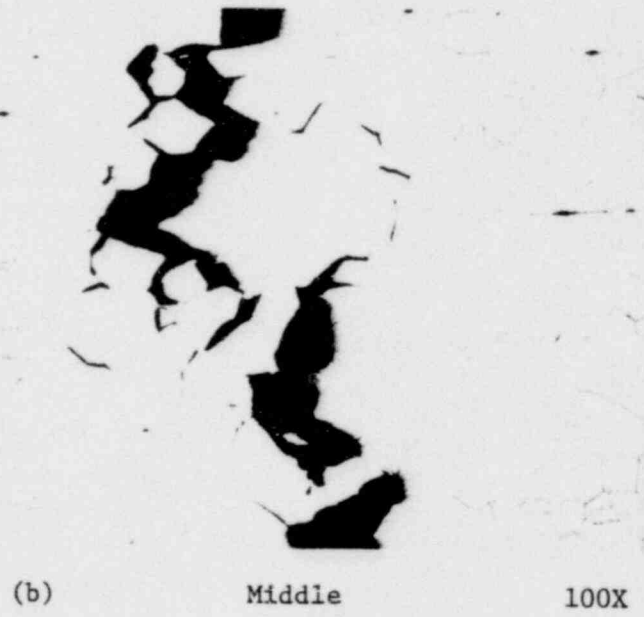
Fig. 1-6 Micrographs showing the intergranular cracks marked by the arrows a and b in Fig. 1-5.

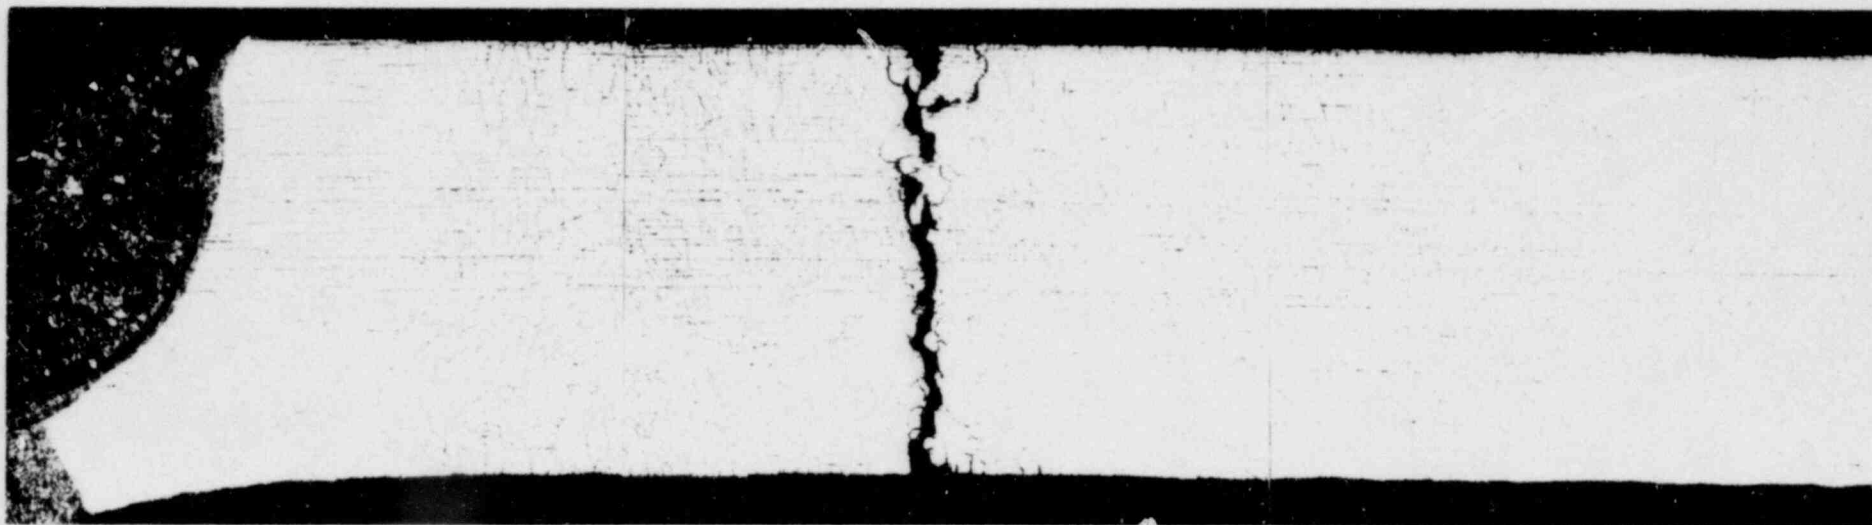
Fig. 1-7 Macrograph of specimen No. 16 showing another section through the crack as marked by a line in Fig. 1-4. The bottom edge is a profile of the inside surface.

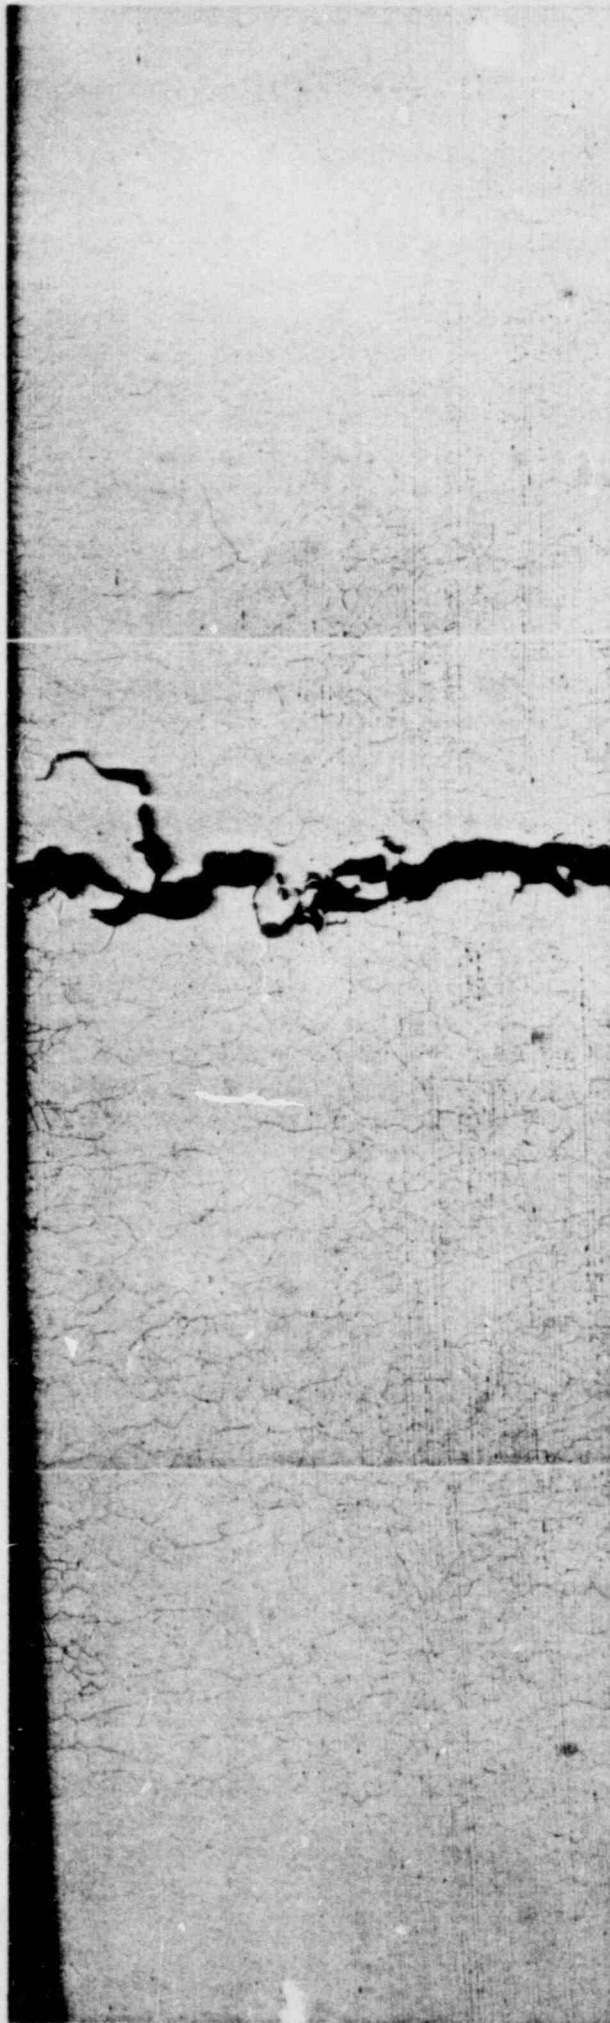
Fig. 1-8 A composite micrograph showing the crack in the far side of the carbide precipitation zone from the weld. The upper edge is a profile of the outside surface of the pipe.

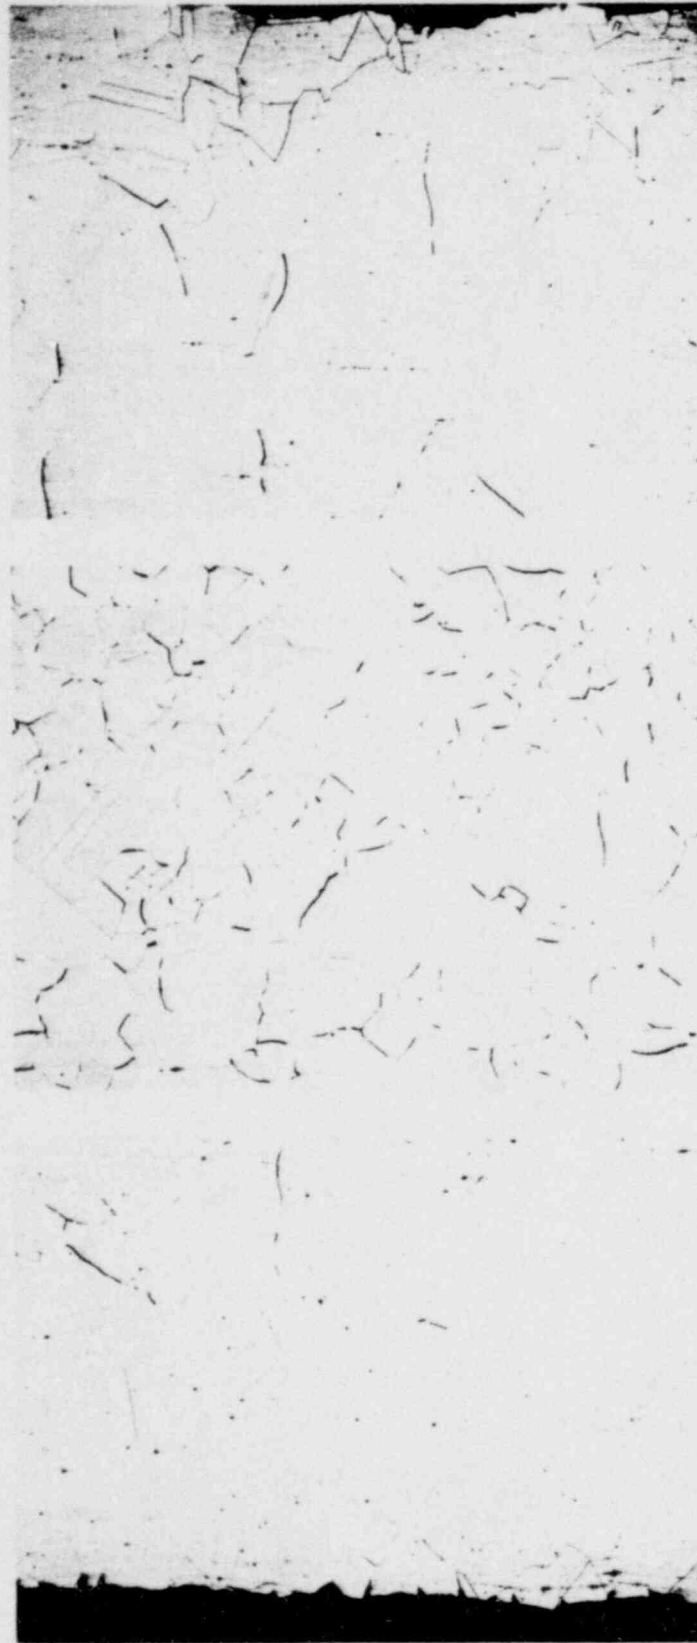
Fig. 1-9 The carbide precipitation in the base metal away from both the circumferential and the longitudinal welds. Note the surface intergranular penetration probably from pickling.

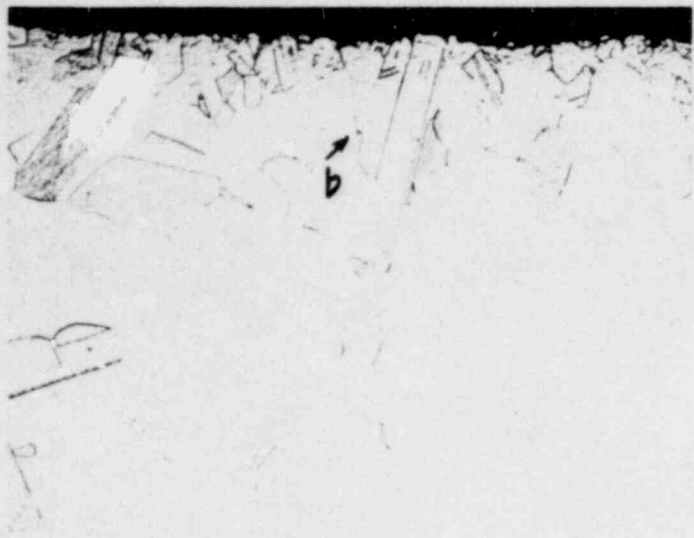
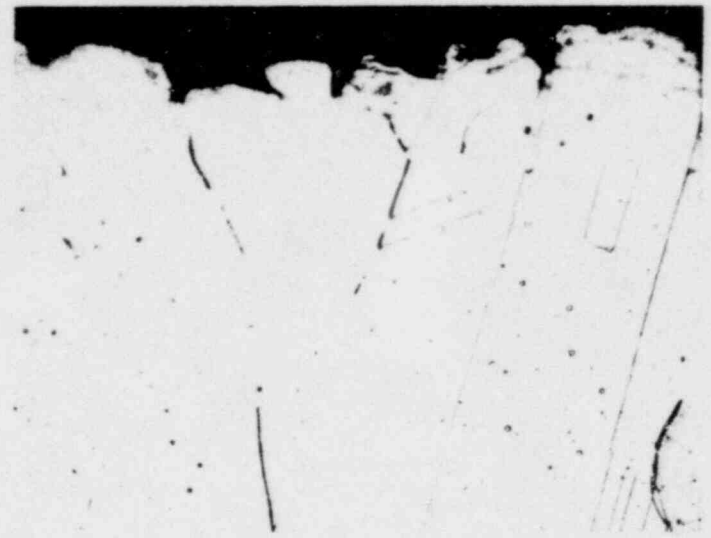
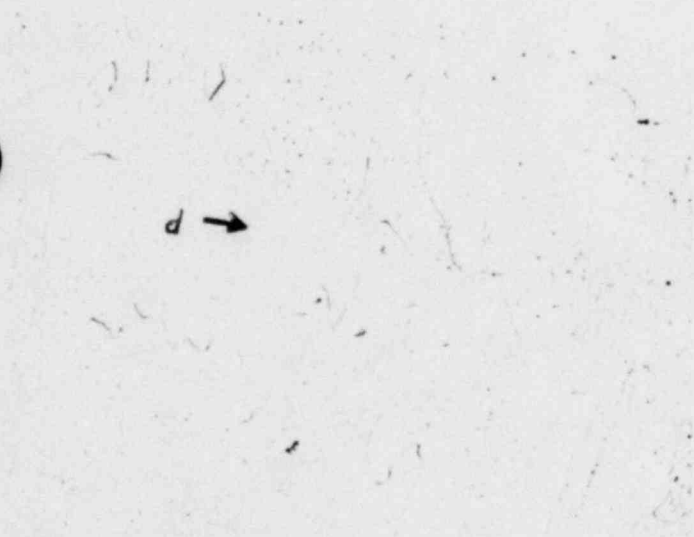
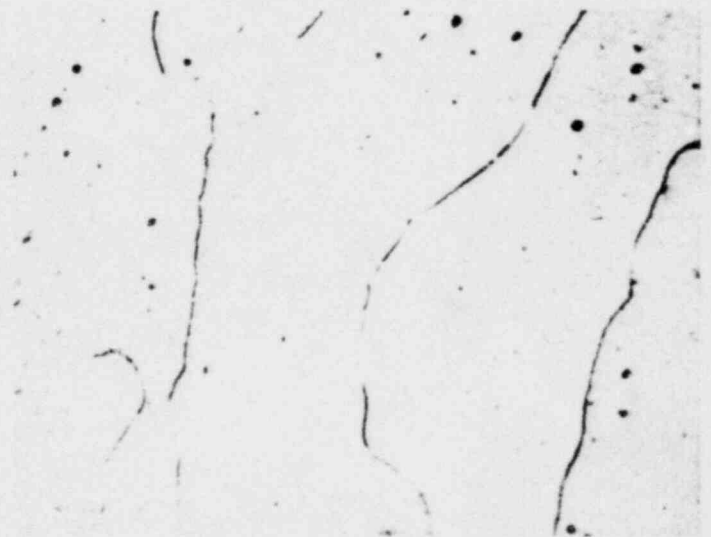
Fig. 1-10 The microstructure of the longitudinal weld showing recrystallized grains, carbide precipitation and intergranular surface attack by pickling. Electrolytic etching in 10% oxalic acid.

These pictures indicate the pipe was solution treated after seam welding.

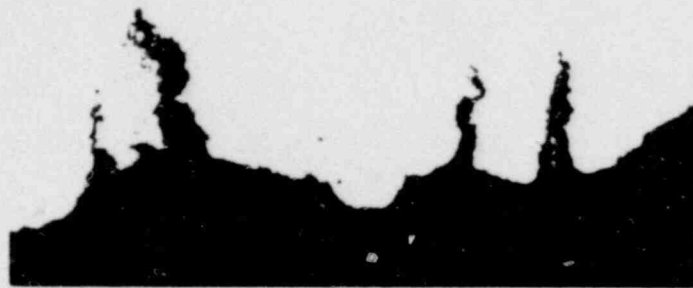
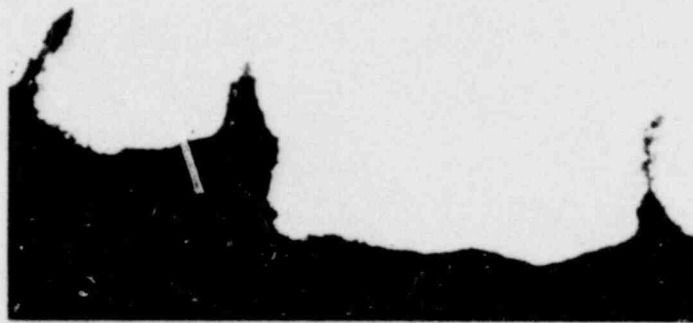
Fig. 1-11 Micrographs showing oxidation (or corrosion) products at the bottom of ditches on the inside surface. As polished.

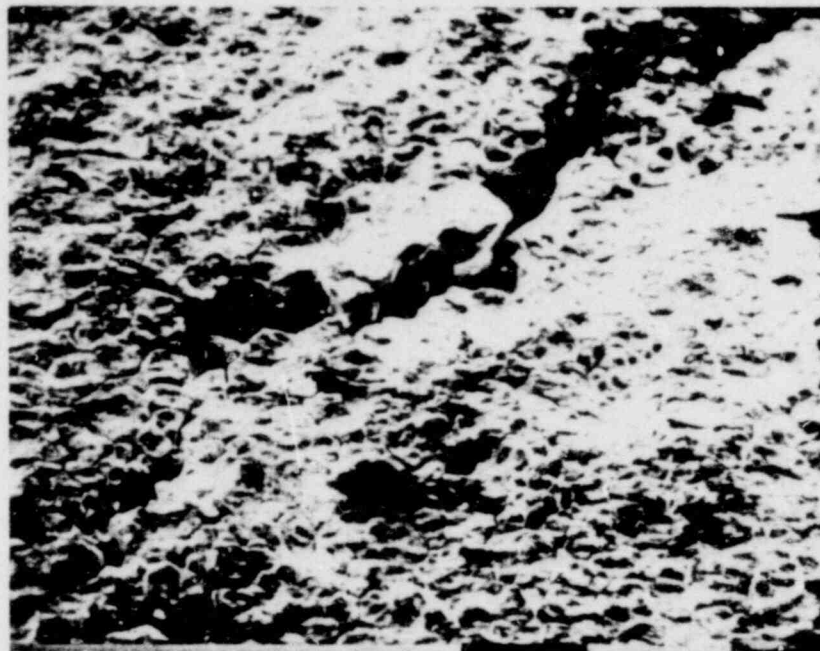
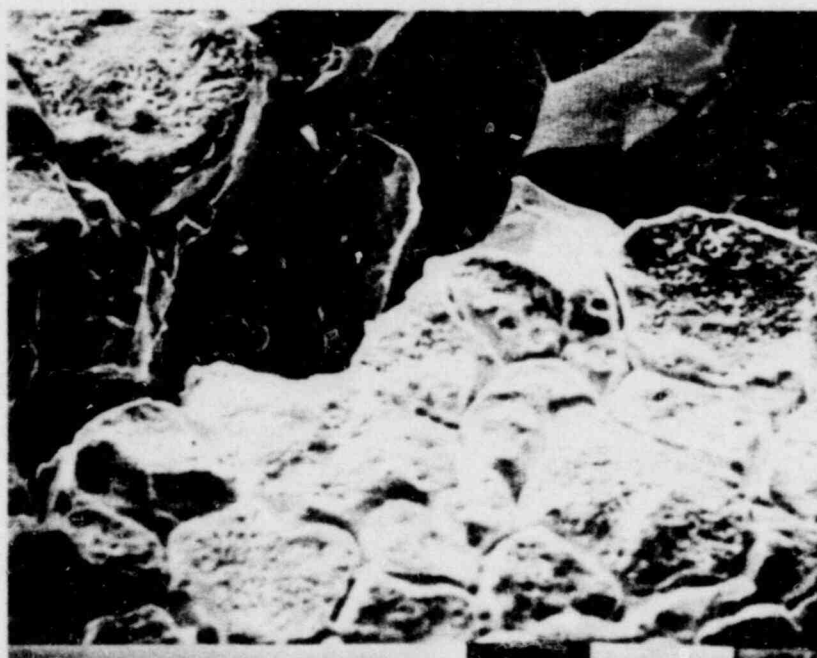
Fig. 1-12 Scanning electron micrographs of the crack as viewed from the inside surface. (b) shows the area marked by the arrow in (a).

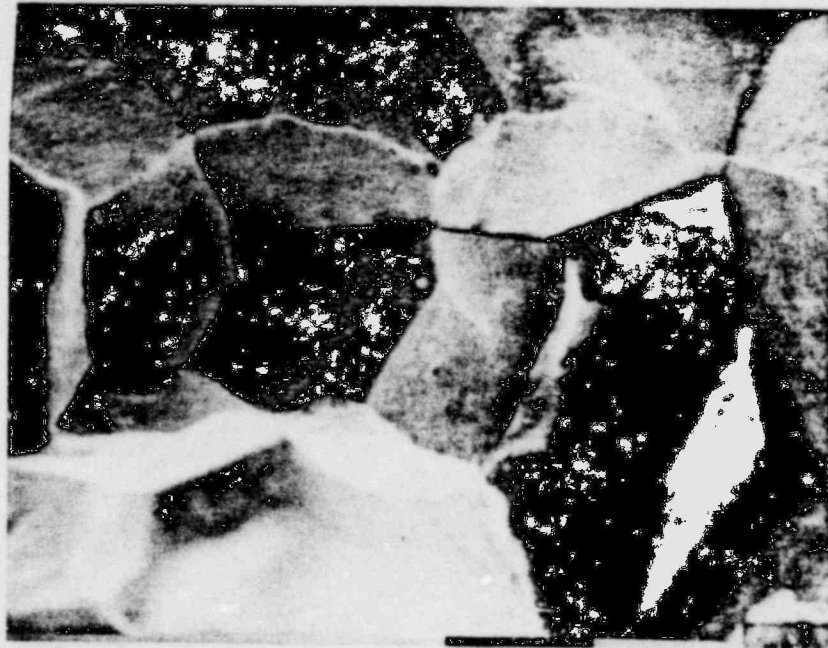
Fig. 1-13 Scanning electron micrographs of the fracture facets in the mid-thickness and near the outside surface.

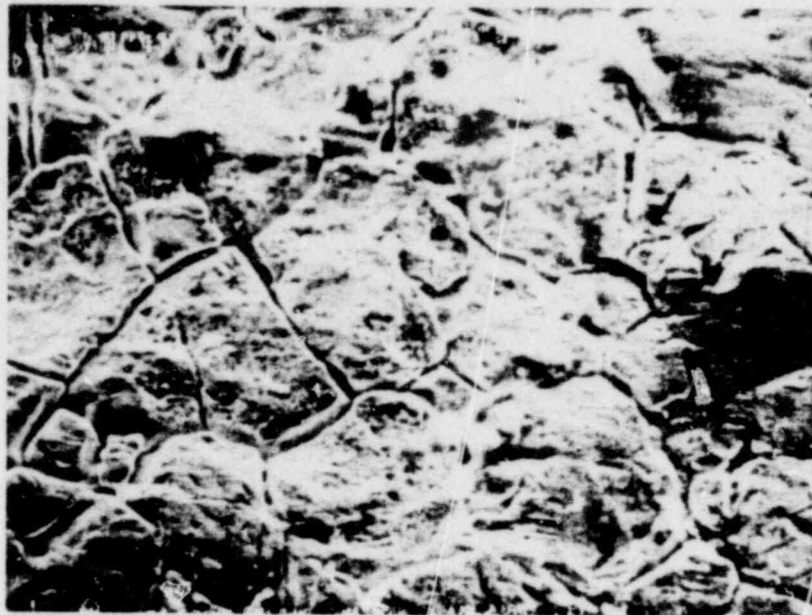
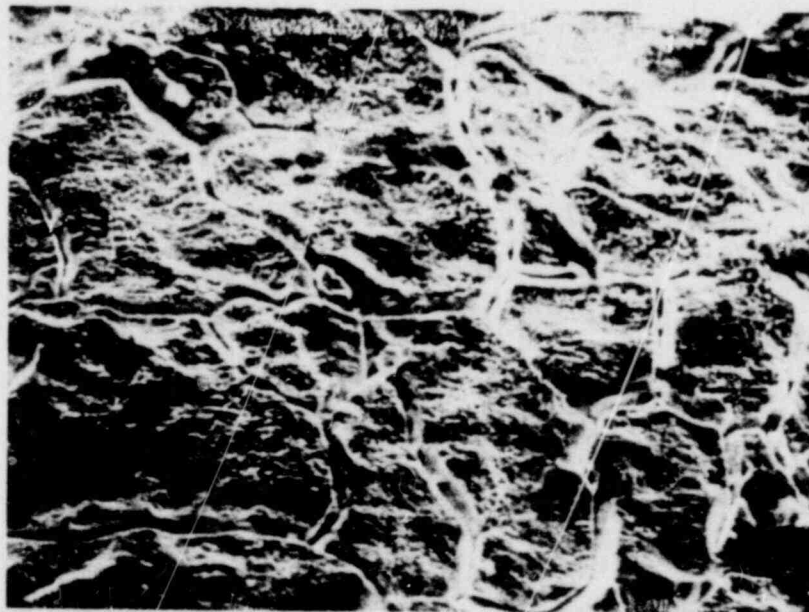
Fig. 1-14 Scanning electron micrographs showing intergranular ditches on both inside and outside surfaces. This is "dried mud cracked" surface apparent at 6X.

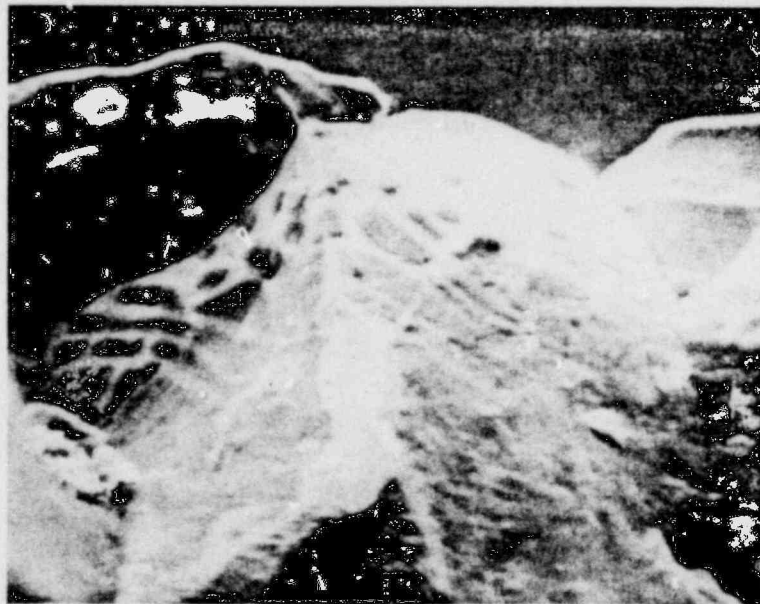
Fig. 1-15 Scanning electron micrographs showing deposit on the fracture facets along the inside surface.

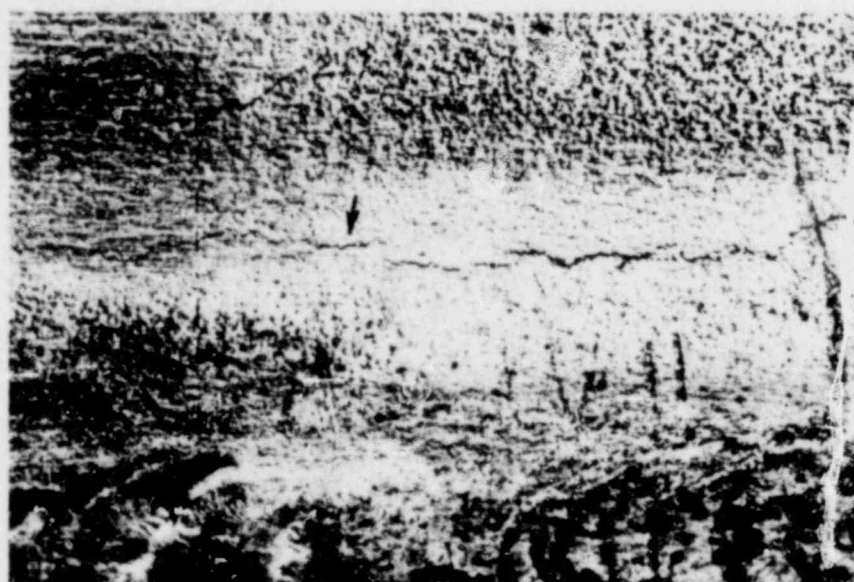
Fig. 2-2 The crack in sample No. 2. The arrows in (a) and (c) show the same area. (b) is a side view of (a).

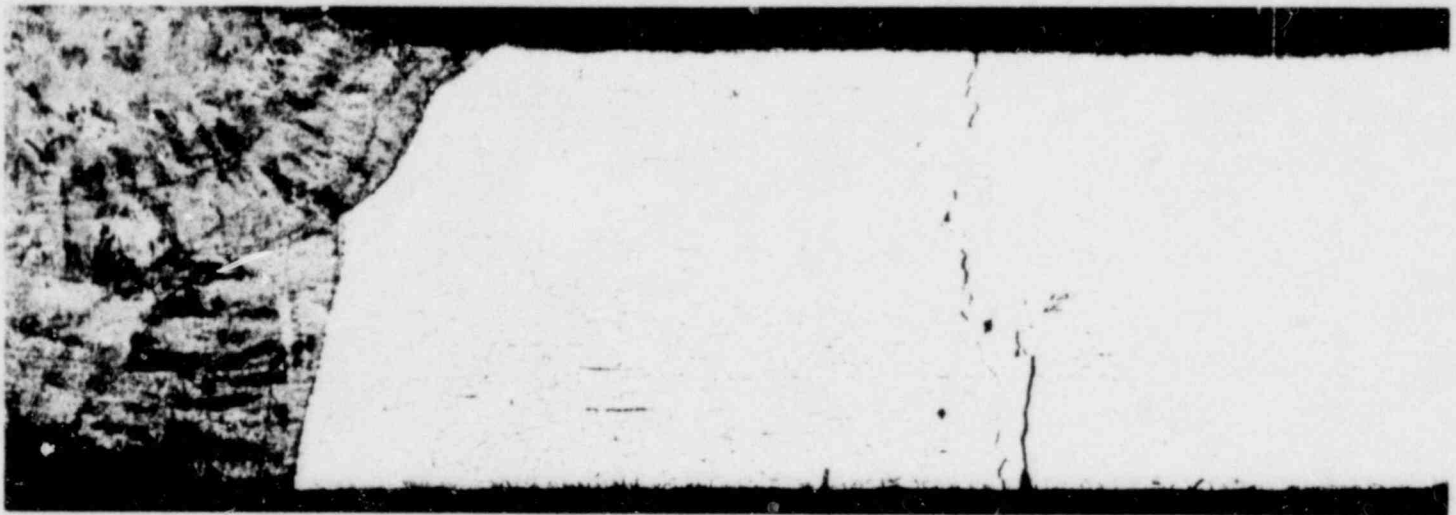
Fig. 2-3 Macrograph of a section through the crack shown in Fig. 2-2.

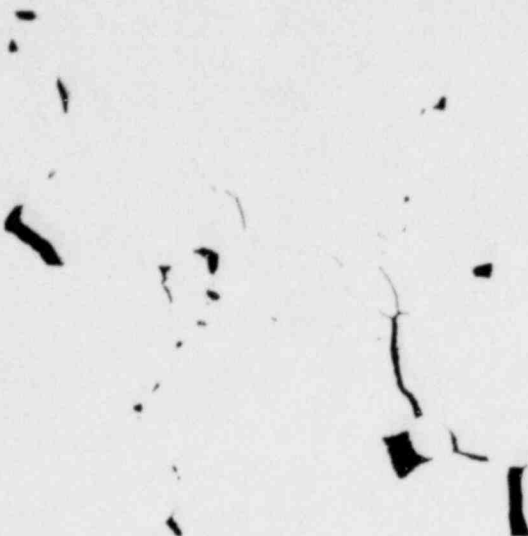
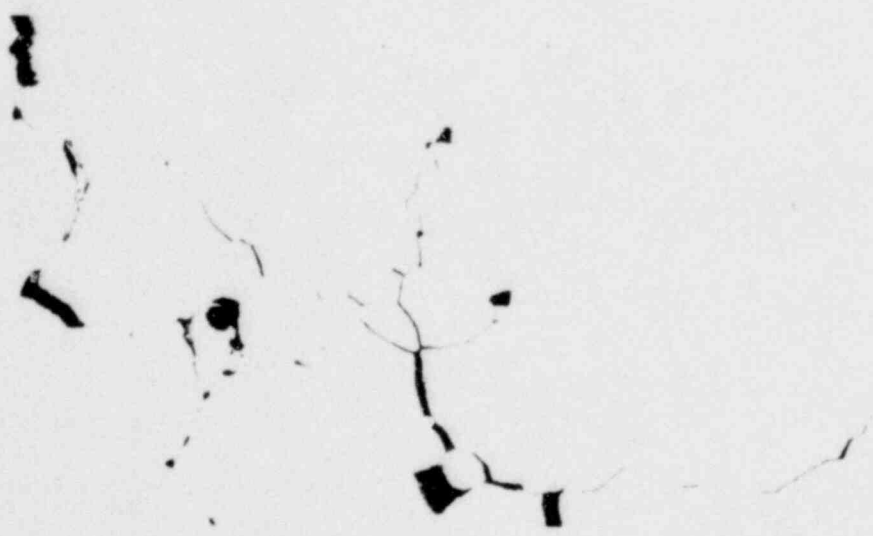
Fig. 2-4 Micrographs showing intergranular cracks marked by the arrow in Fig. 2-3.

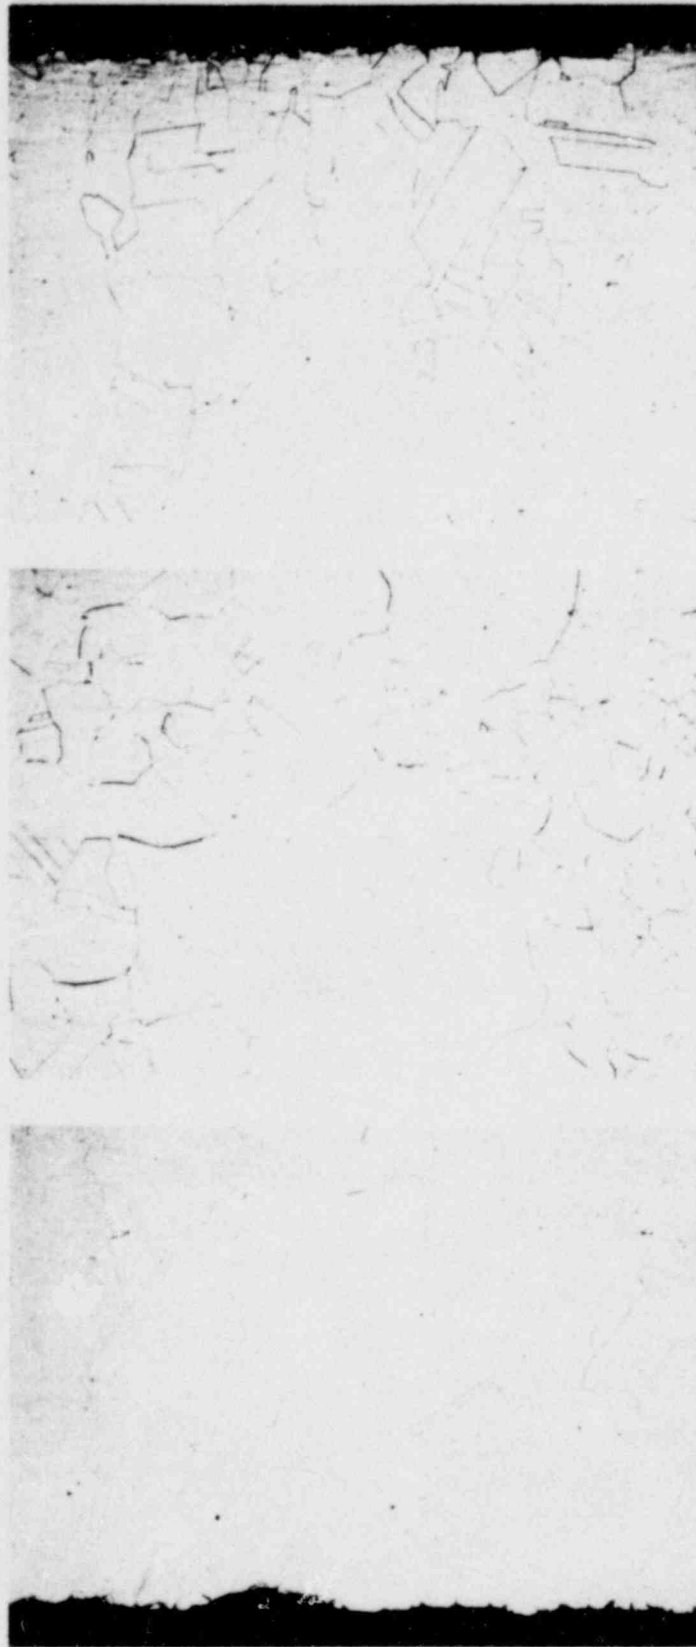
Fig. 2-5 Micrographs showing carbide precipitates in the base metal.
Electrolytic etch in 10% oxalic acid.

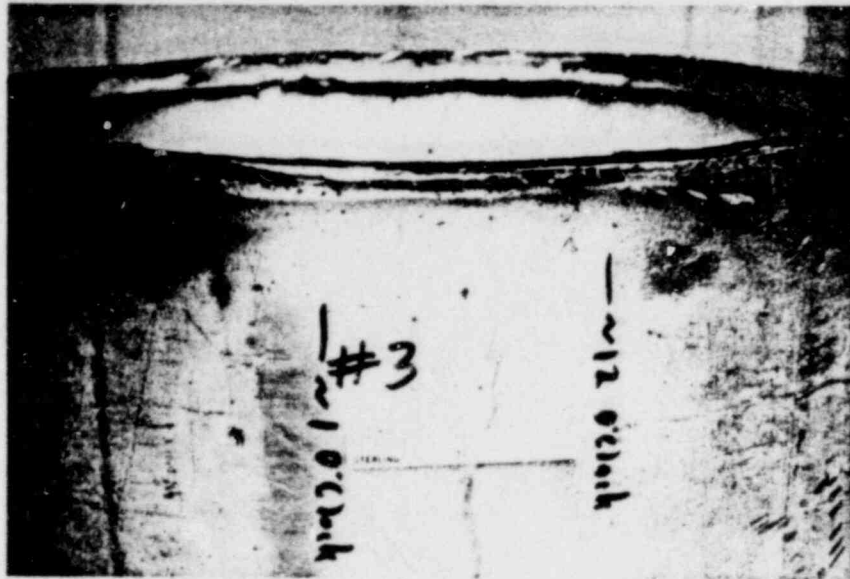
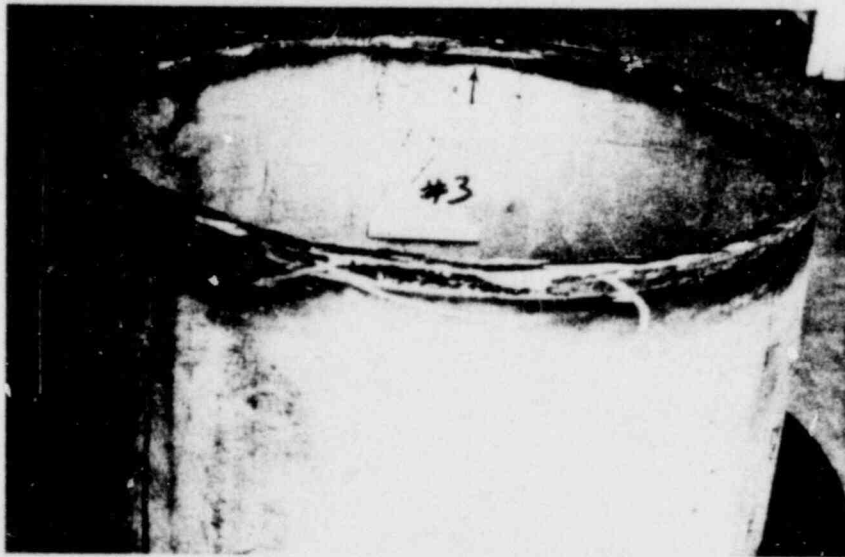
Fig. 3-2 The failed end of sample No. 3. (a) shows the same orientation as Fig. 3-1. (b) is a view from the opposite side. The arrows mark the through crack at the one o'clock position. Both the 12 o'clock and the 7 o'clock positions were flattened.

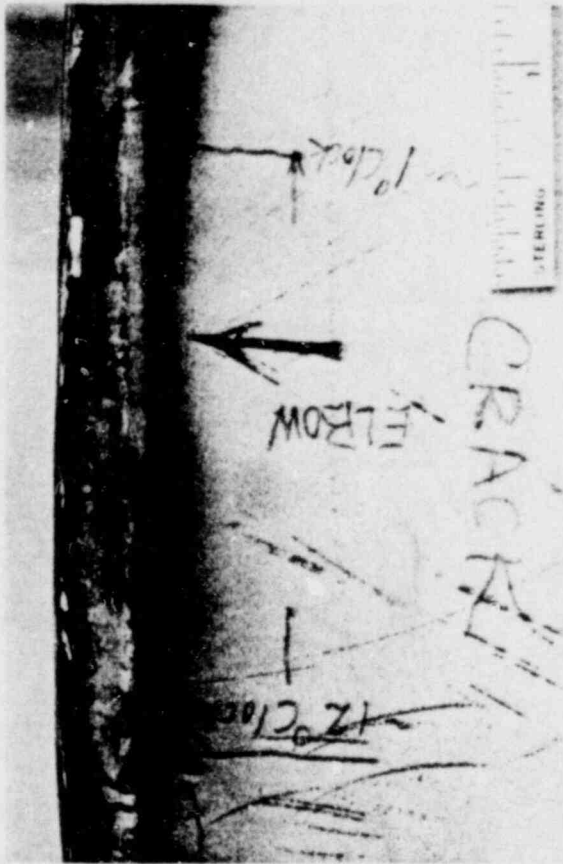
Fig. 3-3 The crack at one o'clock in sample No. 3 as viewed on the inside surface. This crack propagated through the wall.

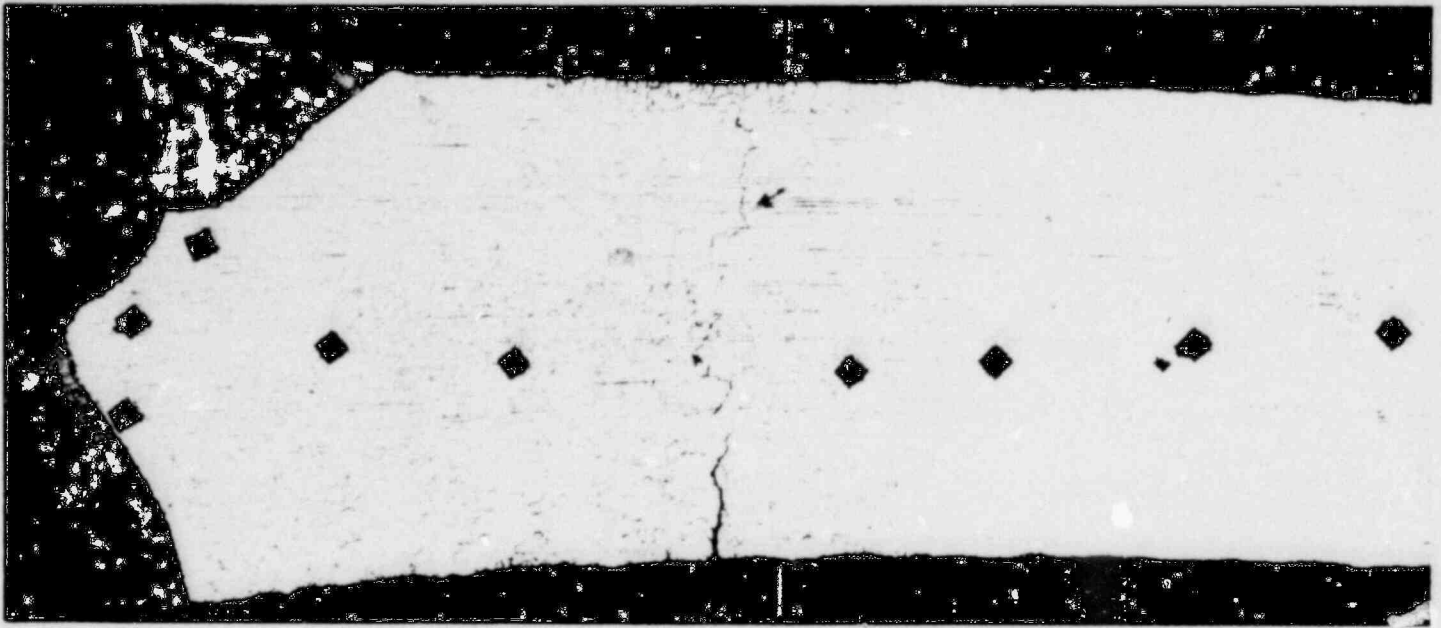
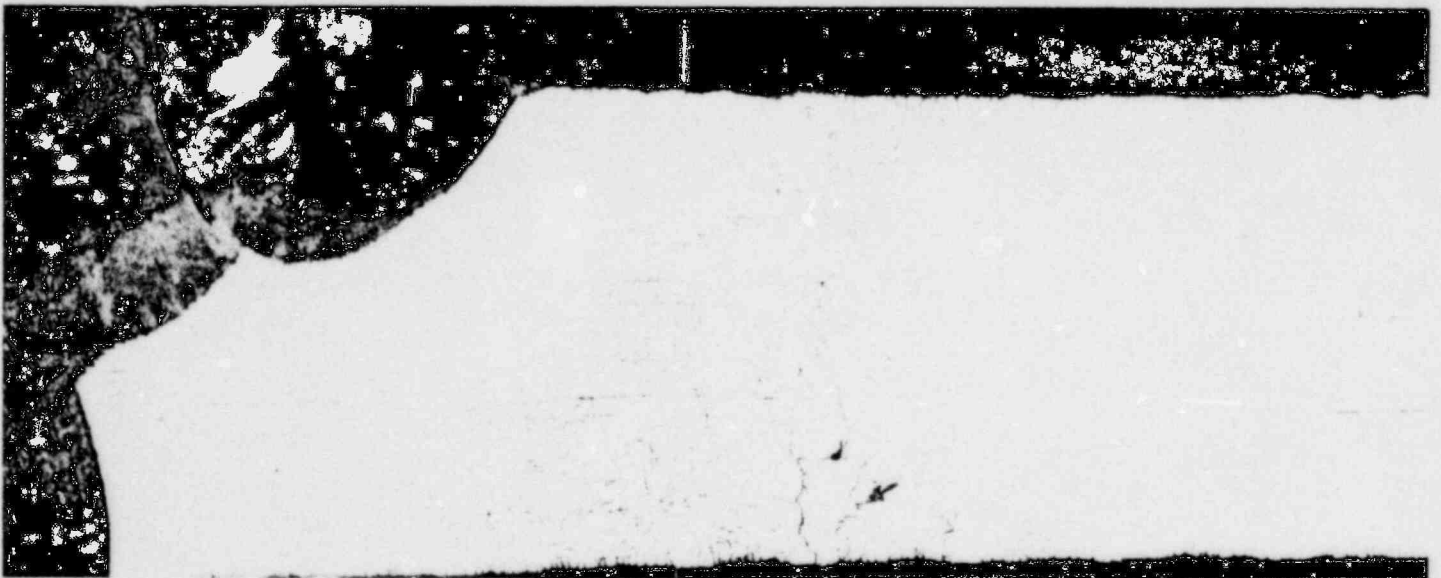
Fig. 3-5 (a) Macrograph showing a section through the crack in Fig. 3-3.
(b) Macrograph showing a section through the crack in Fig. 3-4.
Both electrolytically etched in 10% oxalic acid.

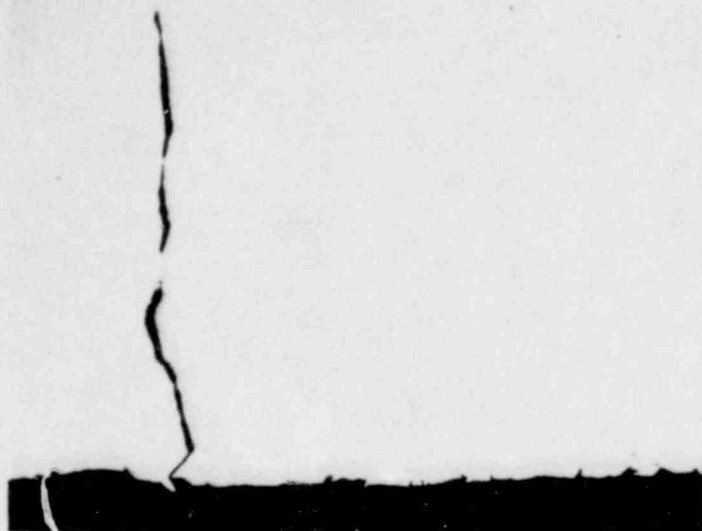
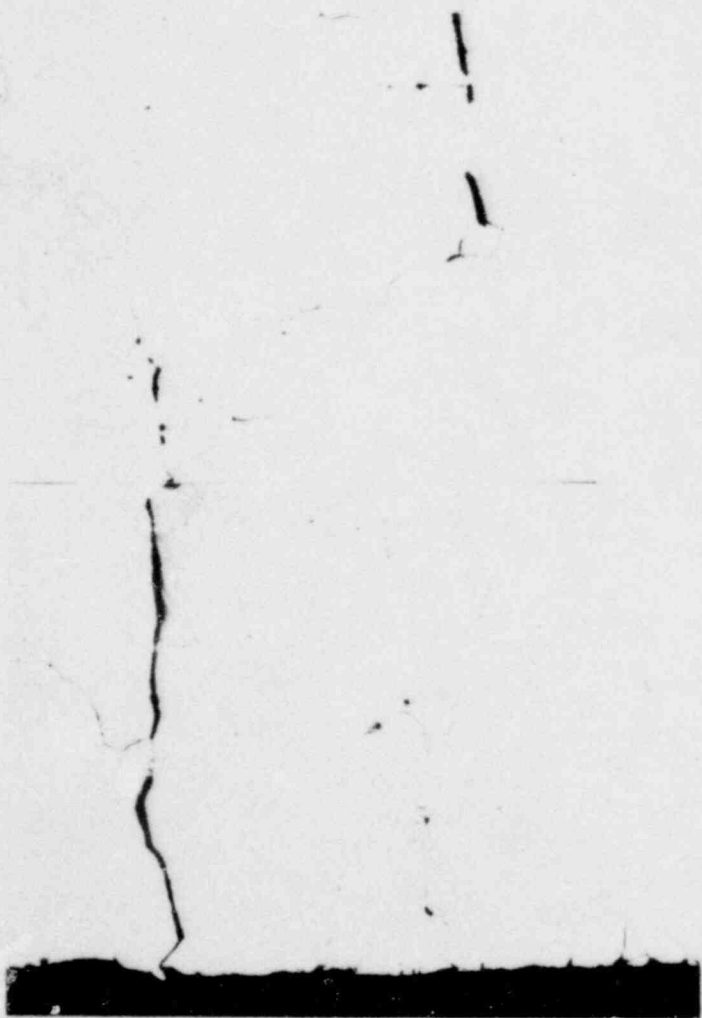
Fig. 3-6 Specimen No. 309 (Sampl-
No. 3)

Micrographs showing the inter-
granular cracks marked by the arrow
in Fig. 3-5 (b) after repolishing.
The interference pattern in (b) was
formed by the etchant that came out
of the cracks.

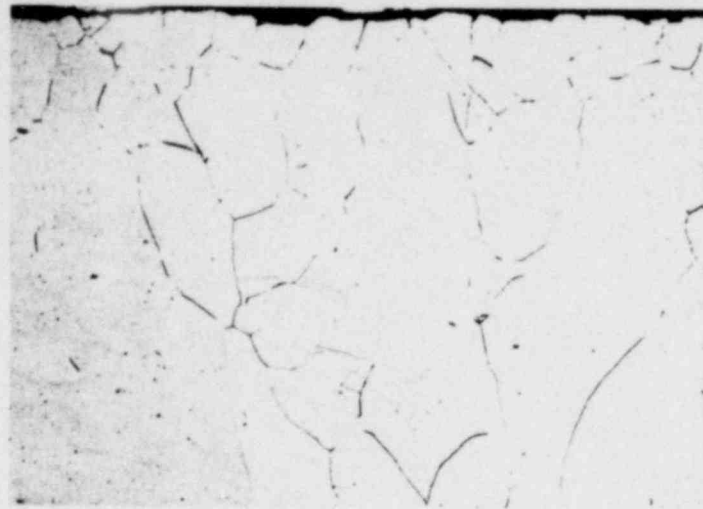
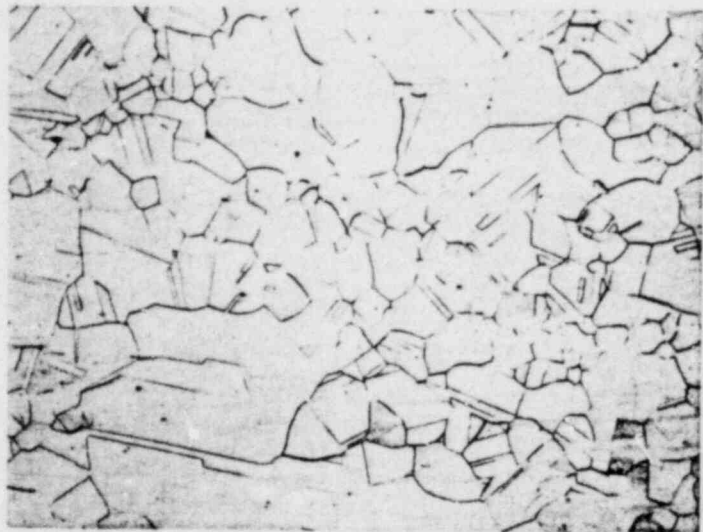
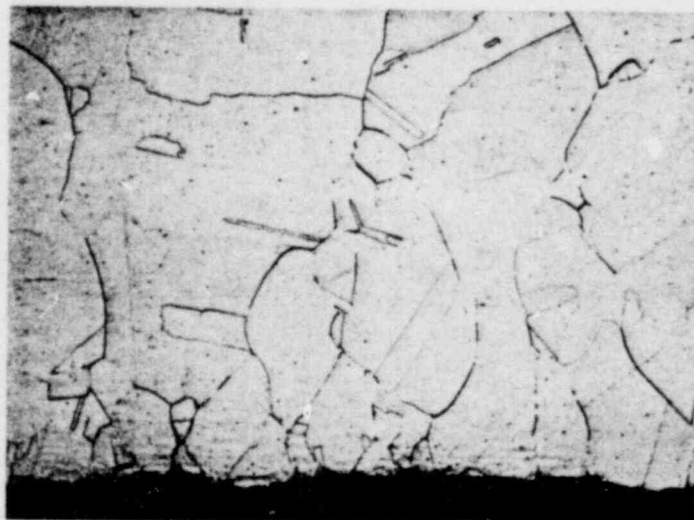
Fig. 3-7 Micrographs showing carbide precipitates in the base metal. Etched electrolytically in 10% oxalic.
