In the Matter of Consumers Power Company
(Midland Plant, Units 1 and 2)
Docket Nos. 50-329 and 50-330

Construction Inspection Plan (WORK COPY)

Facility Name: Midland Plant - Units 1 & 2

Type of Inspection: Special Inspection
(Restart of Construction)

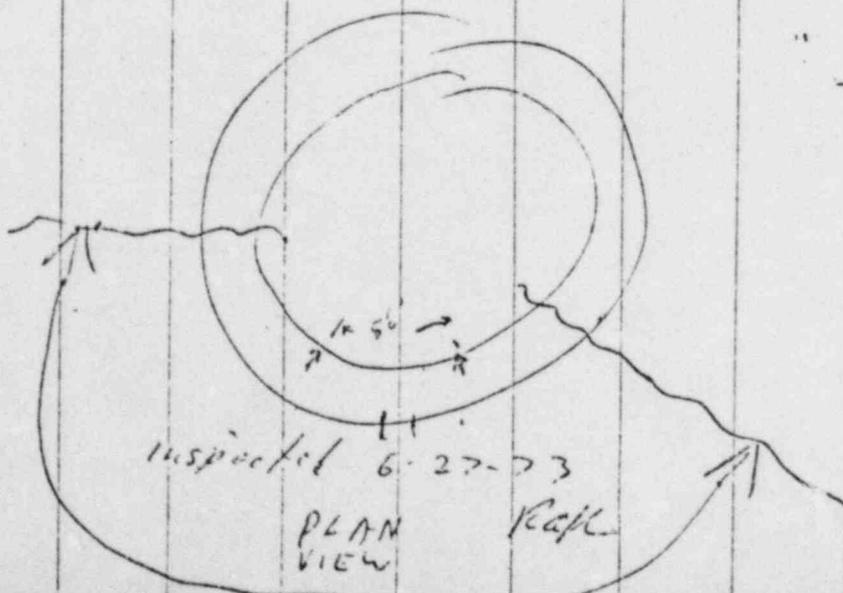
" cracks shown in outside walls - all crack-verticall & predominantly Class 1 only 2 cracks, Class 4, ~ 86' apart (inner wall length gallery case - ~ 700 linear feet.

" cracks were normal drying shrinkage cracks - not unusual, exam. w/ 10X optical no evidence of other type motions - will not impair structural integrity

" Saggin future photo - appears to be same crack. (3+45) Joyce -

Make ITBC for next insp. - inspect rest of T.A.G. & other exposed concrete not visible

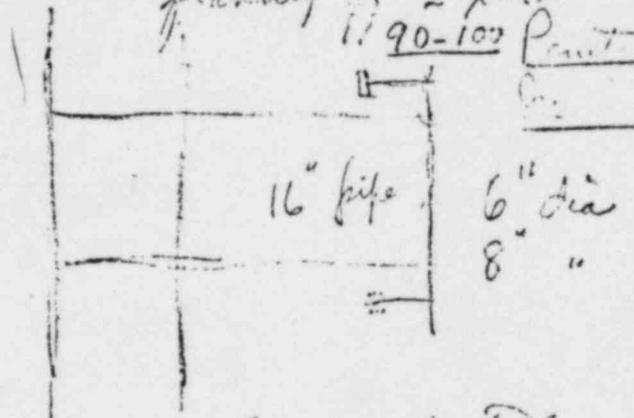
flaking ^{1/2 in}
1190-102 Penetration

Very heavy rusting in pipe
