Point Beach Units No. 1&2  
Docket Nos. 50-266  
-301

SUBJECT: POTENTIAL WELDING DEFICIENCIES IN TANKS FABRICATED BY GRAVER  
TANK AND MANUFACTURING COMPANY

## CALCULATION IDENTIFICATION NUMBER

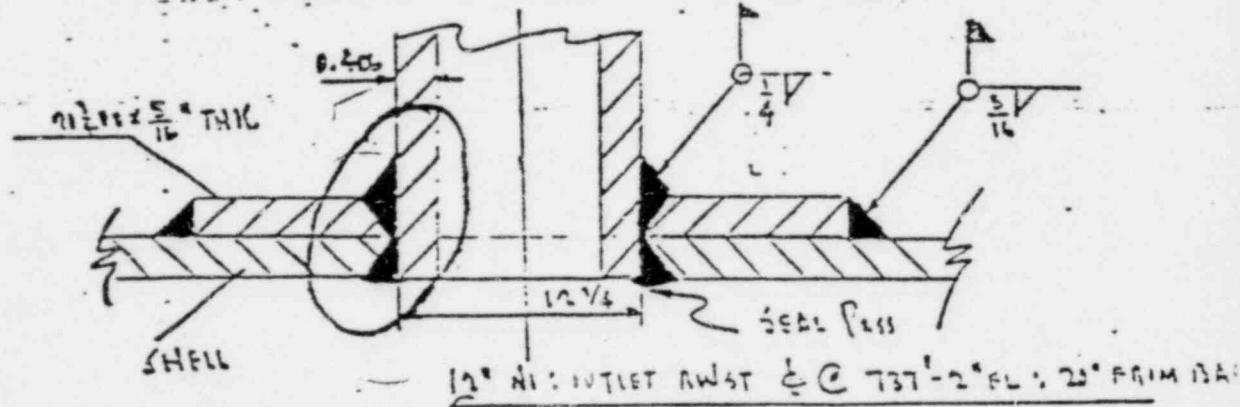
## CONNECTION NI AS REQUIRED BY BVS-183

CONNECTION NI OF B.V. UNIT 1 REFUELING WATER STORAGE TIC WAS NOT INSTALLED AS REQUIRED BY F-11-650 OR BY STKHE & WEBSTER PROCUREMENT SPEC B.V.S-183. THE SPEC. REQUIRES A FULL PENETRATION WELD BETWEEN THE NOZZLE NECK & SHELL AND BETWEEN THE NOZZLE NECK & REINFORCING PAD; IT ADDITIONALLY REQUIRES THAT THE PAD-NECK FULL PENETRATION BE CAPPED WITH A FILLET & REQUIRES A CIRCUMFERENTIAL PAD-SHELL FILLET AROUND THE OUTSIDE OF THE PAD.

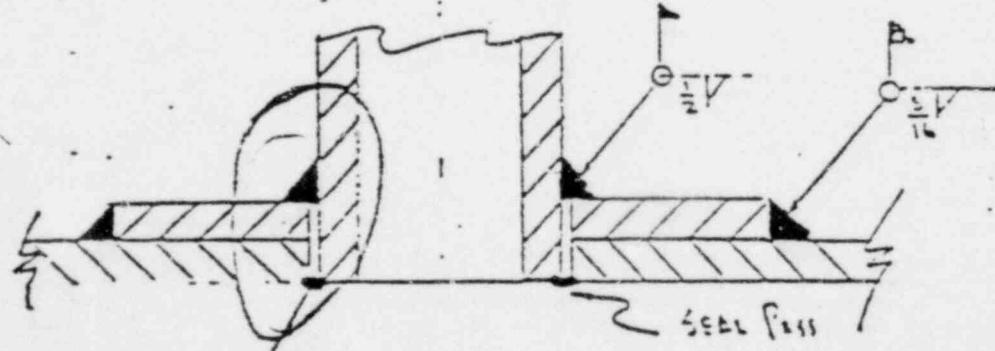
"As-Fabric" Condition

THE TR. MFGR. DID NOT COMPLETE THE PENETRATION WELDS; THEREFORE THE ONLY WELDS HOLDING NI TO THE PAD & SHELL, ARE THE FILLETS.

"NO WELD MITAL"

→ THIS CALCULATION CHECKS THE STRESSES IN THE FILLETS CAUSED BY OBE FABRIC LOSS
