U.S. NUCLEAR REGULATORY COMMISSION  
OFFICE OF INSPECTION AND ENFORCEMENT

Report No. 50-346/80-12

Facility Name: Davis-Besse

Inspection on April 21-24 and May 2 and 6-8, 1980 (Report No. 50-346/80-12)

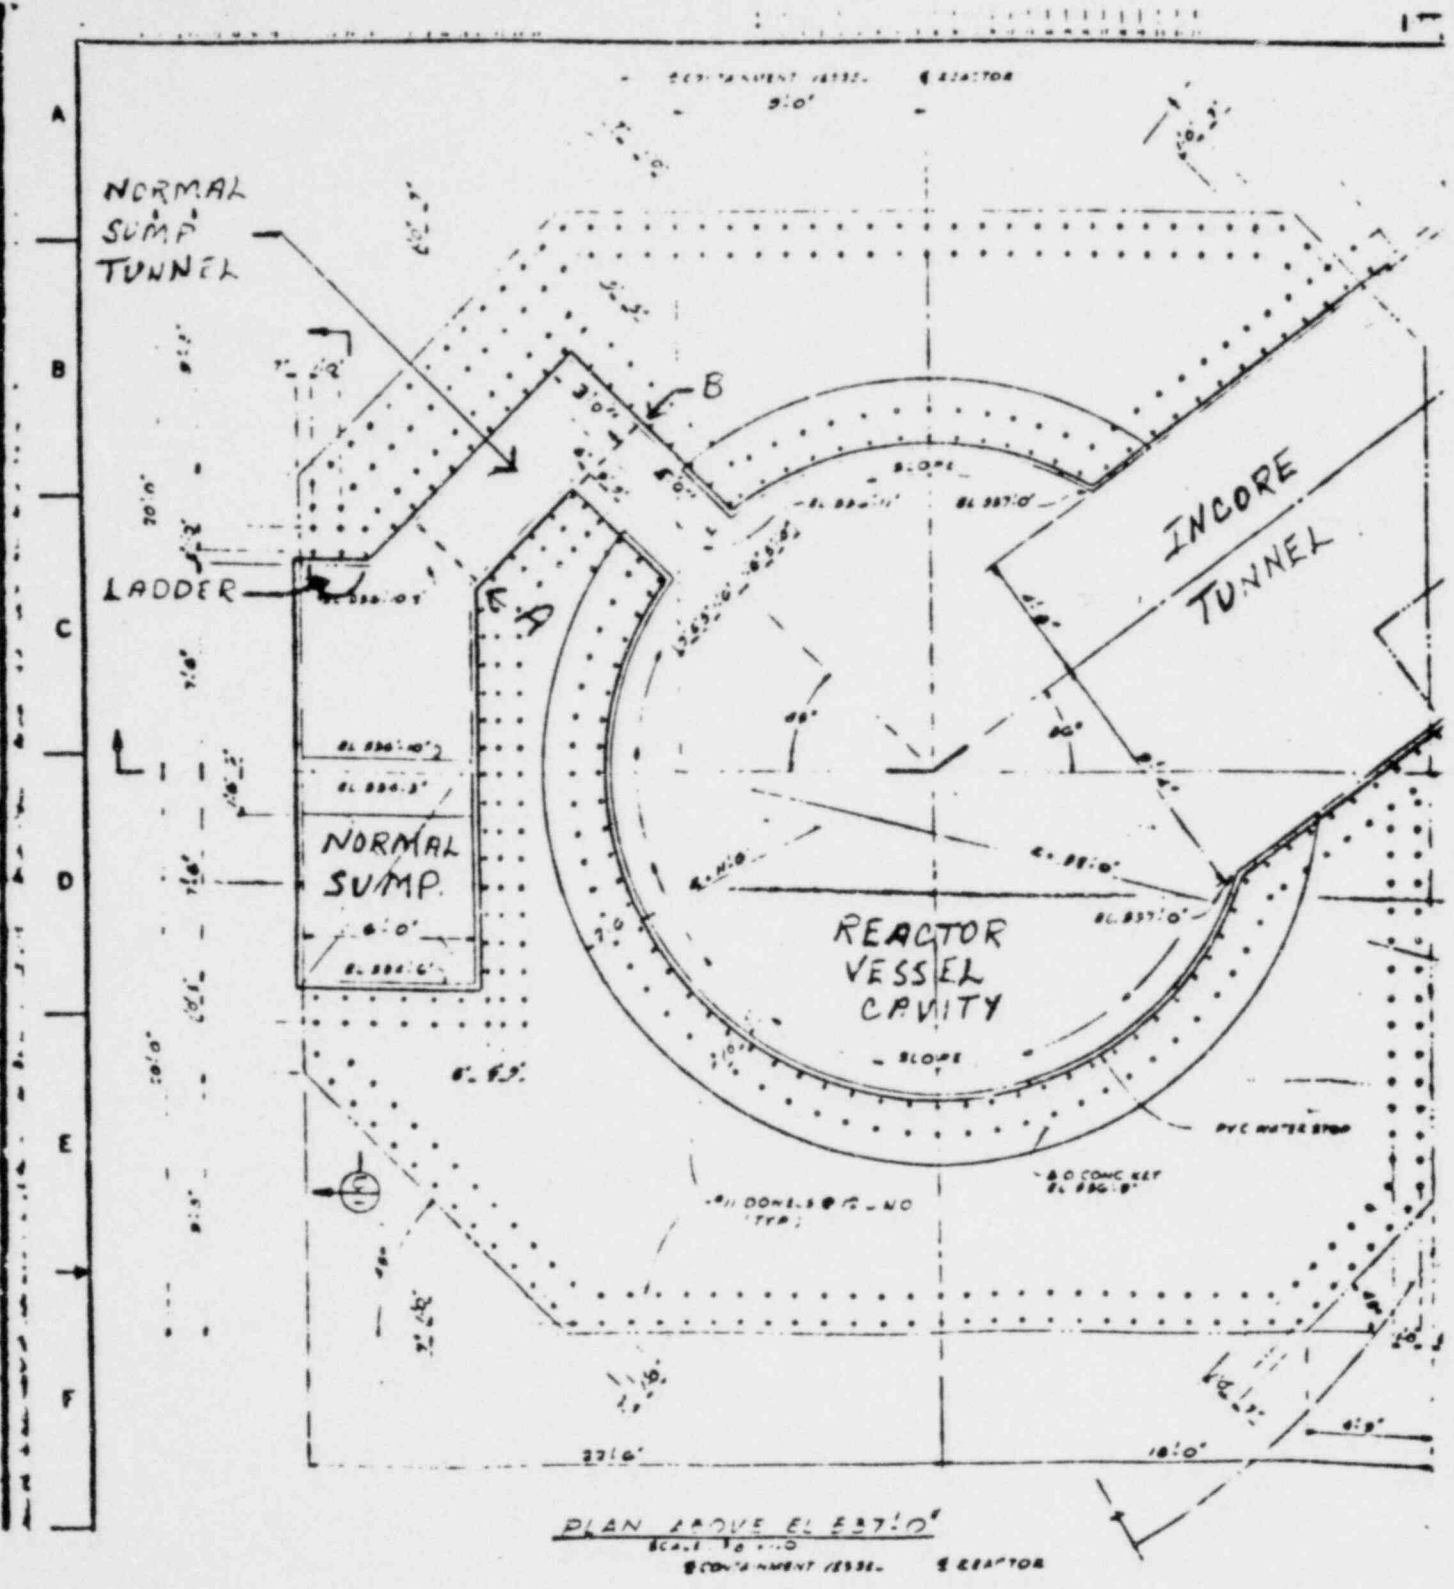
FIGURE 1.

On April 30, 1980, about 11:30 p.m., a senior chem and rad tester accompanied an assistant shift supervisor in a descent to the normal sump tunnel (Figure 1) for a momentary look into the reactor vessel cavity, if radiation levels permitted, to check for any evidence of water leakage from the canal seal plate. This check was made to fulfill step 4.2 of procedure SP1102.15 titled "Fill, Drain, and Purification of the Refueling Canal." No evidence of significant leakage was detected. At the time

At the time of a previous outage in 1978, when the incore instruments were to be withdrawn to the "parked position" beneath the reactor vessel, a temporary wooden door was constructed at the base of the ladder in the tunnel to separate the section of the tunnel leading to the cavity under the reactor vessel from the other end of the tunnel where the normal sump and related equipment are located. A little later in 1978, a Facility Change Request (FCR) was submitted to provide a permanent woven wire barricade or doorway to replace the temporary structure. The proposal suggested the structure be prefabricated for quick installation during shutdowns. Although coded as a "Special High Priority Item" on the FCR, it had not been prepared for installation during the current 1980 refueling outage. Therefore, another temporary door was requested in the tunnel. Contracted crafts personnel constructed the temporary door just around the 90 degree turn in the normal sump tunnel (dotted Line B in Figure 1) rather than the requested location at the base of the ladder (dotted Line A in Figure 1), reportedly due to the complication of piping located in the latter area. Radiation protection supervisory personnel efforts to relocate the door during the weekend before the scheduled late Sunday evening (April 27th) beginning of incore withdrawal to the parked position were unsuccessful. An entry in the H.P. Log on April 27, 1980, noted that the referenced door was improperly located and because of shielding considerations the location was not satisfactory. On April 28, after the

Although a survey sheet/floor plan of the normal sump tunnel (showing only one 90 degree bend leading directly to the Reactor Vessel Cavity) is a standard form available to H.P. personnel, this form was neither posted at the access nor was it consulted by the senior chem and rad tester before entry. Both he and the assistant shift supervisor were unfamiliar with the area, due to very infrequent entries.

During a subsequent interview by the inspectors, the senior chem and rad tester stated he was unaware that the door had been constructed at the wrong location in the tunnel. Although the fact had been noted in the H.P. Log two days earlier, he stated he did not recall reading it. He further stated his normal practice was to read the H.P. Log, but on this occasion he failed either to read or remember the entry. The normal sump tunnel entry without adequate job planning and preparation, as noted by examples described above, constitutes noncompliance with Technical Specification 6.8.1.a and implementing procedure HP 1601.05.1, Section 6.3.4.

- (1) Procedures were modified to prohibit visual inspection of the reactor vessel cavity when the incore instruments are withdrawn to the parked position.
- (2) Two high range survey meters of different types must be used for any entry into a high radiation area.
- (3) The occurrence and changes to procedures put into effect were discussed with operations and health physics personnel.
- (4) The entrance to the normal sump tunnel and other high or potentially high radiation areas in containment have now been posted with a floor plan of the area and, where applicable, the most recent survey data, in the manner previously used for posting such areas located outside of containment.

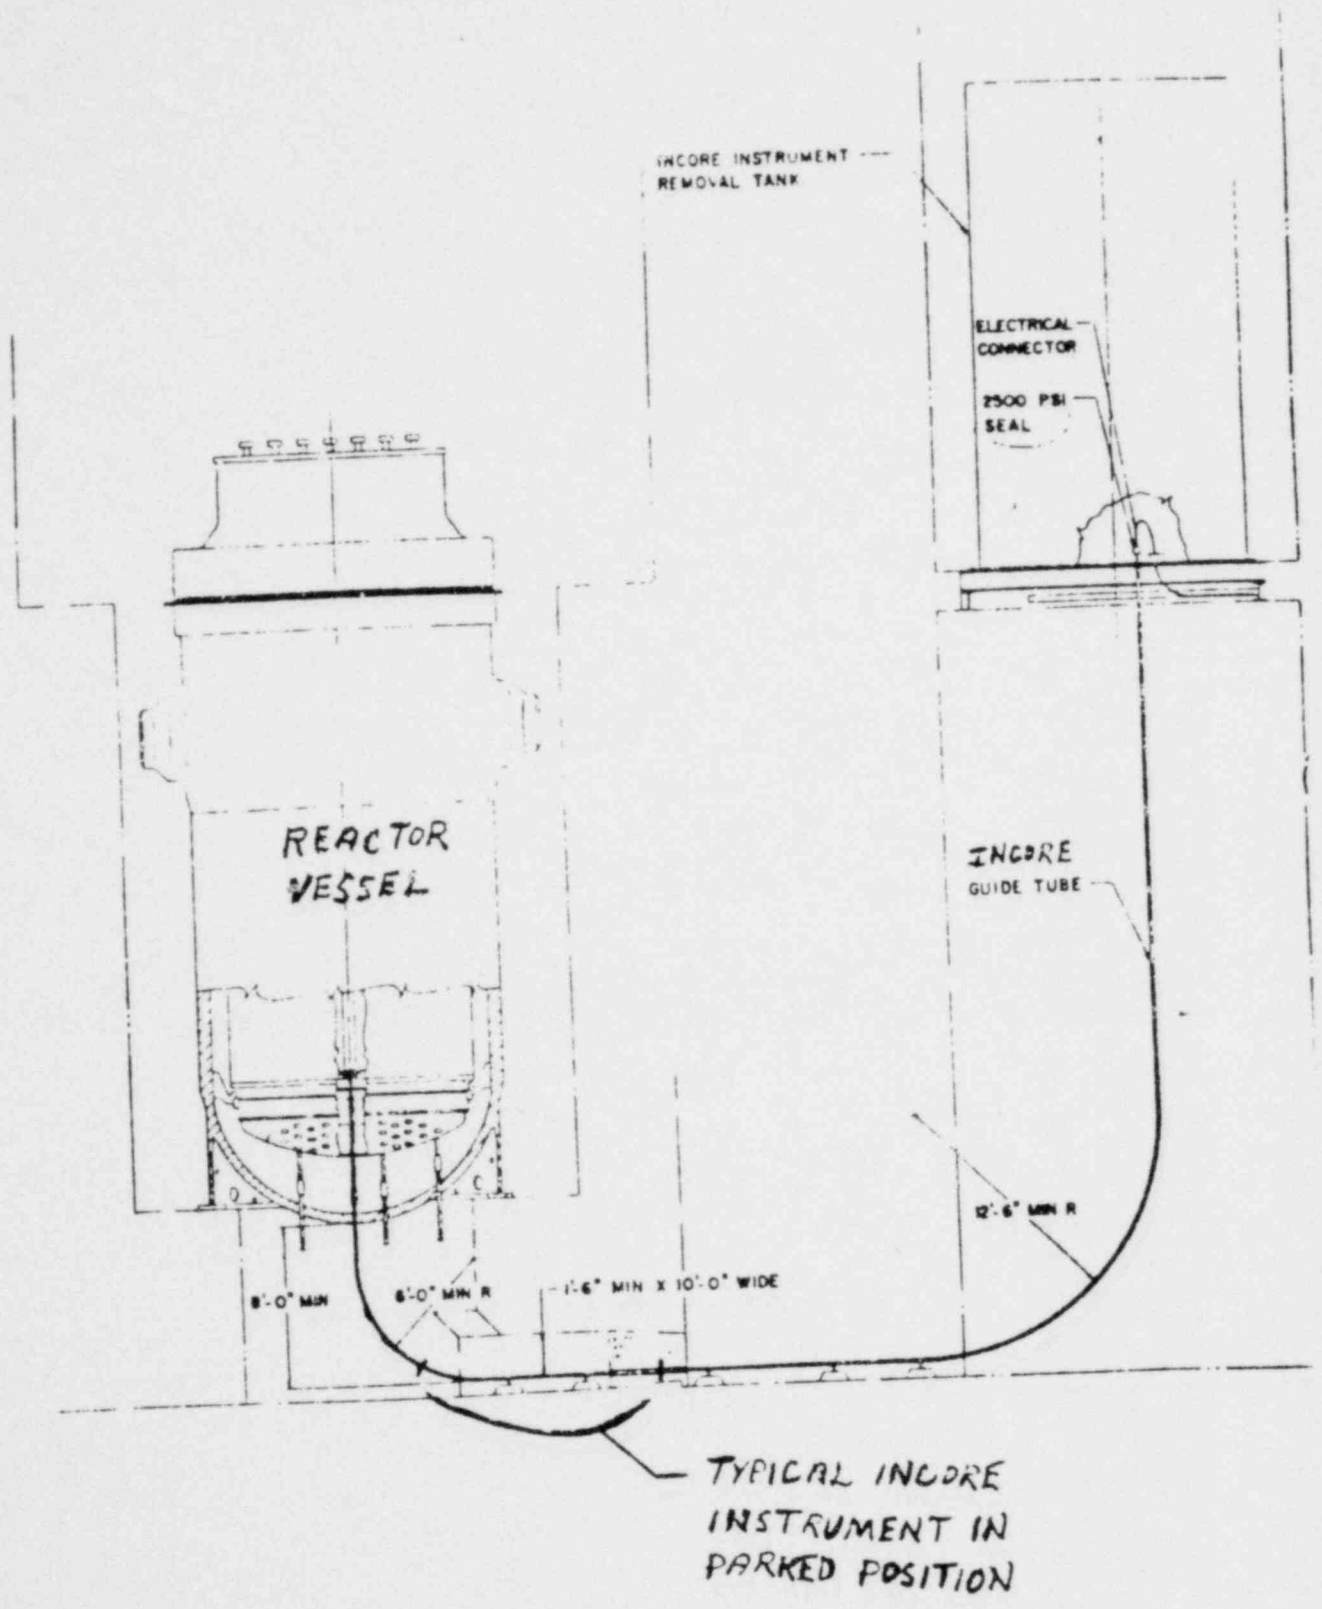
FIGURE 2.

of the occurrence, the incore instruments were in the parked position (Figure 2) beneath the reactor vessel and extending into the incore instrument tunnel. The cavity was a recognized locked, and posted high radiation area. Entry of both persons was covered by proper Radiation Exposure Permits (REP's).

Incore Monitor Guide Tube
