South Texas Project
Units 1 & 2
Final Report on the Safety
Injection System Piping Deficiency

FINAL REPORT

SAFETY INJECTION SYSTEM PIPING DEFICIENCY May 30, 1980

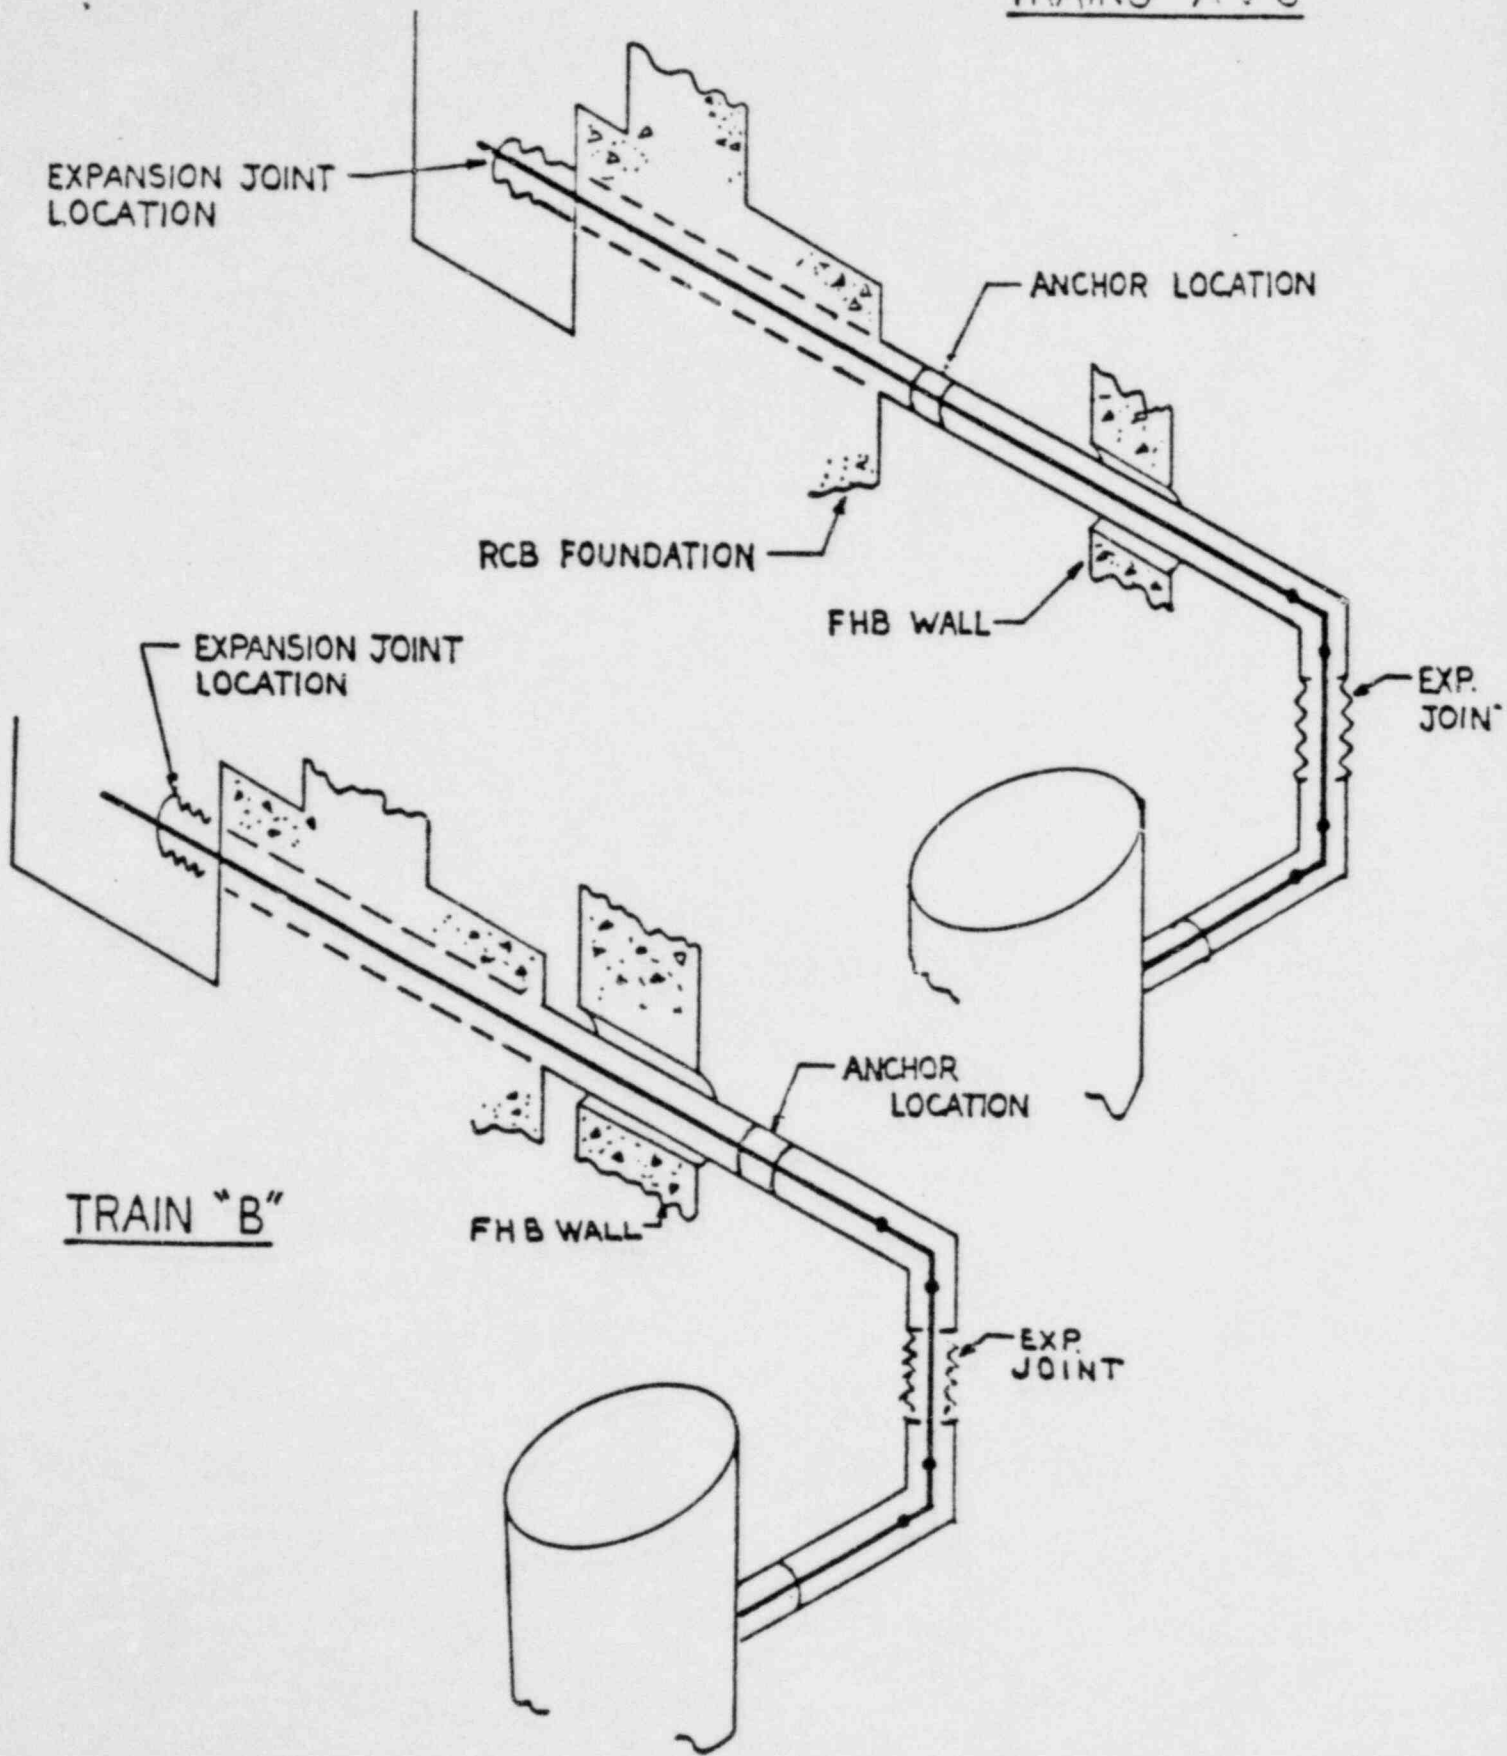
FIGURE - 1

During a routine review, a design deficiency was discovered which, if left uncorrected, could have adversely affected the safety of operations. The joint between the 16 inch Safety Injection System piping and the emergency sump liner was shown on the construction drawing to be a one-quarter inch seal weld, which does not meet the design load criteria.

If this deficiency were to have been left uncorrected, the weld at sump liner/process pipe interface could fail. The process pipe would then be free of restraint and would impose a load on the recirculation valve which exceeds the allowable end loads. It could not then be guaranteed that the valve would operate as required. Because this problem affects all three trains, this is a common mode failure which could cause loss of safety system functions.

This deficiency will be corrected by anchoring the process pipe to the guard pipe outside the containment building and adding an expansion joint to the process pipe inside the emergency sumps (see Figure 1).

- Pipe Stresses
- Recirculation Valve End Loads
- Safety Injection Pump Load Limits
- Sump Liner Load Limits
- Containment Penetration Sleeve Load Limits
- Differential Settlement Criteria
- Containment Pressure Boundary Continuity
- Process Pipe and Guard Pipe Should Not Impact During a Seismic Event
- Constructability
