Portland General Electric Company
Trojan Nuclear Plant
71760 Columbia River Hwy
Rainier, Oregon 97048
(503) 556-3713

October 23, 1989
CPY-269-89

LICENSEE EVENT REPORT (LER)

TITLE (4): **Containment integrity violated during local leak rate testing.**

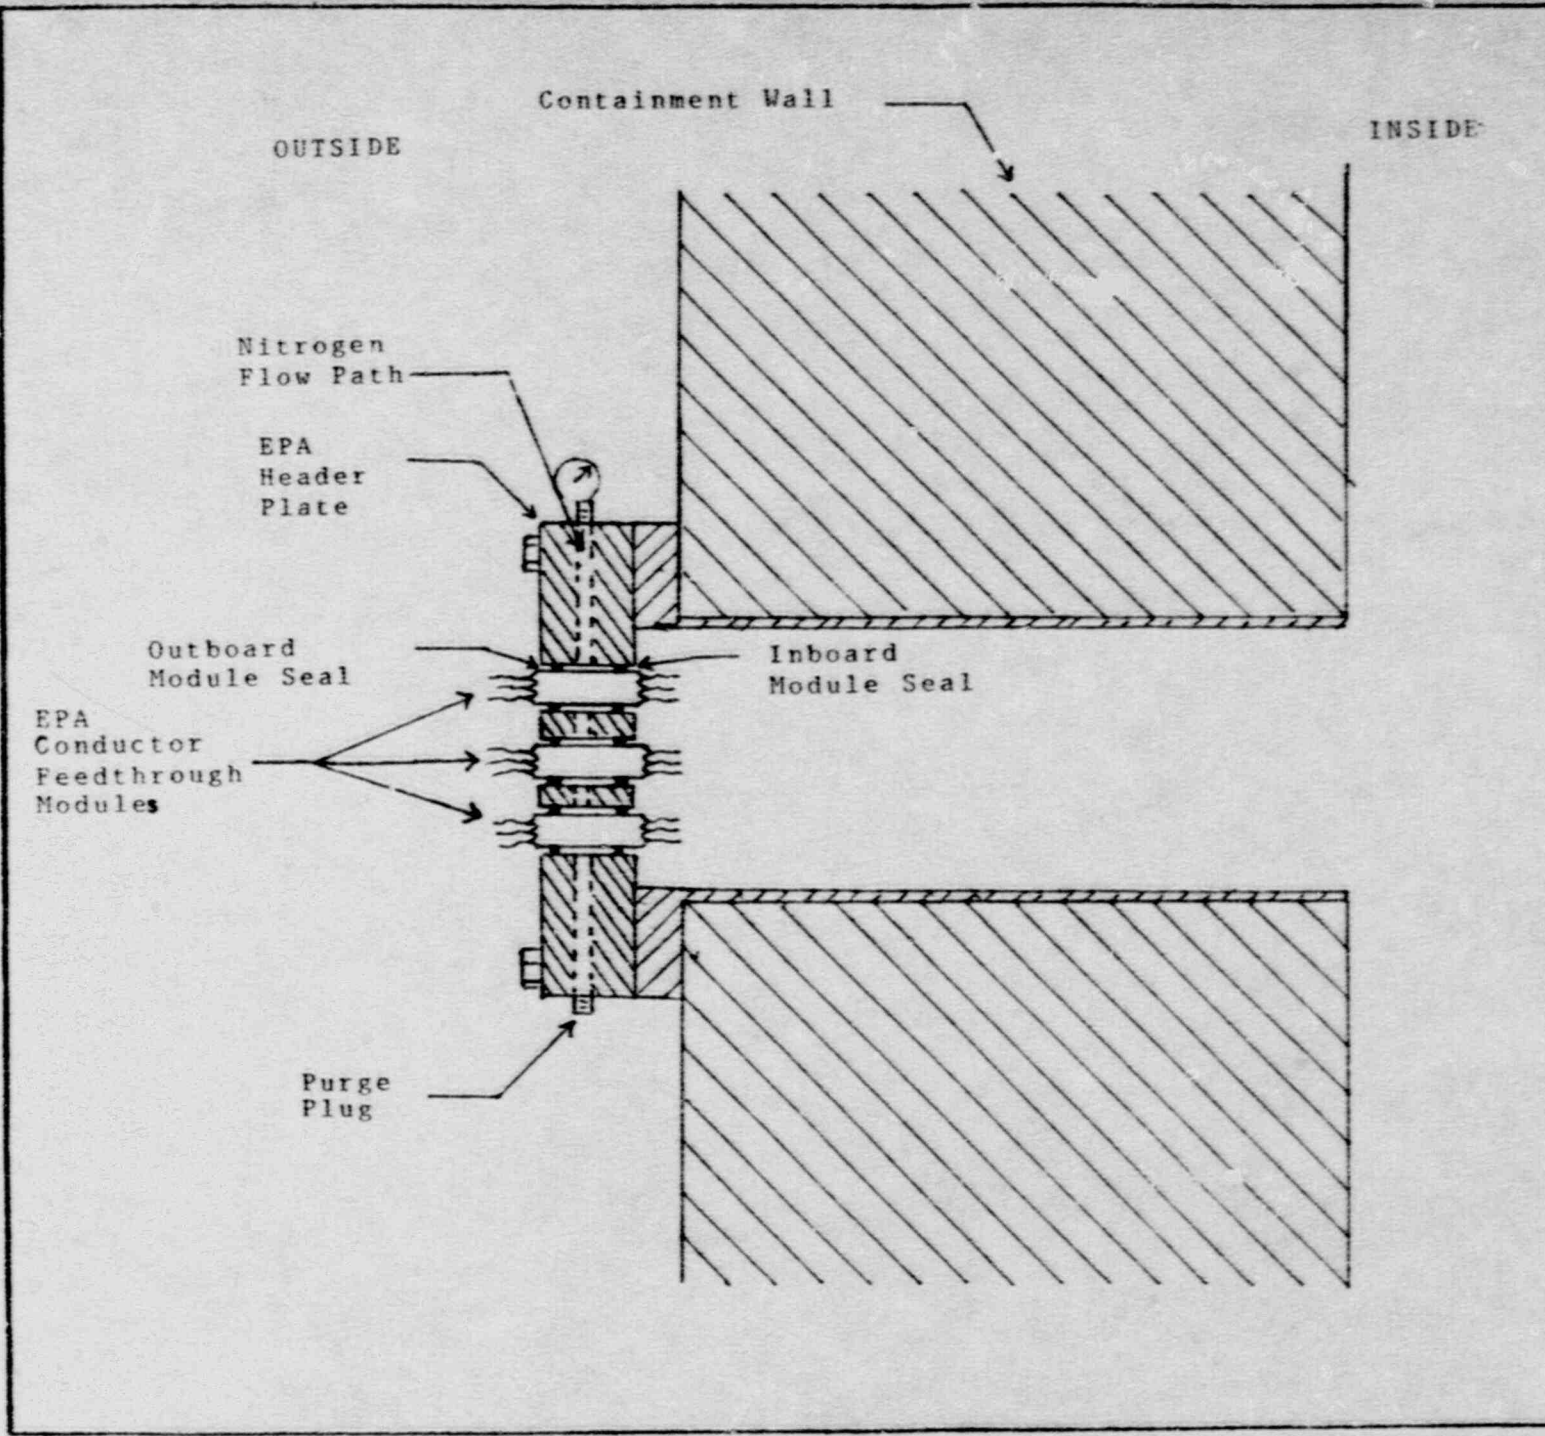
Figure 1 - Amphenol SAMS Electrical Penetration Assembly (EPA)

The first step in doing a LLRT on an EPA is to purge the penetration by removing the purge plug (see Figures 1 and 2 attached). This step was added on May 15, 1987, in response to INPO Nuclear Network Operating Plant Report EO 1910 "Electrical Penetrations Assemblies" of December 12, 1986. Nitrogen is purged through the port to verify the flow path is not obstructed from the check valve (see figure 2 attached) to the purge port. This ensures all the modules and the check valve will be pressurized during the test. The LLRT test cart is then connected to the purge port and the LLRT is conducted.

1. The removal of the purge plug for purging provides a direct path from inside Containment to the atmosphere, because the inboard seal of an EPA does not provide a Containment pressure boundary seal. Therefore when in Modes 1-4 with the purge port plug removed, Containment integrity is no maintained and the Action Statement of TTS 3.6.1.1 is entered.

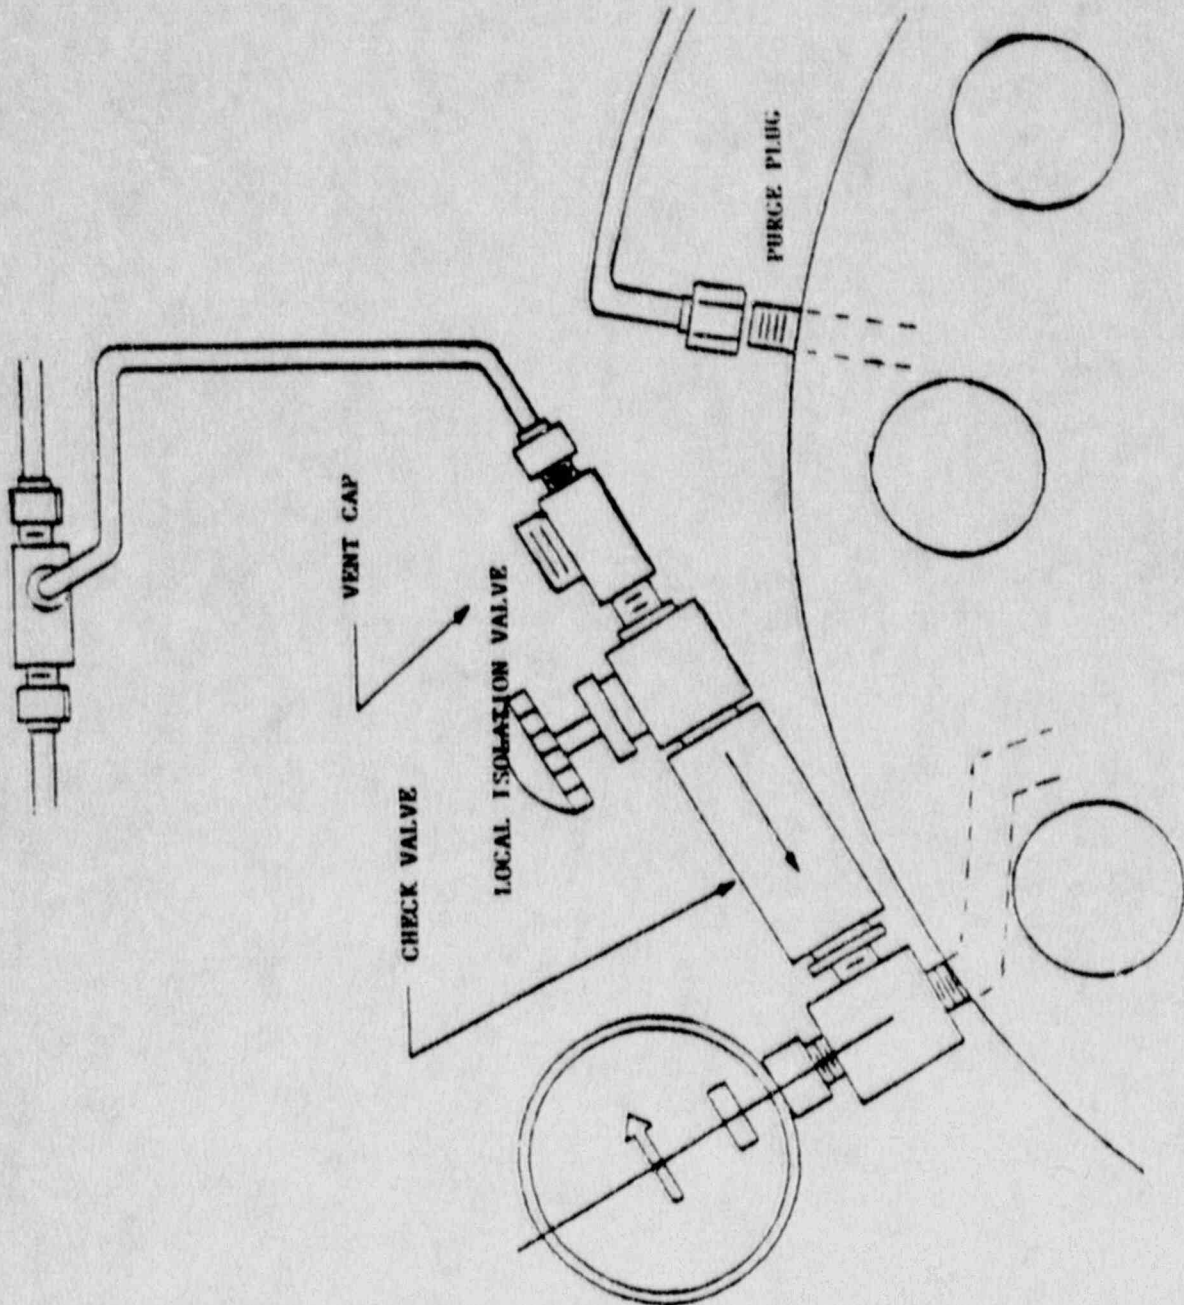
Figure 2 - Nitrogen System Interface

- b. In late 1988 information was disseminated outside of engineering that the inboard seal could not be considered a pressure boundary. PET 5-2 was reviewed with this information in mind, and the check valve in the nitrogen feed system was included in the boundary for PET 5-2. It is believed the entrance into TTS action statements was missed because the procedure does not address the possibility that testing might occur during Modes 1-4 (see cause 1). The procedure infers the test will be done in Mode 5 or 6, but does not disallow Modes 1-4. Personnel failed to realize the additional concerns with using PET 5-2 to quantify leakrates in Modes 1-4.
