Subject: NRC Region I Augmented Inspection Team (AIT) Inspection (50-220/89-80) of the use of the Radwaste Building sub-basement as a long-term liquid waste retention facility at Nine Mile Point, Unit 1

U.S. NUCLEAR REGULATORY COMMISSION  
REGION I

Report No. 50-220/89-80  
Docket No. 50-220  
License No. DPR-63  
Licensee: Niagara Mohawk Power Corporation  
300 Erie Boulevard West  
Syracuse, New York 13202

Facility Name: Nine Mile Point Unit 1

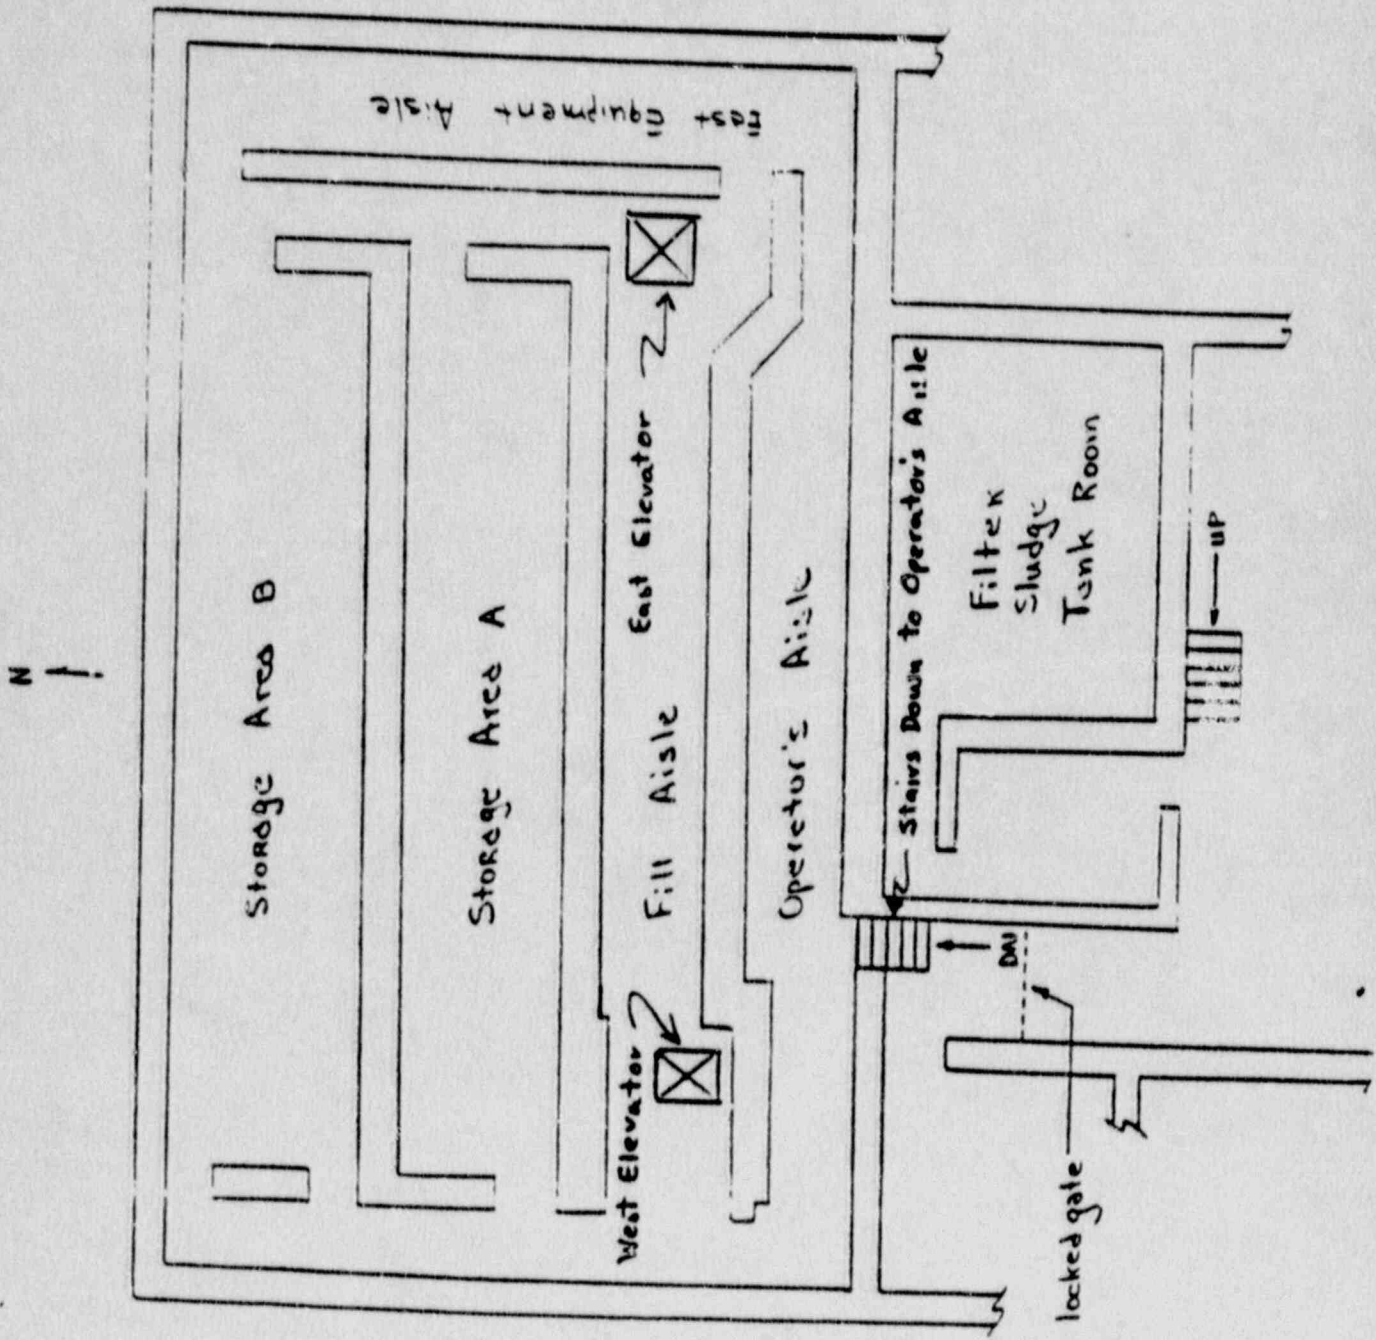
Figure 1

The 225' elevation of the Radwaste Processing Building is a sub-basement of approximately 2400 square feet, subdivided by 30" thick shield walls into five working areas: the operator's aisle, the fill aisle, storage areas A and B, and the east equipment aisle (see Figure 1). The room is the lowest point in the radwaste building and contains two floor drain sumps. The #11 sump is located in the east equipment aisle and the #12 sump is located at the west end of the operator's aisle. The sumps were used for the collection of waste from routine washdowns/decontaminations of the processing line. In addition, the sumps received additional inputs from other sources within the radwaste building. Both the floor and the lower portions of the walls were painted with a protective coating to facilitate decontamination of the room. The room was designed to receive processed wastes in the form of dewatered resins and sludges, transfer the waste material into 55-gallon drums, provide temporary storage capability, and to make final transfer to a loading dock for shipment in shielded casks.

Floor Plan  
225' Elevation Sub-basement  
Radwaste Building
