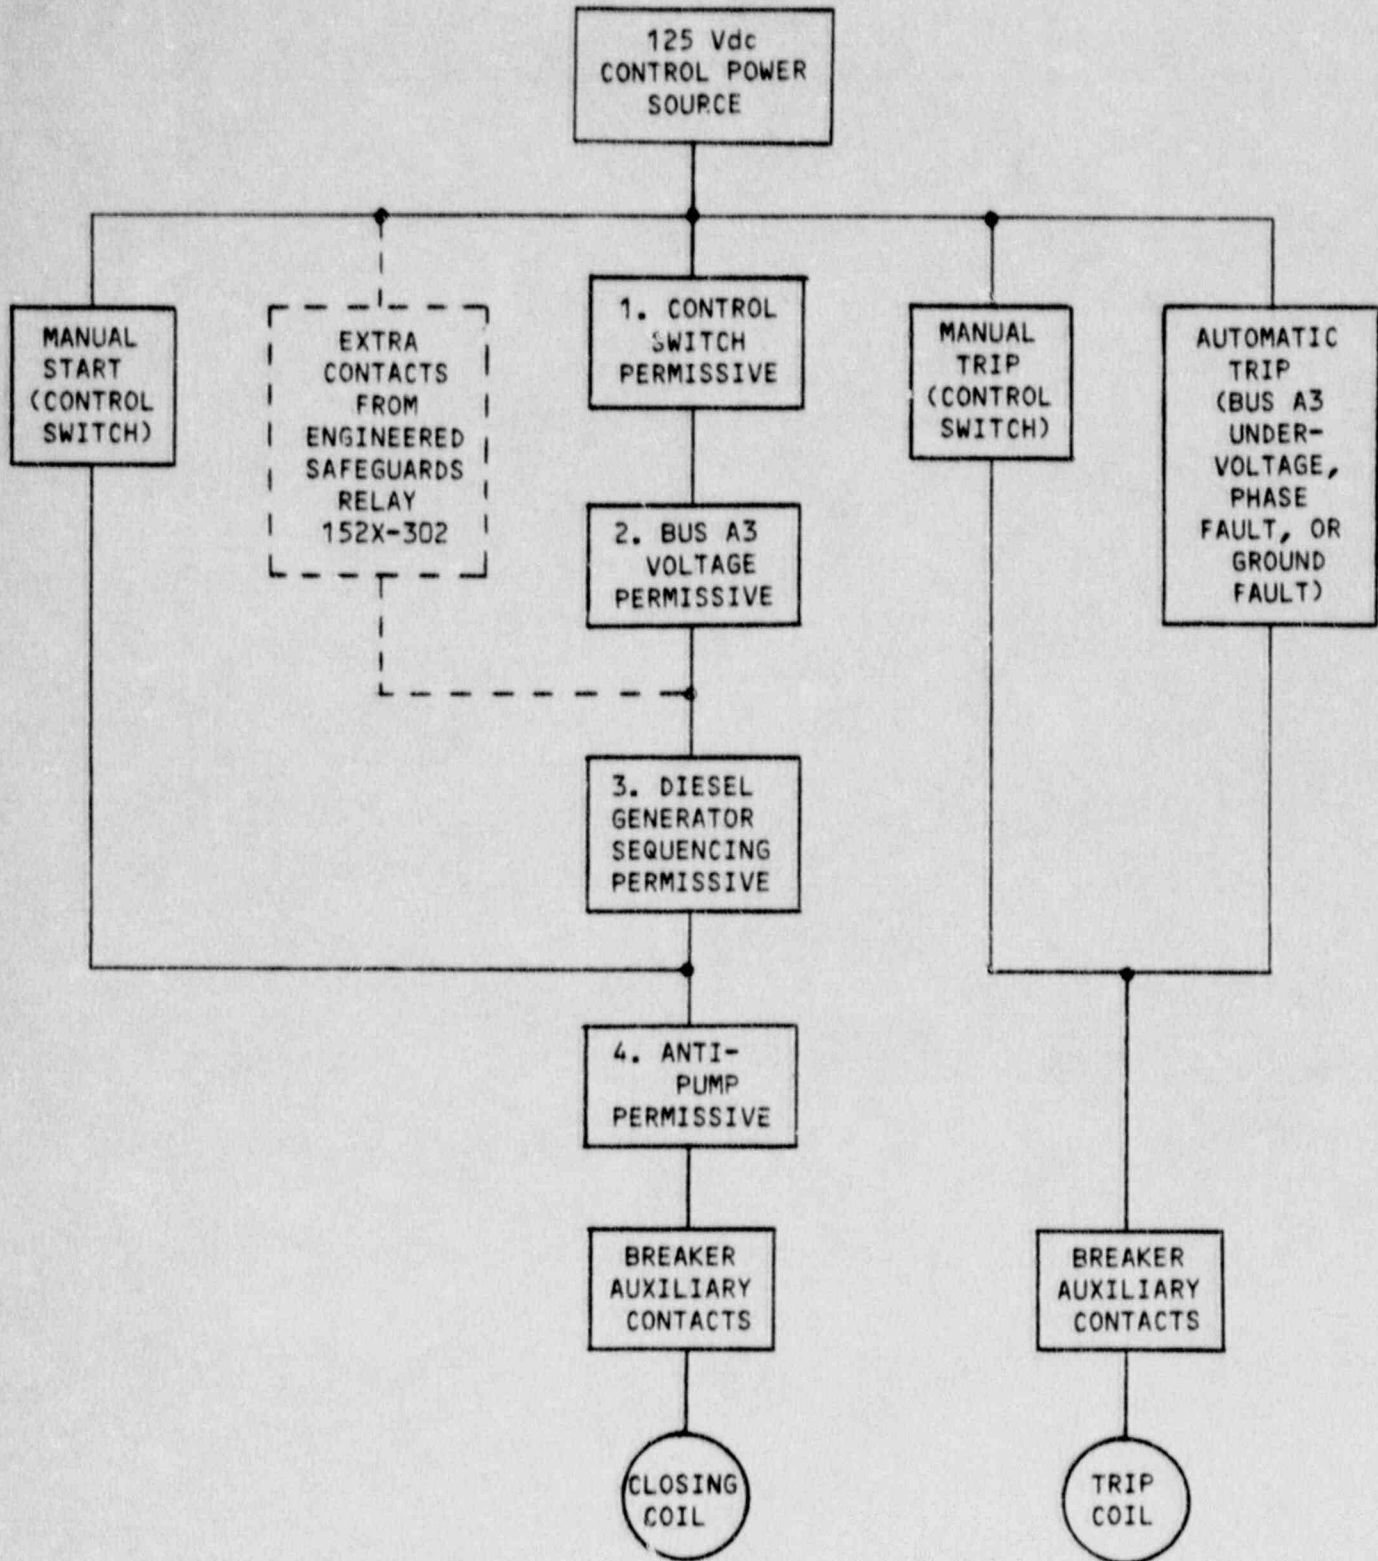
FIGURE 2

On September 13, 1989, a review of the control circuits for the remaining service water pump motor feeder breakers revealed that an identical wiring error existed in the control circuit for Service Water Pump P4C (Breaker A402). The licensee issued a second condition report (CR-1-89-484). The operability assessment for this condition report was performed by a third engineer who identified a scenario in which the extra contacts would have prevented the circuit from performing its intended safety function. Under plant conditions where: (1) an ESF signal would be generated (resulting in a reactor trip and turbine-generator trip); (2) offsite power remained available; and (3) if a fast transfer (approximately 6 cycles or 1/10 of a second) of plant safety-related loads from the unit auxiliary transformer to the startup transformer failed to occur, but a slow transfer (less than 2 seconds) did occur, the wiring error would have prevented the automatic restart of the affected service water pumps. The normally operating service water pumps would trip on undervoltage at their respective 4160 VAC buses if a fast transfer did not take place. Pump restart would be prevented because the extra contact in the breaker control circuits would have sealed in the circuit breaker anti-pump circuit, which was designed to lock out the breaker in the tripped position.

The licensee determined that the extra contacts had existed in the breaker control circuits since plant construction in 1974. Although Service Water Pump P4B was unaffected by the wiring error, only Pumps P4A and P4C were operating in the normal system lineup. P4B was a standby "swing pump" that could be powered from either electrical division and was used to replace Pumps P4A and P4C when they were taken out of service. If pumps P4A and P4C were in service when an ESF signal and slow transfer to offsite power occurred, neither pump would restart. The standby pump (P4B) would have to be manually started to reestablish service water flow. Under these conditions, a single failure of P4B would result in the loss of all service water. Restart of Pumps P4A and P4C could only be accomplished through nonroutine operator actions at the breaker cubicles in their respective switchgear rooms since the anti-pump circuit bypassed both the remote and local control switches.

A simplified block diagram of the control circuit for Breaker A302 is shown in Figure 2. The control circuits for Breakers A303, A402, and A403 are similar. The control circuit is designed to either: (1) close the breaker by energizing

Following a trip of Breaker A302 on Bus A3 undervoltage, four conditions (permissives) must be satisfied before the breaker will automatically reclose to restart Pump P4A. The permissives are numbered 1 through 4 on Figure 2 and are listed below:

1. The pump must be running when the undervoltage condition occurs (the control switch contacts are closed in the "after start" position; a pump not previously running will not automatically start).

2. The voltage at Bus A3 must have returned to above the undervoltage trip setpoint (i.e., bus voltage is acceptable for pump operation).
3. Power to Bus A3 must be supplied from upstream 4160 VAC Bus A1 via Circuit Breaker A309 within 2 seconds of the undervoltage condition or breaker closure is prevented until 15 seconds after power is restored to Bus A3 from Emergency Diesel Generator No. 1 via circuit Breaker A308. The 15-second delay is provided to ensure proper diesel generator load sequencing. The tripping of Feeder Breaker A309 on Bus A3 undervoltage is delayed for 2 seconds to allow time for a slow transfer to restore power to the bus from offsite.

None of the above conditions for automatic restart of a service water pump depend on the existence of an ESF signal. However, the extra contacts from engineered safeguards Relay 152X-302 that were found wired onto the breaker close circuit effectively bypass the control switch and Bus A3 voltage permissives. The extra contacts are shown using a dashed line in Figure 2. The problem caused by the extra contacts is that on an ESF signal where a slow transfer from the unit auxiliary transformer to the startup transformer occurs, the breaker will trip on bus undervoltage, but the existing breaker close signal will not clear because the Bus A3 voltage permissive is bypassed by the contact. The slow transfer will restore power to Bus A3 within 2 seconds (therefore, Bus Feeder Breaker A309 remains closed), but not before the breaker has attempted to reclose and the anti-pump circuit has energized and sealed in. Since both the remote and local control switch contacts are bypassed by the extra contact, reset of the anti-pump circuit (hence, breaker closure to restart the pump) is not possible without nonroutine operator action (e.g., removing the circuit breaker 125 VDC control power fuses at the breaker cubicle in the switchgear room. If the extra contact were not in the circuit and a slow transfer occurred, the Bus A3 voltage permissive would clear the close signal at the same time that the breaker trips on bus undervoltage. Reclosure of the breaker does not occur until bus voltage returns to an acceptable level (seal in of the anti-pump circuit will not occur until after the breaker has successfully reclosed).

the licensee declared Pumps P4A and P4C inoperable. The third service water pump (P4B) remained operable; its breaker control circuits did not contain the extra contacts. The ANO-1 Technical Specifications (TS) contained a limiting condition for operation (LCO) that required the reactor to be in the hot shutdown condition within 36 hours if two out of the three service water pumps were not operable to provide redundant and independent flow paths. On September 15, 1989, the licensee removed the extra contacts and exited the LCO.
