Maine Yankee

Subject: Maine Yankee Licensee Event Report 89-005-00, Emergency Core Cooling System (ECCS) Valve Not Fully Closed

LICENSEE EVENT REPORT (LER)

Title(4)
Emergency Core Cooling System (ECCS) Valve Not Fully Closed

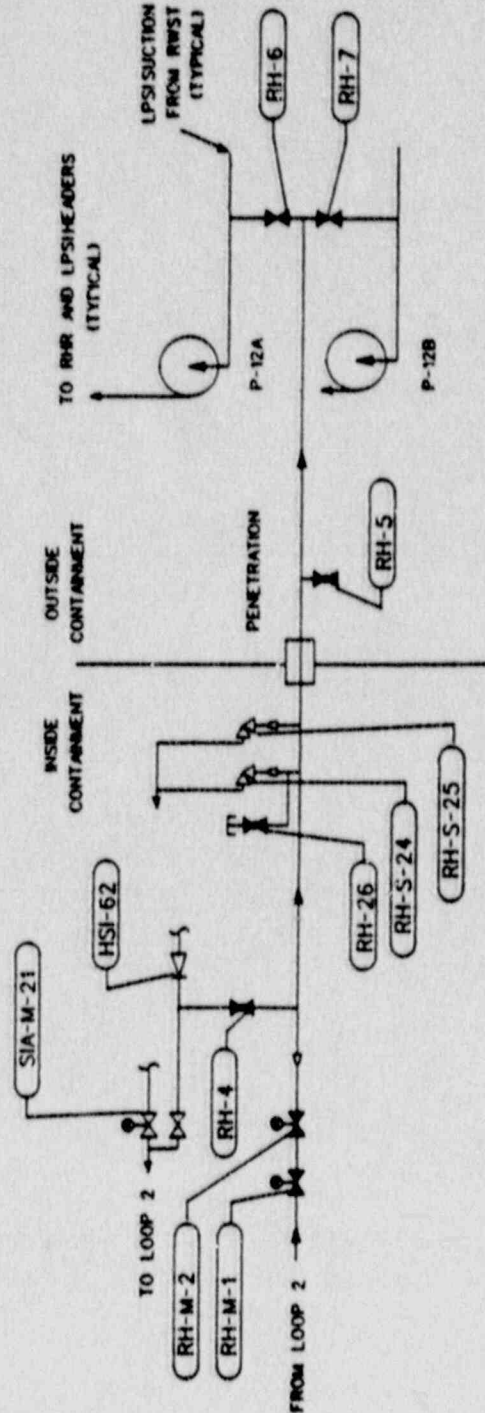
During plant startup on October 15, 1989, while shutting down the Residual Heat Removal (RHR) (BP) system, operators identified leakage past the B train RHR pump (P) suction valve (V), RH-7. During normal operation, the RHR pump serves as the B train Low Pressure Safety Injection (LPSI) (BP) pump. Technical Specifications require RH-7 to be locked shut for Emergency Core Cooling System (ECCS) operation. Additionally, RH-7 is one of the locked shut containment isolation barriers, outside containment, for the RHR penetration (PEN). Refer to the attached figure.

RH-7 is a manual valve operated remotely by reach rods. The handwheel mounting pedestal has a slot to provide local position indication. A position indication pin goes through the slot into a collar that moves up and down the threaded pedestal extension stem as the valve is opened and closed. The position indication pin impacted on the bottom of the slot, preventing full valve closure. The pin was removed and the valve was closed six more turns. Six turns equates to approximately 5% open. Further investigation revealed that the slot was too short for the full valve stroke.

Review of operating data and maintenance history determined that RH-7 had probably been in this condition since December 1988. At that time, the valve stem and the angle drive between the reach rod and the valve gear box were replaced. The post-maintenance functional test did not include verification that the position indication allowed full valve travel. The valve stem had been bent and several gear teeth in the angle drive had sheared due to excessive force when closing the valve. This indicates that prior to the maintenance, the valve was fully closed. There is no record of changing the handwheel pedestal or the pedestal extension stem.

The condition of local position indication on similar ECCS valves was checked. The position indication pins on three other valves were found impacting on the ends of the position indication slots, however, no valves were found where the position indication arrangement adversely impacted on valve position. The position indication slots for the three other valves have been elongated, to prevent impacting by the position indication pins. Post-maintenance functional testing requirements will be revised by the end of the 1990 refueling outage to ensure the position indication does not prevent full stroke valve operation. Also, a recently developed procedure for reach rod maintenance includes requirements to ensure position indication matches actual valve position.
