50-269

TRIP REPORT/OCONEE POWER OSCILLATIONS SUBJECT:

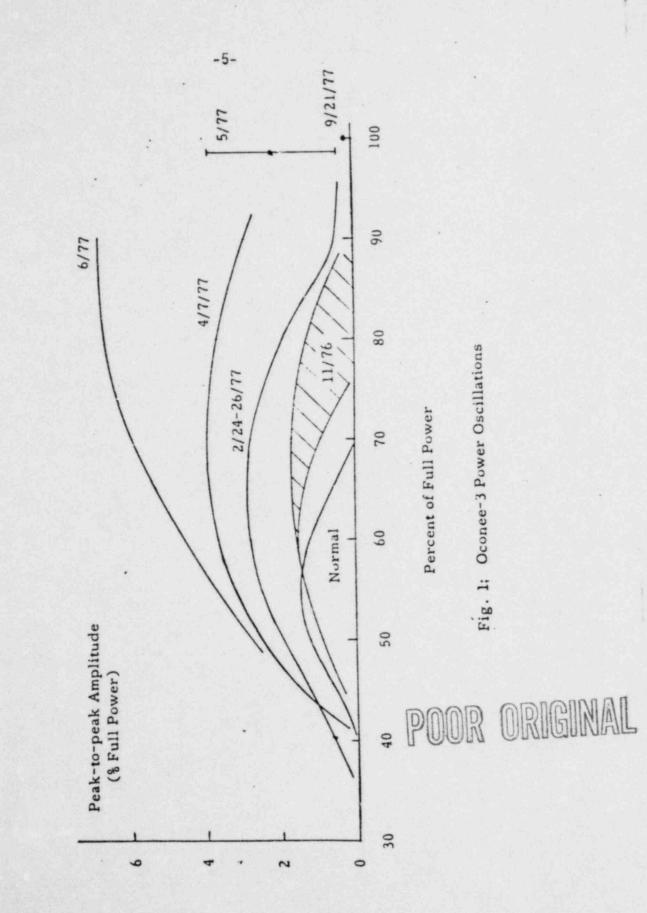
For Oconee Units 1, 2, and 3, the Licensee considers 0.25 he.tz power oscillations to be normal in the power range from 40 to 70% when the peak-to-peak amplitude is 1.5% of full power. Following the first re-fueling outage for Unit-3 which occurred last fall, the power oscillations became progressively larger as shown in Figure 1.
